**Subject: 2026 Annual USEPA CCR Landfill Inspection Report**  
**Brunner Island Ash Disposal Area No. 8**

**APPENDIX A**  
**INSPECTION PHOTOGRAPHS WITH MAP LOCATIONS**

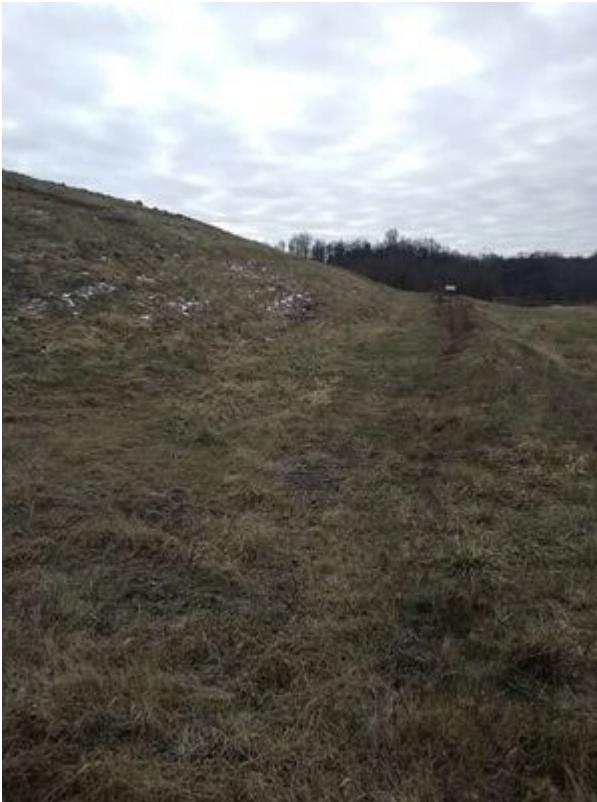
Inspection Record: 120925 122219

Feature	Longitude	Latitude	Elevation (ft)
Embankment	-76.6897149	40.0879721	297.172
Feature Condition			
Satisfactory			
Embankment			
EmbkOutsideSlope

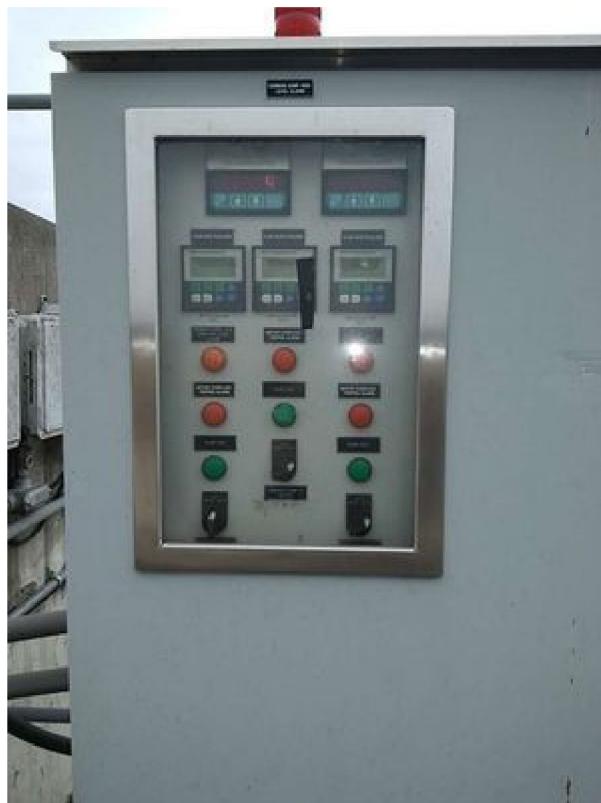
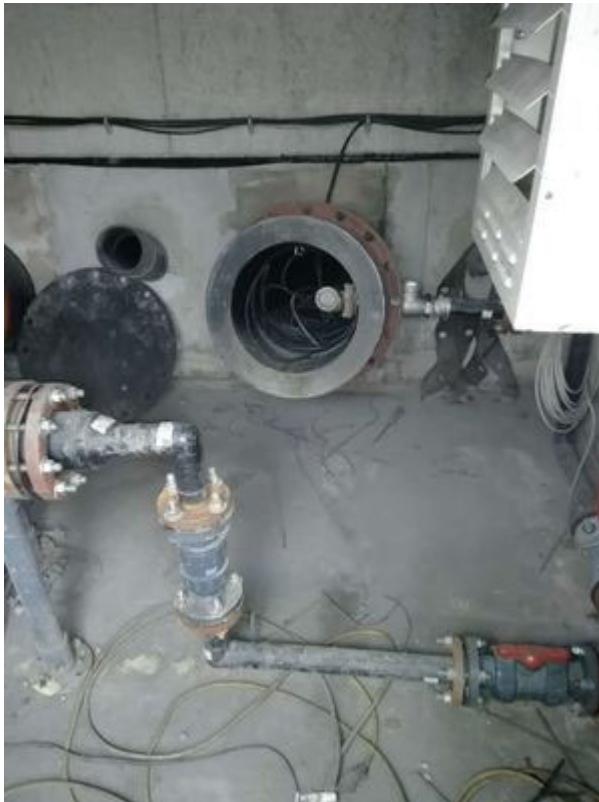
Inspection Record: 120925 130821

Feature	Longitude	Latitude	Elevation (ft)
Outlet Works	-76.6895343	40.0880968	295.278
Feature Condition	Satisfactory but check carefully next inspection		
Outlet Works			
OutletWorksOutlet_Pipes			
Inspection Notes	Pump #1 is off. #2 and #3 are in auto.

- Clean out the partially blocked culvert under the access road.
- Continue to monitor the leakage rate into the leachate detection zone. If the leakage rate increases to previously high levels, identify the cause and repair if necessary.
- Place additional stone overtop the eastern berm/rain flap where the geotextile protection layer is exposed.
- Continue to evaluate the need to raise the elevations on the exterior slopes, specifically the northern and western slopes, against the waste and place additional waste and soil and stabilize, as necessary, to meet design grades. This should be performed with the use of topographic survey.
- Perform necessary repairs to pump 1 and re-establish the pump to the “auto” setting.

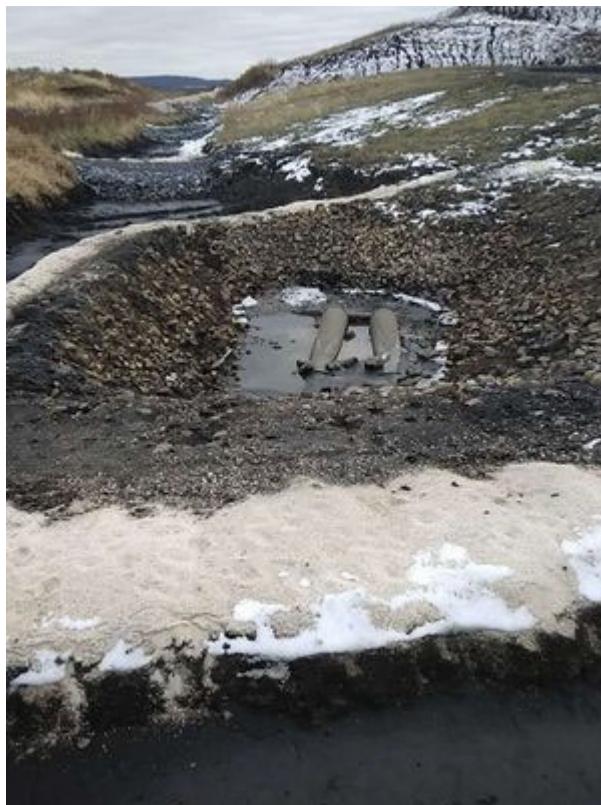
Inspection Record: 120925 131019

Feature	Longitude	Latitude	Elevation (ft)
Outlet Works	-76.6894149	40.0880441	292.770
Feature Condition			
Satisfactory			
Outlet Works			
OutletWorksOutlet_Pipes			
Inspection Notes	Leachate pipes are exposed and surrounding filter is intact.

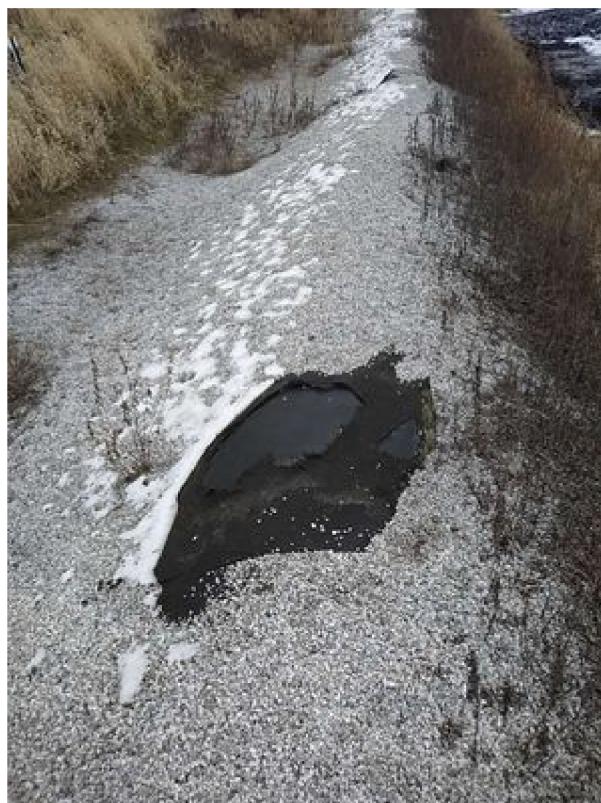
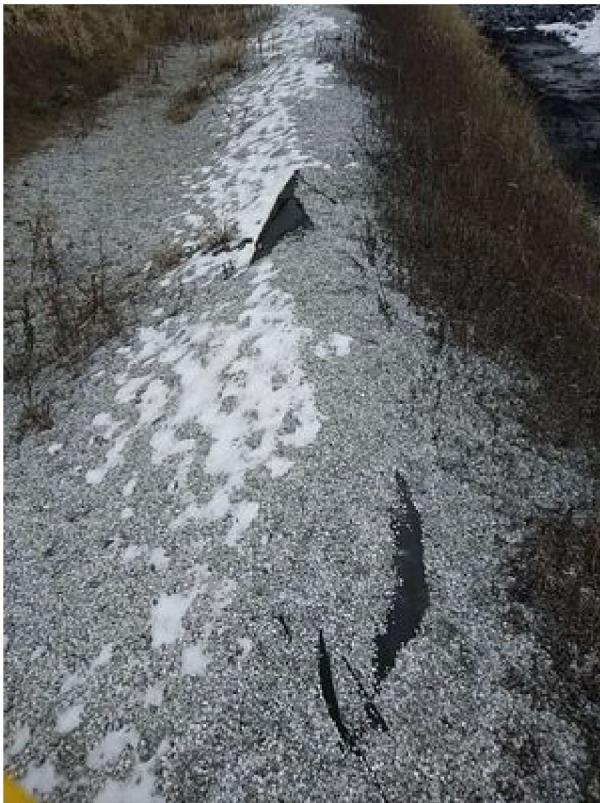
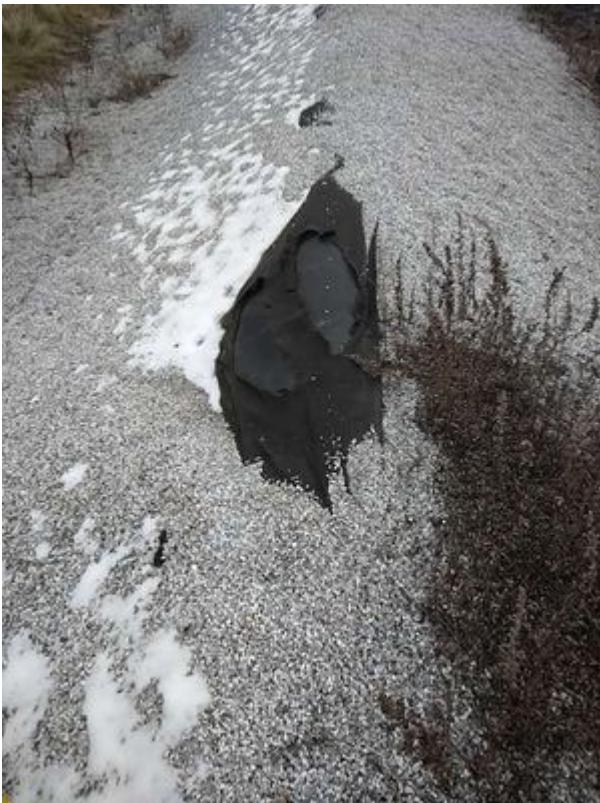
The eastern berm/rain flap, which separates cell 1 from the future cell development, included a geomembrane liner that is welded to the landfill's liner system along with a geotextile protection layer and stone overtop the geotextile protection layer. The stone was thin in multiple areas and the geotextile protective layer was exposed and worn, though the geo-membrane does not appear to be damaged. It is recommended to replace the stone per the design drawings where the geotextile protection layer is exposed and any areas where the stone is noticeably thin. The western side of waste is currently offset into the landfill and will eventually need to be filled in to achieve the maximum capacity.

Inspection Record: 120925 131149			
Feature	Longitude	Latitude	Elevation (ft)
Other	-76.6892403	40.0879766	294.738
Feature Condition			
Requires action this season			
Inspection Notes	Replace pea gravel on rainflap berm in 10 locations.

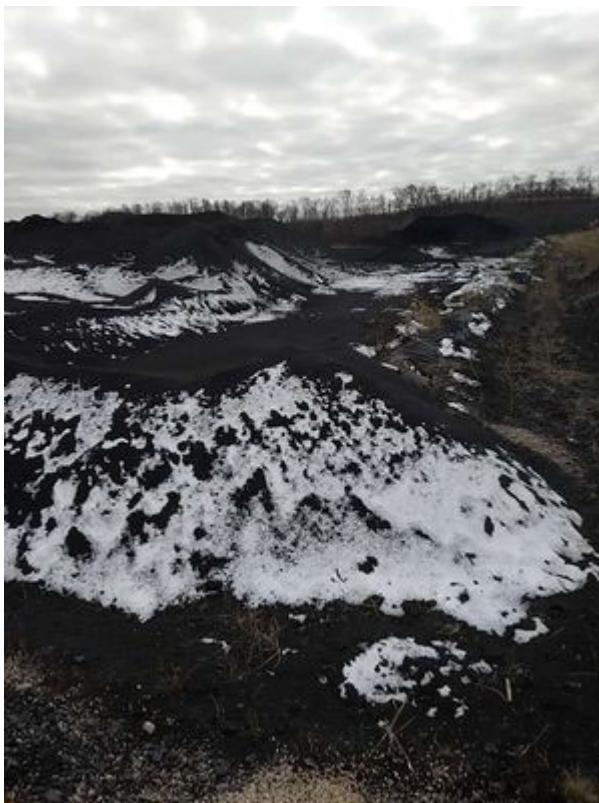
Inspection Record: 120925 131626

Feature	Longitude	Latitude	Elevation (ft)
Other	-76.6881670	40.0865892	305.557
Feature Condition			
Satisfactory			
Inspection Notes	Permitted in and out area of the landfill.

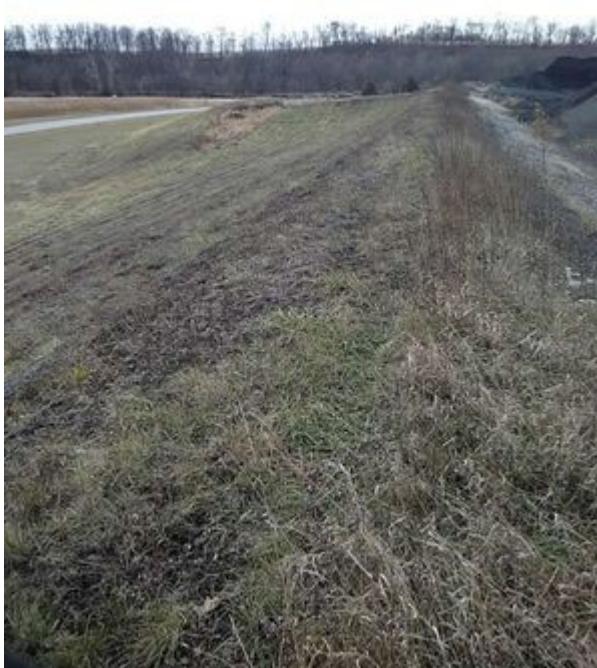
Inspection Record: 120925 131903

Feature	Longitude	Latitude	Elevation (ft)
Embankment	-76.6878576	40.0861951	310.198
Feature Condition			
Satisfactory			
Embankment			
EmbkOutsideSlope			
Inspection Notes	Southern end of landfill.

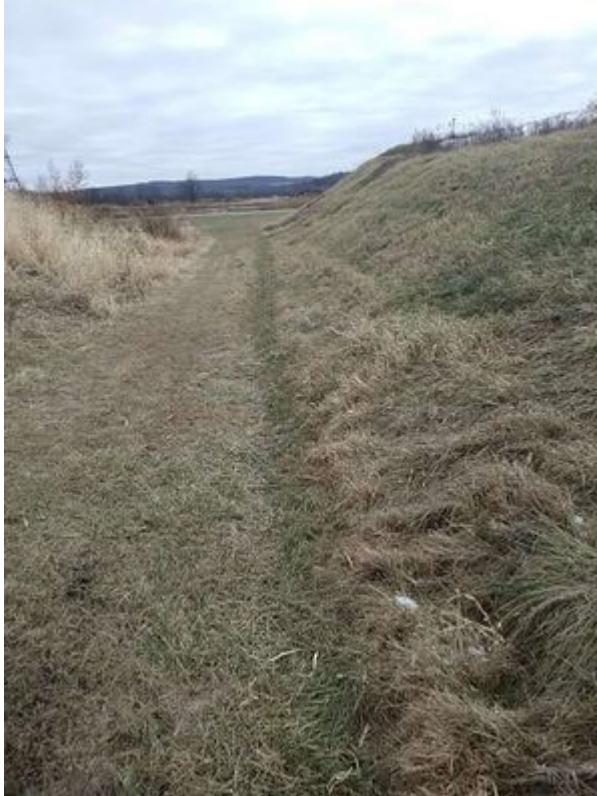
Inspection Record: 120925 132148

Feature	Longitude	Latitude	Elevation (ft)
Embankment	-76.6880353	40.0866133	293.515
Feature Condition			
Satisfactory			
Embankment			
EmbkOutsideSlope

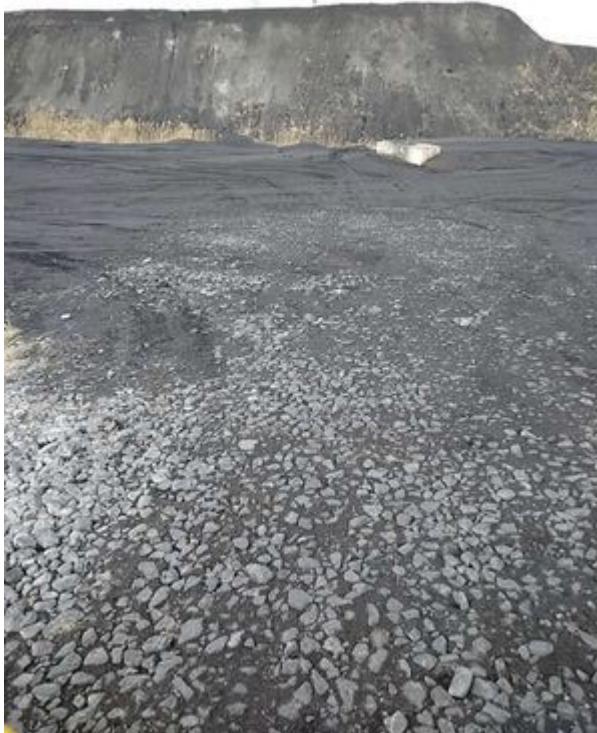
Inspection Record: 120925 132422

Feature	Longitude	Latitude	Elevation (ft)
Access Rd	-76.6884862	40.0859224	309.996
Feature Condition			
Satisfactory			
Inspection Notes	Access into the in and out area.

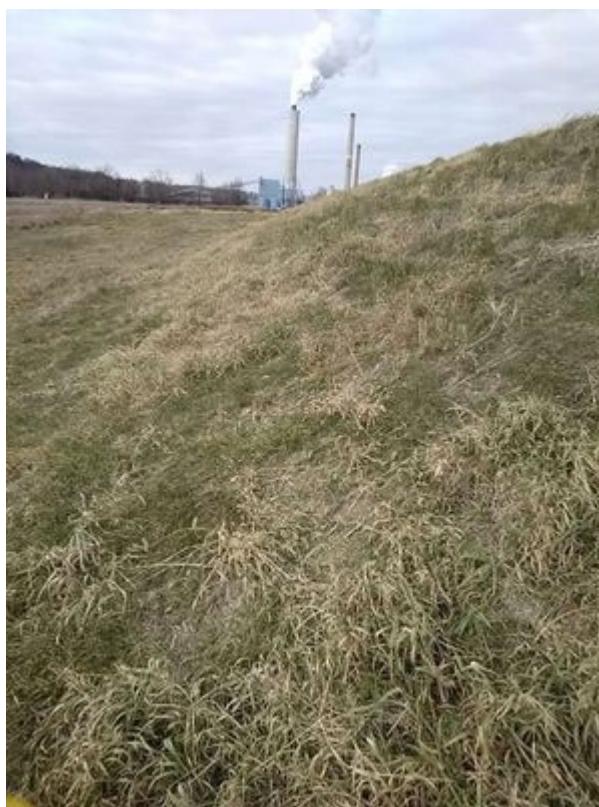
Inspection Record: 120925 132915

Feature	Longitude	Latitude	Elevation (ft)
Embankment	-76.6893838	40.0855824	290.794
Feature Condition			
Satisfactory			
Embankment			
EmbkOutsideSlope

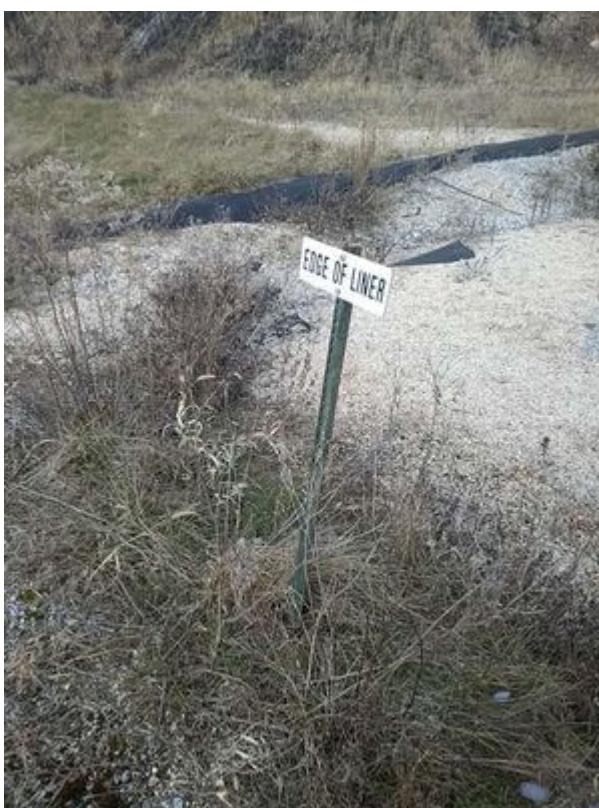
Inspection Record: 120925 133029

Feature	Longitude	Latitude	Elevation (ft)
Other	-76.6894496	40.0858418	304.282
Feature Condition			
Satisfactory			
Inspection Notes	Edge of liner sign.

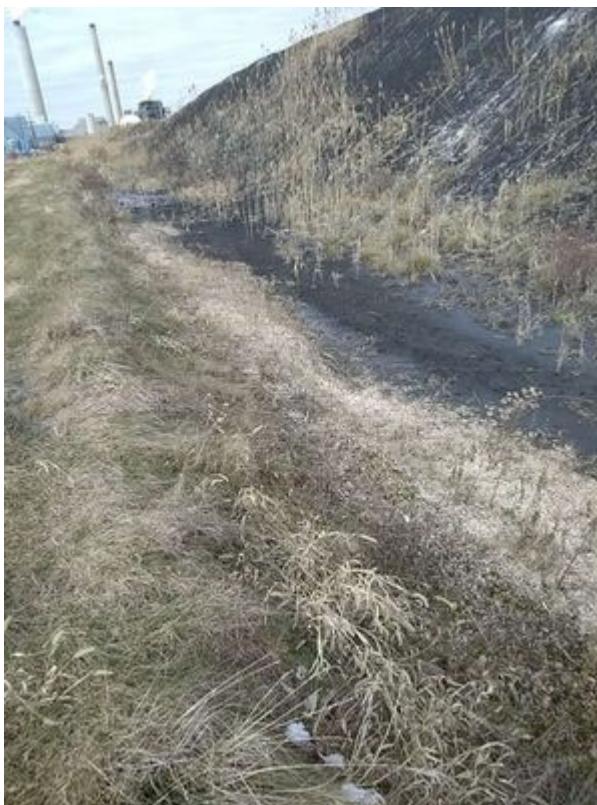
Inspection Record: 120925 133122

Feature	Longitude	Latitude	Elevation (ft)
Other	-76.6895516	40.0860385	305.471
Inspection Notes	Area that is to be filled in the future.

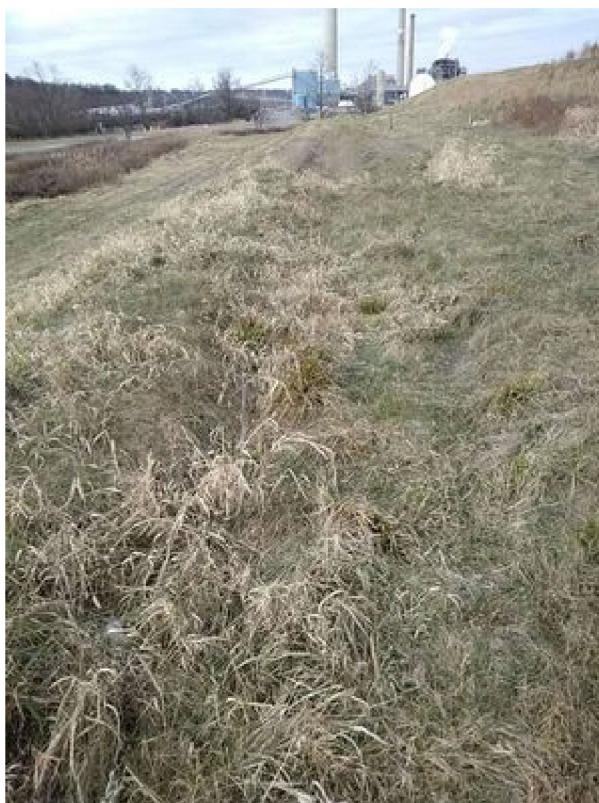
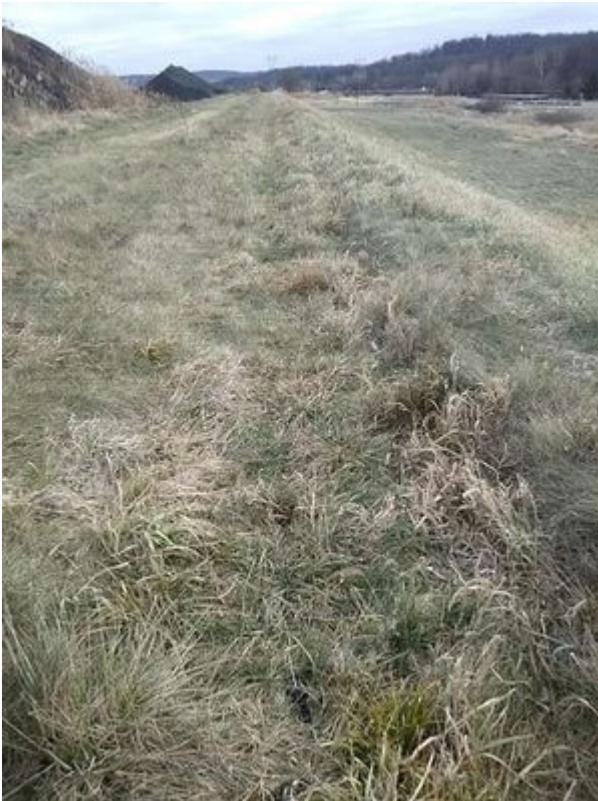
Inspection Record: 120925 133404

Feature	Longitude	Latitude	Elevation (ft)
Other	-76.6901747	40.0866697	301.260
Feature Condition			
Satisfactory			
Inspection Notes	Stormwater channel is in good condition.

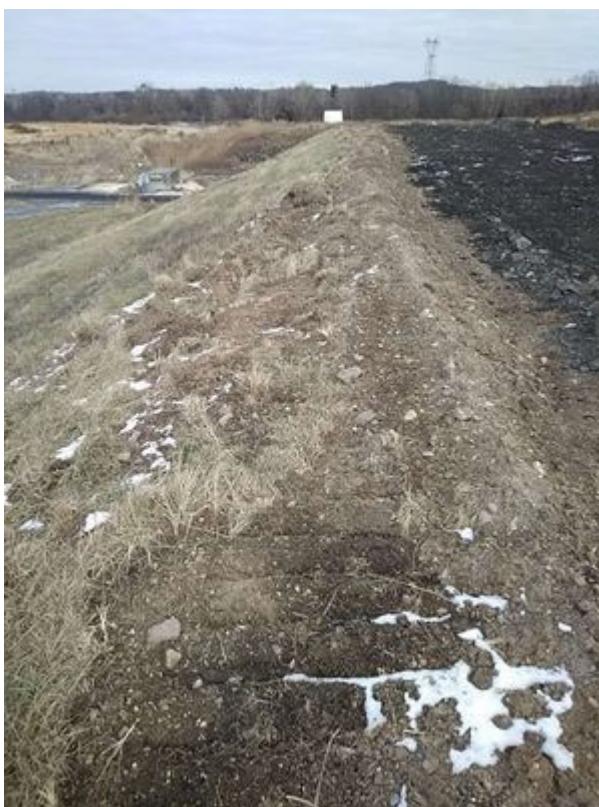
Inspection Record: 120925 133741

Feature Condition	
Requires action this season

Inspection Notes	Top bench berm. Appears to be slightly shorter than design. Confirm with survey and raise as needed.
------------------	--

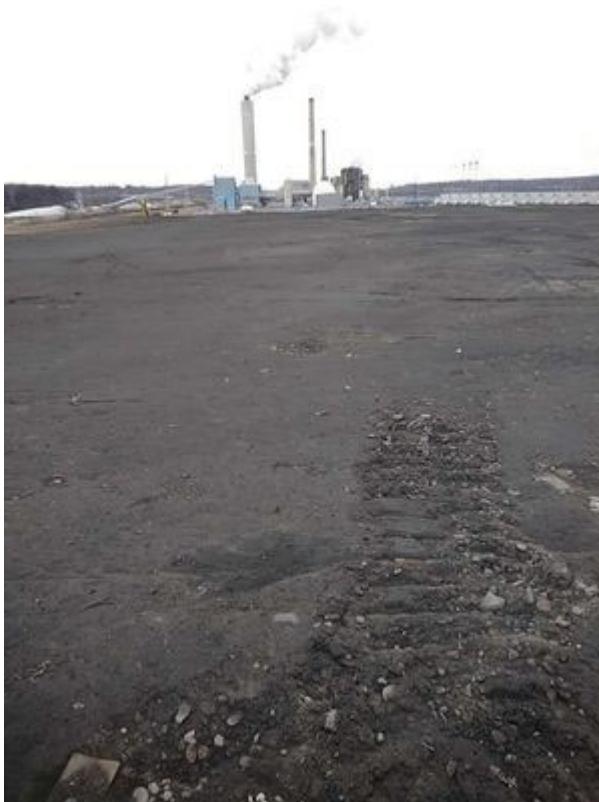
Inspection Record: 120925 144353

Feature Condition	
Satisfactory	
Inspection Notes	Active waste area has been rolled and compacted.
