**Subject: 2025 USEPA CCR Surface Impoundment Annual  
Inspection Report - Brunner Island Ash Basin No. 6**

Brunner Island Ash Basin No. 6 is an inactive Coal Combustion Residual (CCR) surface impoundment that initiated closure activities in June, 2019. The final receipt of waste entering the basin from CCR and non-CCR waste streams occurred on May 31<sup>st</sup>, 2019. While the basin is undergoing closure, it is required to comply with the operating criteria of the CCR Rule. The basin is owned and operated by Brunner Island, LLC, a wholly owned subsidiary of Talen Energy (Talen). The ash basin is formed by an earthen embankment dam with a maximum height of approximately 30 feet when measuring the height of the dam to the surrounding surface elevation outside of the basin. The ash basin is, therefore, required to have an annual inspection performed by a qualified engineer in accordance with the CCR Final Rule. The ash basin is also subject to regulation by the Pennsylvania Department of Environmental Protection (PADEP) and is classified as Size B, Hazard Classification 3 under the PADEP Dam Safety Guidelines, corresponding to a medium-sized, significant-hazard-potential dam.

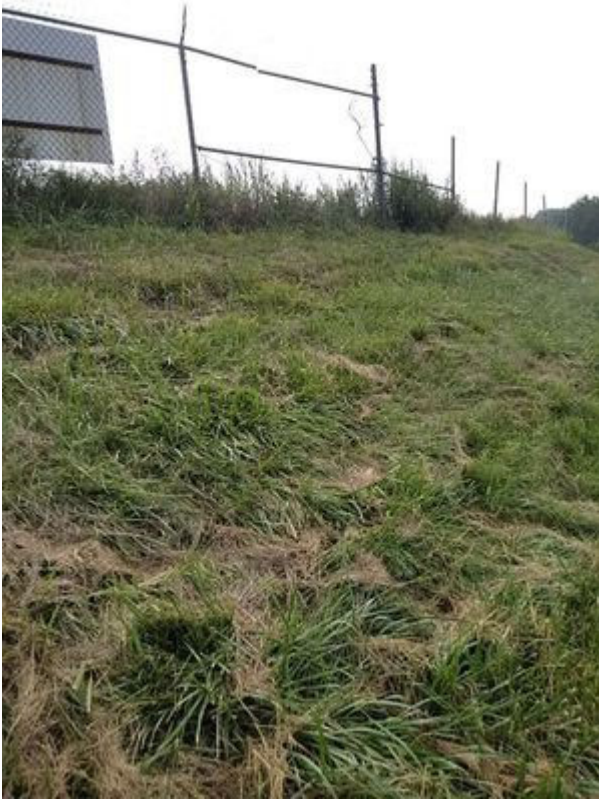
| Inspection Notes | Slight slope irregularity. |

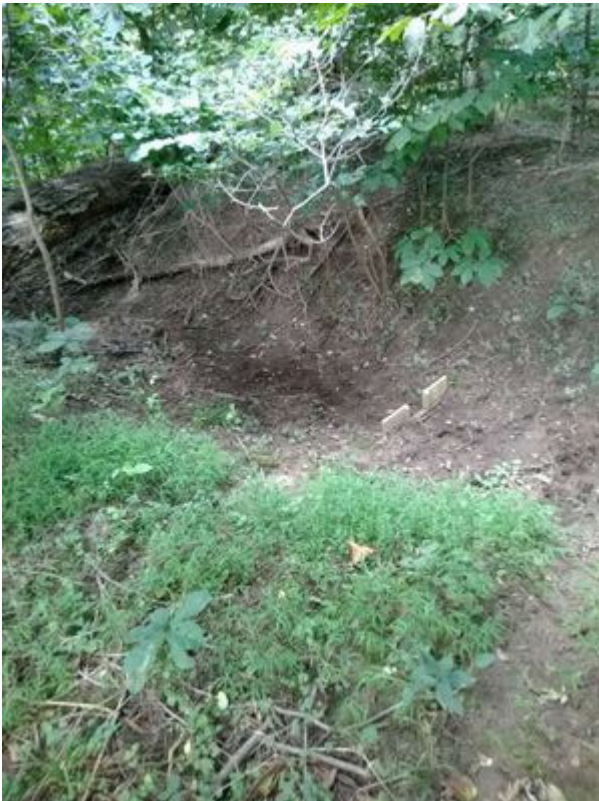
| Inspection Notes | Previously wet area beyond toe is dry. |

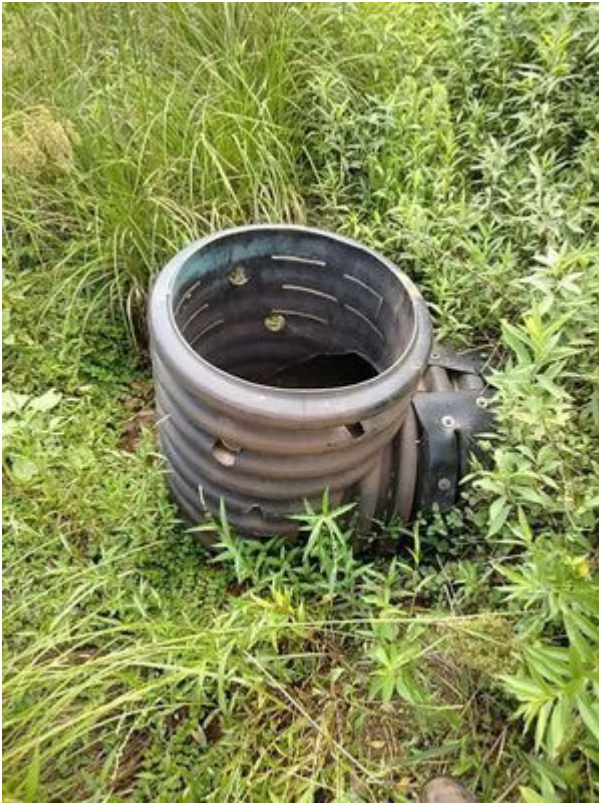
| Inspection Notes | Riser in e&s pond is dry. |

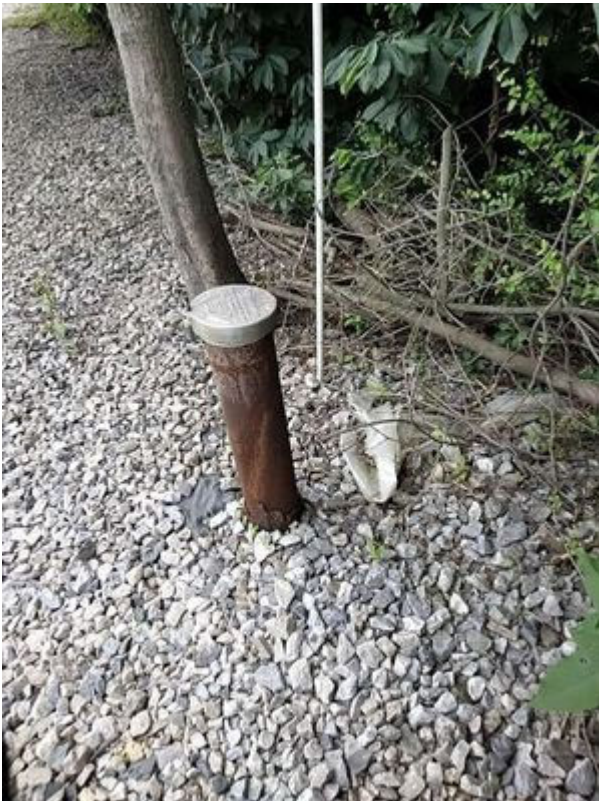
| Inspection Notes | Previously observed well in artesian condition is dry. |

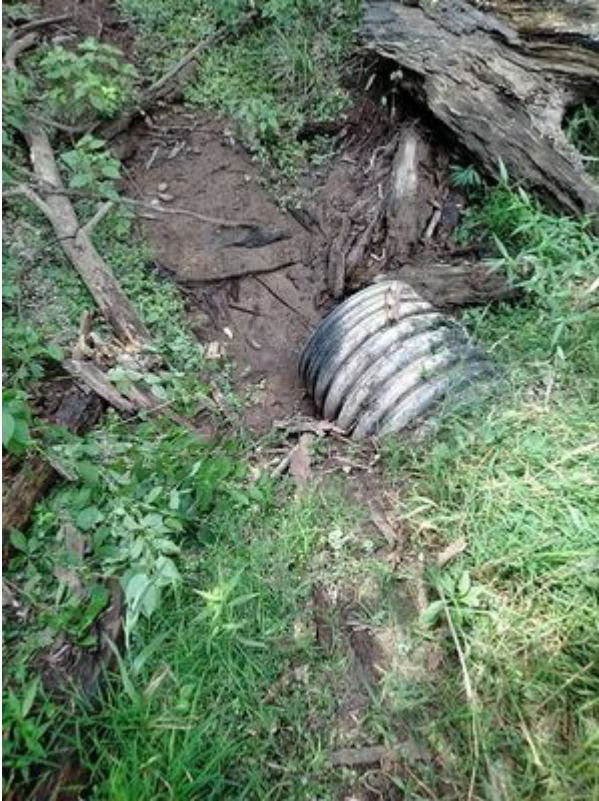
| Inspection Notes | Previously fallen tree overtop e&s pond pipe was removed. |

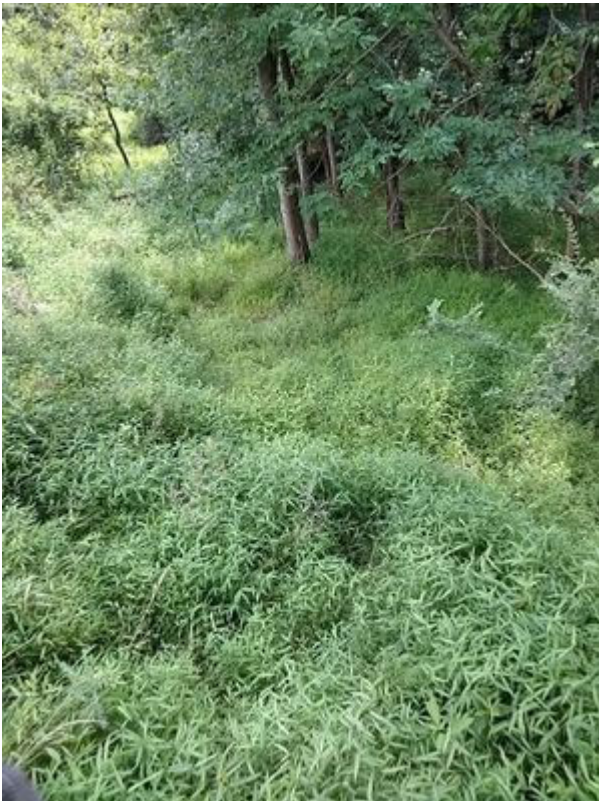
| Inspection Notes | Previously observed saturated area beyond the toe is dry. |

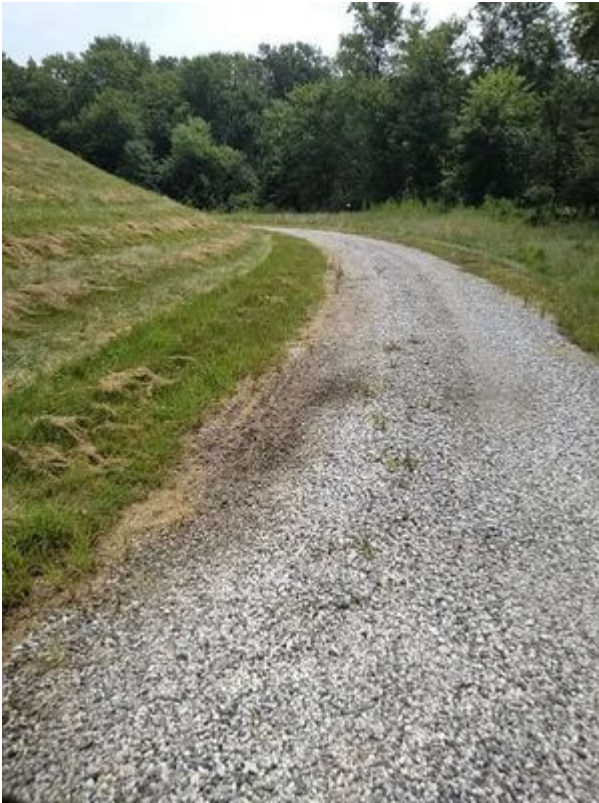
| Inspection Notes | Area is dry. |

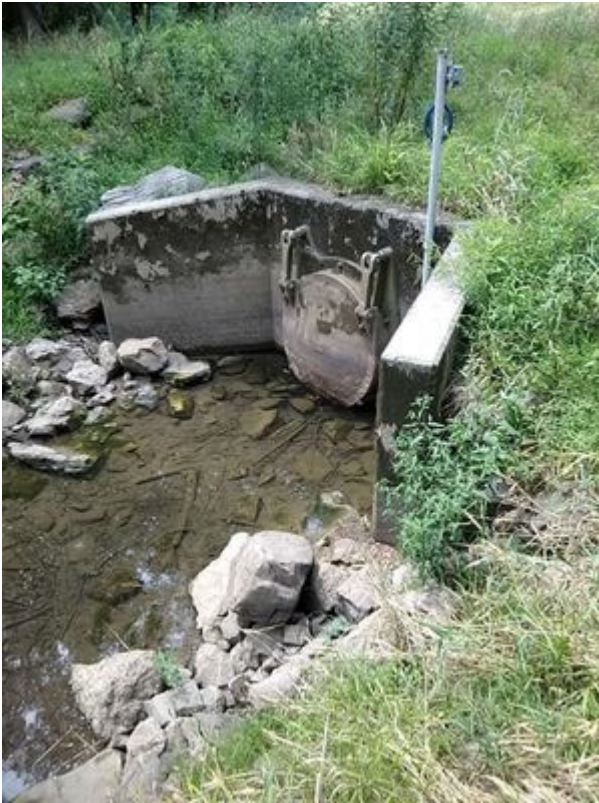
| Outlet Works | Outlet Works Factor |
|---|---|
| OutletWorksGates | Corroded |

| Inspection Notes | Slight corrosion on flapper gate. |

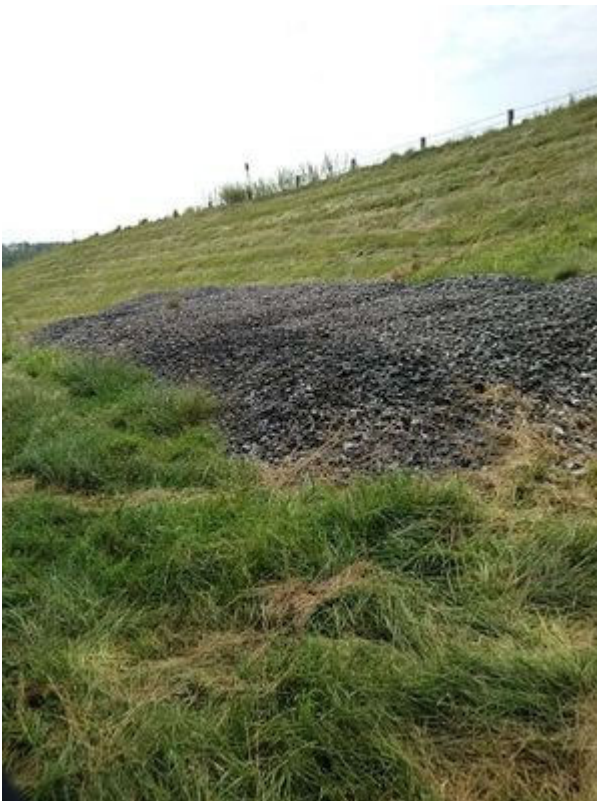
| Inspection Notes | Area around rock filter on the embankment is dry. |

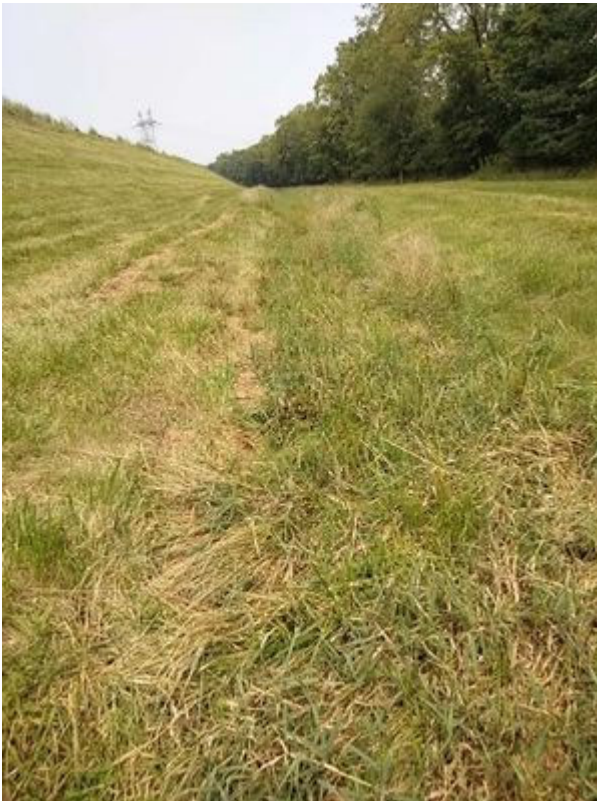
| Inspection Notes | Historic e&s pond is dry. |

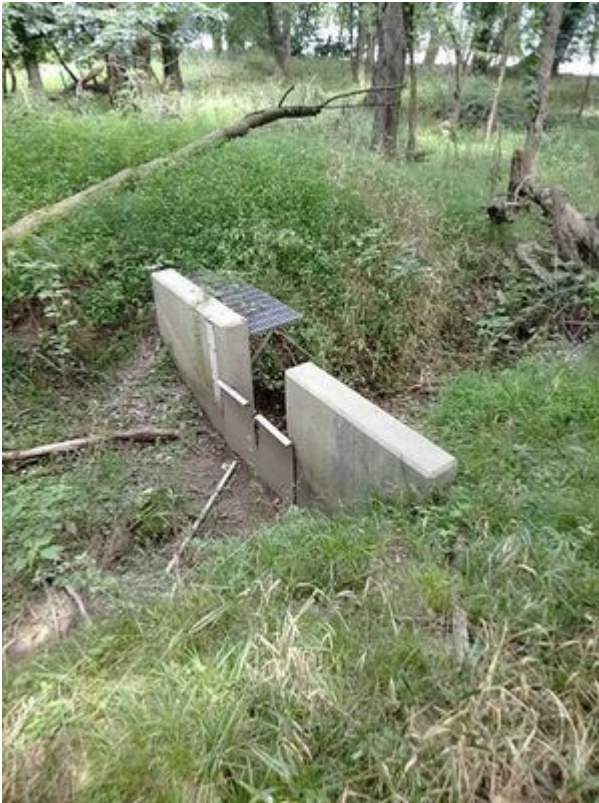
| Inspection Notes | Previously monitored weir is dry. |

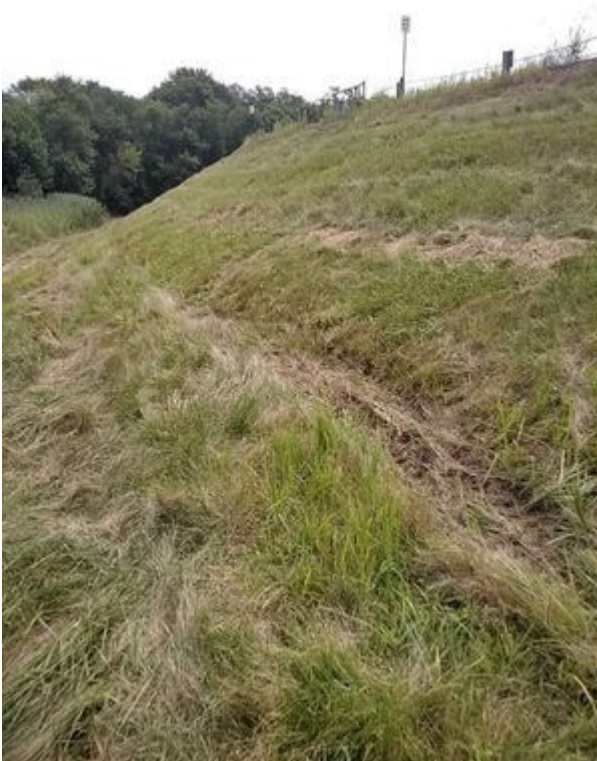
| Inspection Notes | Previously observed saturated area is dry. |

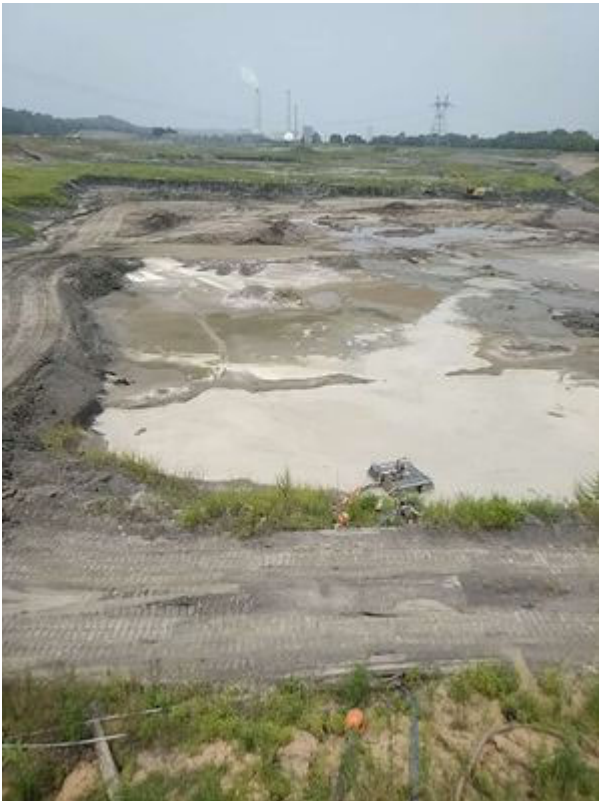
| Inspection Notes | CCR removal is ongoing. |

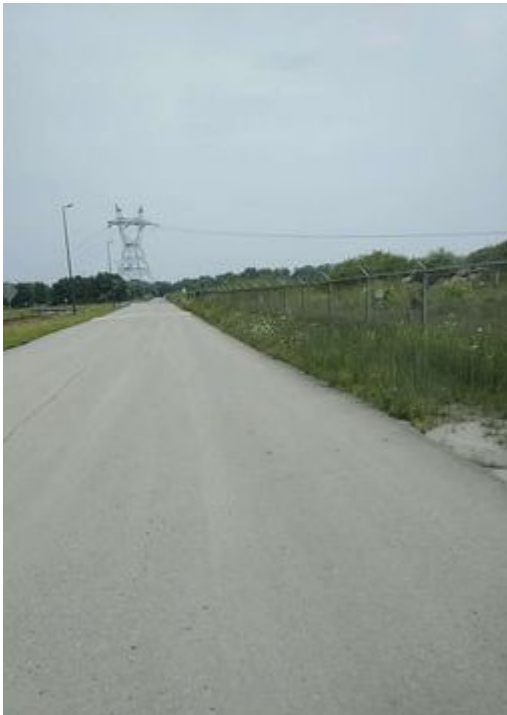
| Inspection Notes | Shared dike. |
