2025 Surface Impoundment Annual Inspection Report

Colstrip Steam Electric Station

Colstrip, Montana

January 15, 2026

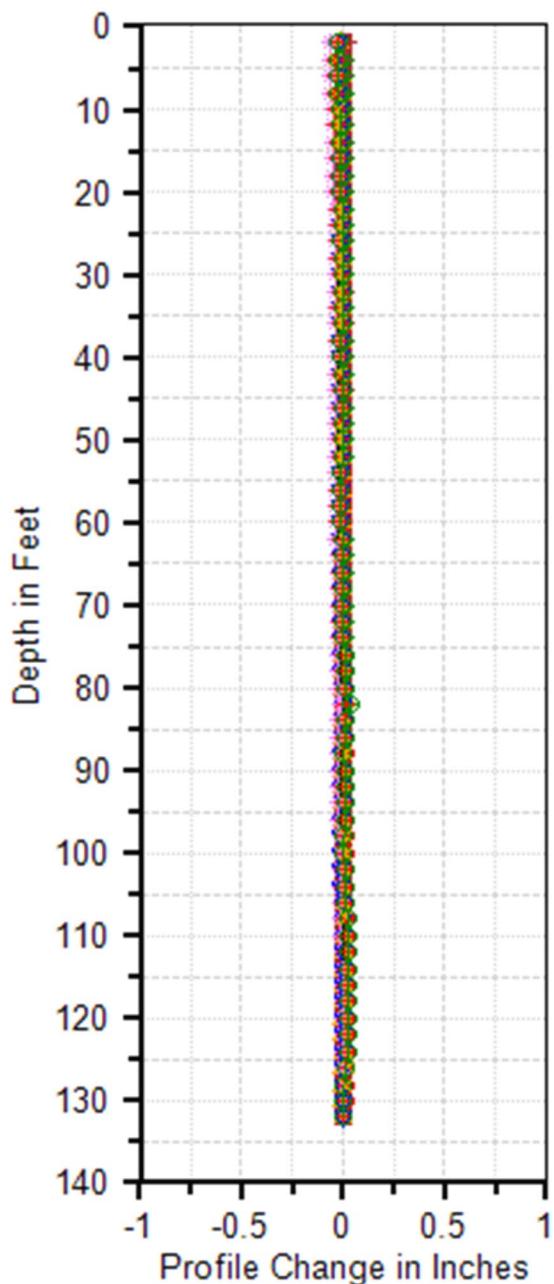
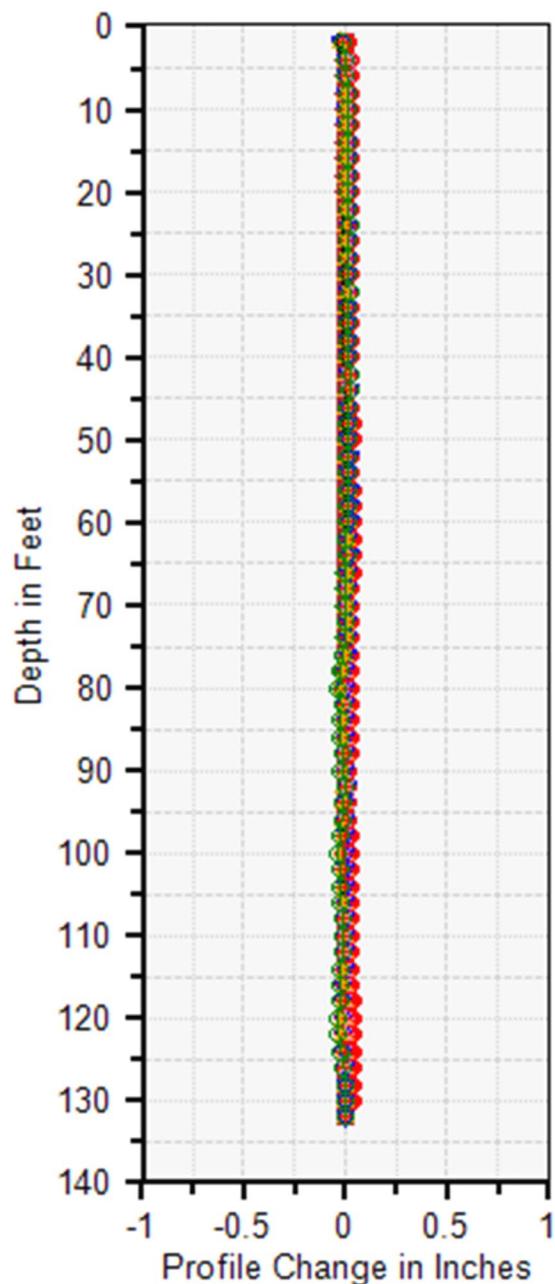
MD-12-3INC A

Issue with baseline survey in February, March used as baseline.

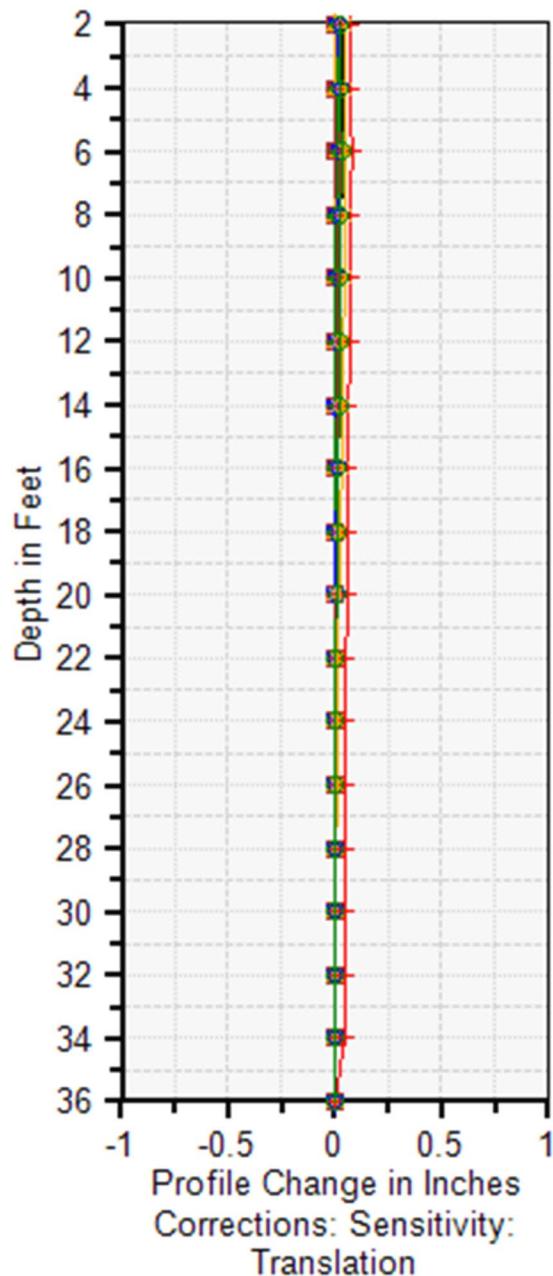
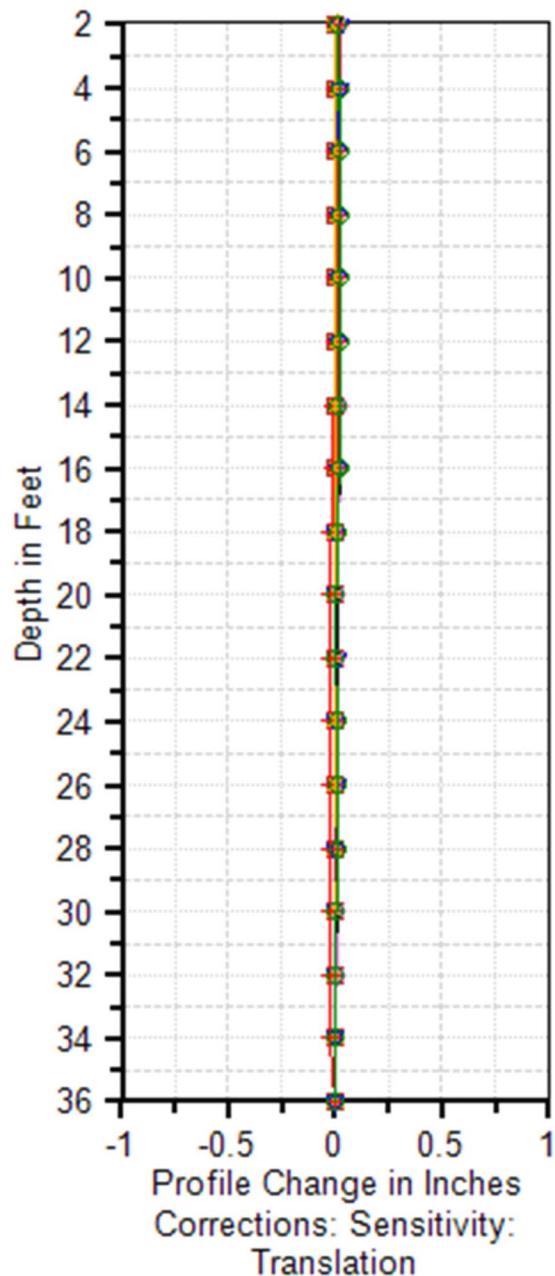
EHP H-15-19INC A

Issue with baseline survey in February, March used as baseline | Sensitivity Correction - April survey | Translation Correction - October survey

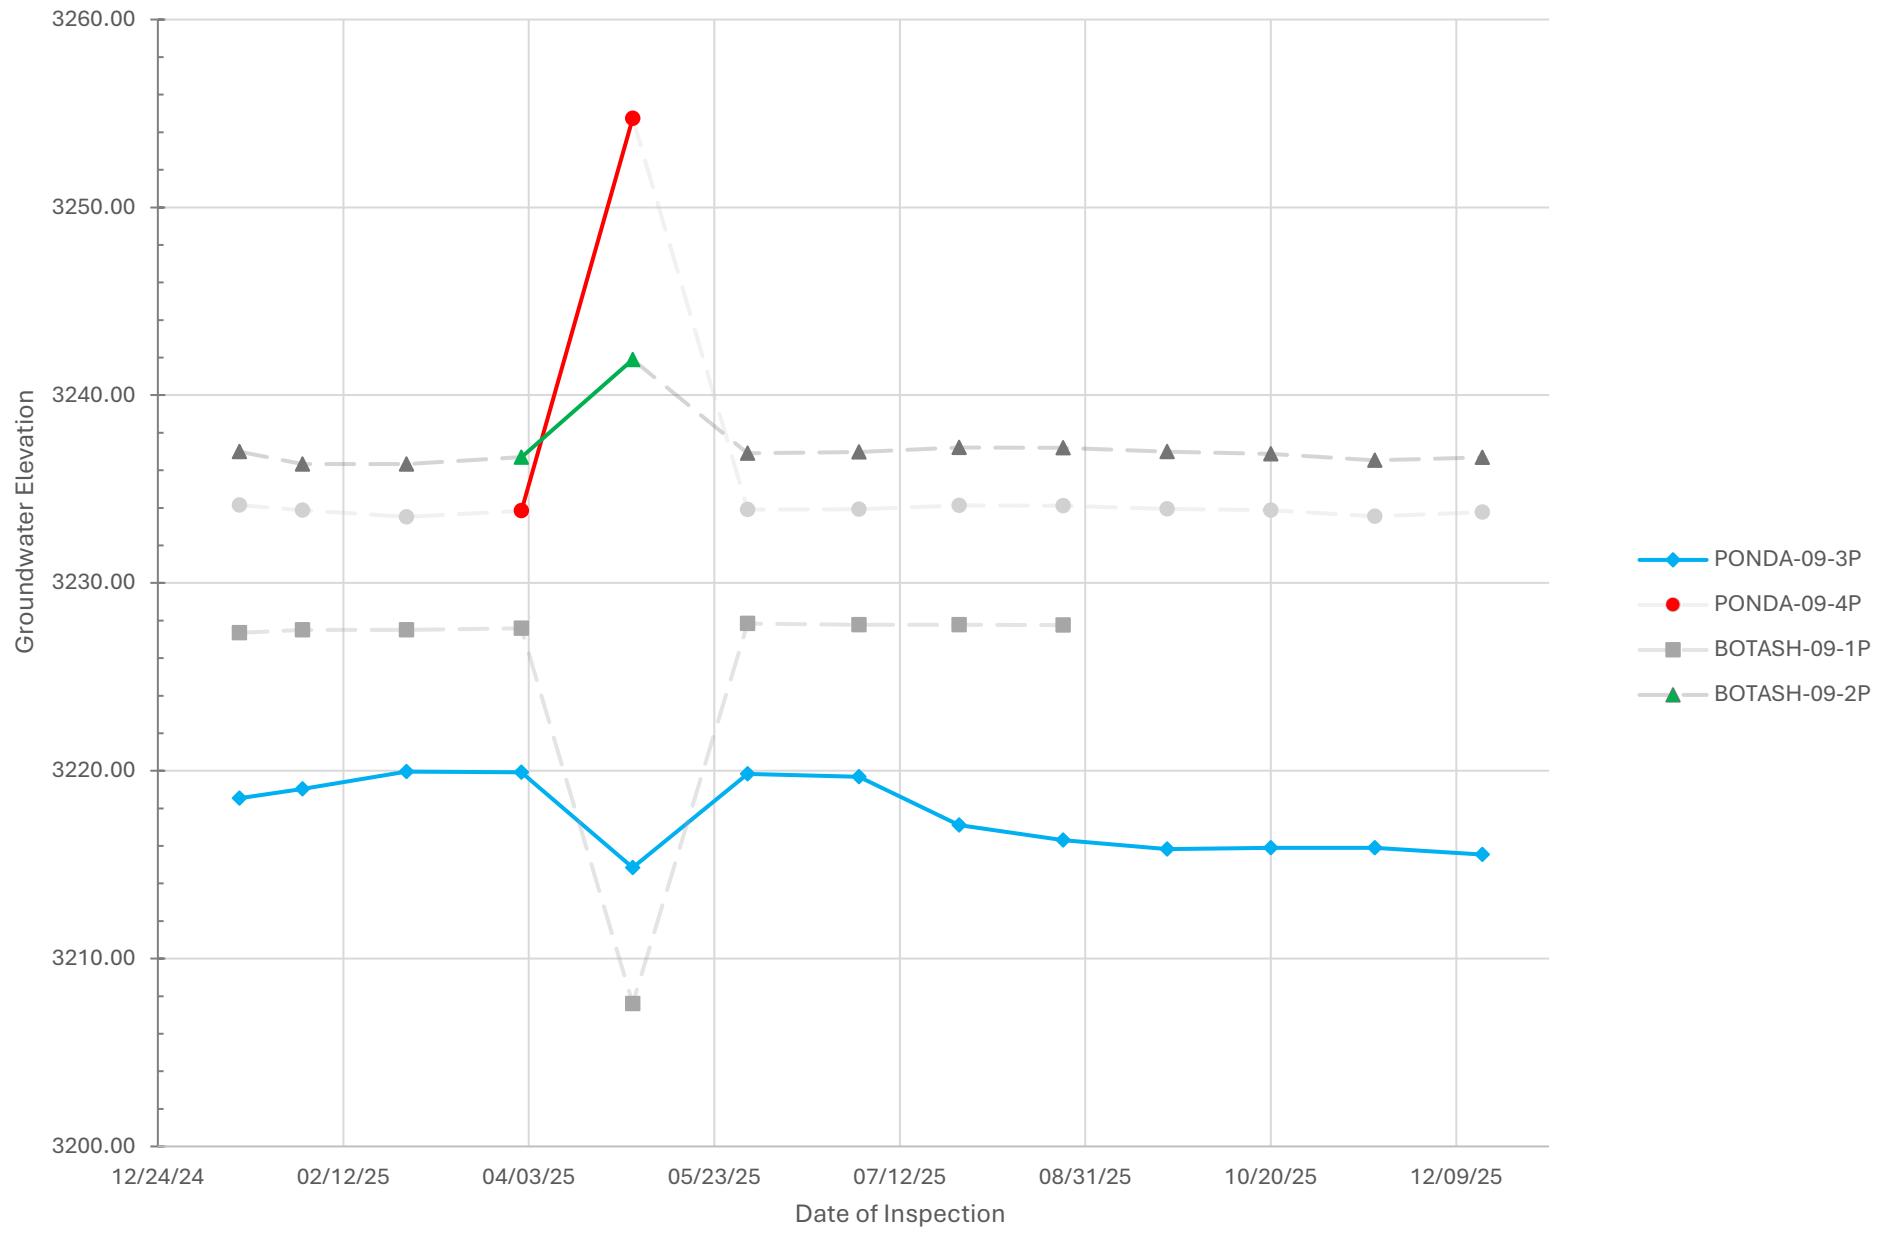
Units 1&2 Bottom Ash Pond

Piezometer A-24-P21 located in Units 3 & 4 EHP was not measured in February, June or September, it was mistaken for an abandoned adjacent piezometer. Piezometer readings in May for Units 1 & 2 Bottom Ash bonds appear to be an isolated anomaly but returned to normal readings and was likely caused by operator or instrument error.
