**Subject: 2026 USEPA CCR Landfill Inspection Report
Montour Ash Disposal Area No. 3**

1.0 Summary

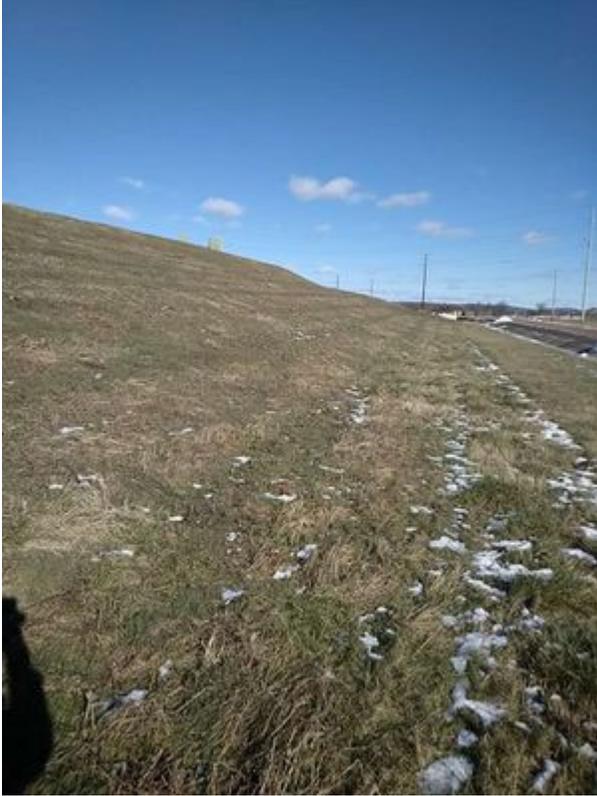
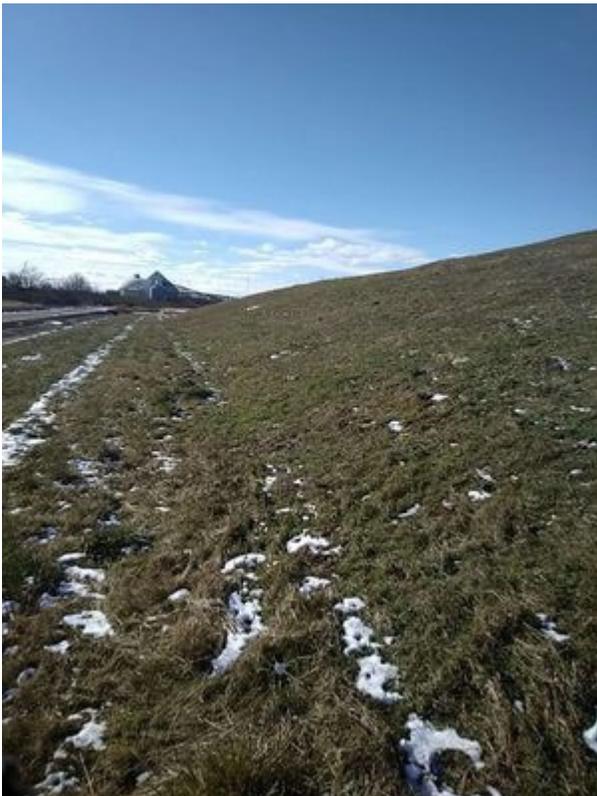
Feature	Longitude	Latitude	Elevation (ft)
Embankment	-76.6584605	41.0622988	534.219
Feature Condition			
Satisfactory			
Embankment			
EmbkOutsideSlope

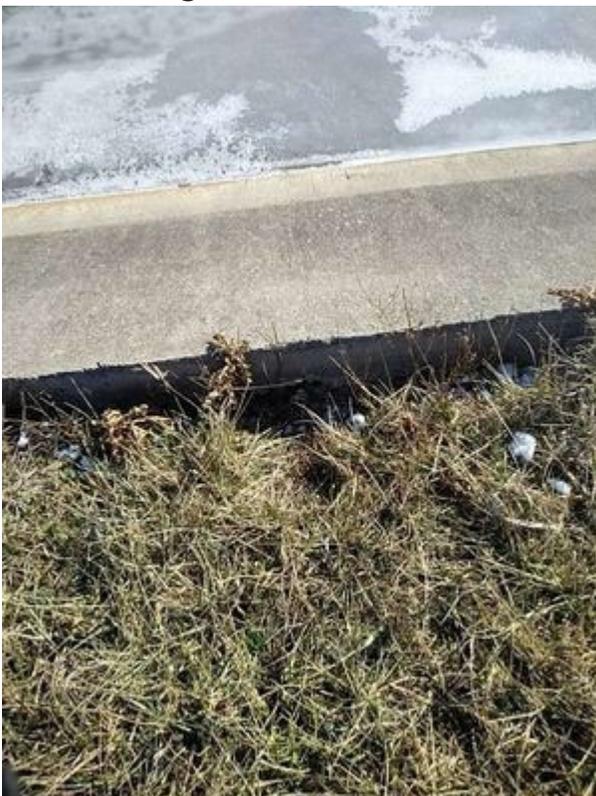
Feature	Longitude	Latitude	Elevation (ft)
Other	-76.6585495	41.0620747	530.611
Feature Condition			
Requires action			
Inspection Notes	Settlement along edge of concrete channel.

landfill or asphalt (non-landfill) side of the concrete channel where the void spaces are observed due to settling. Continue to maintain the top perimeter berm and remove sediment from the swale as necessary to maintain swale capacity. Remove the vegetation from below the flapper gate where the groundwater drainage system daylight and lubricate the gate.

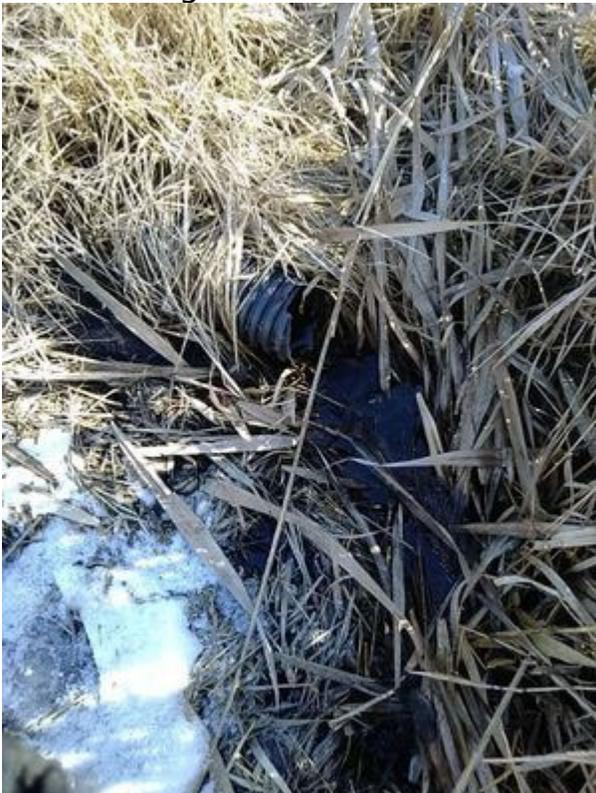
Feature	Longitude	Latitude	Elevation (ft)
Outlet Works	-76.6593152	41.0616328	527.658
Feature Condition			
Satisfactory			
Outlet Works			
OutletWorksToe_Drains			
Inspection Notes	#1 flowing at approx. 5 gpm.

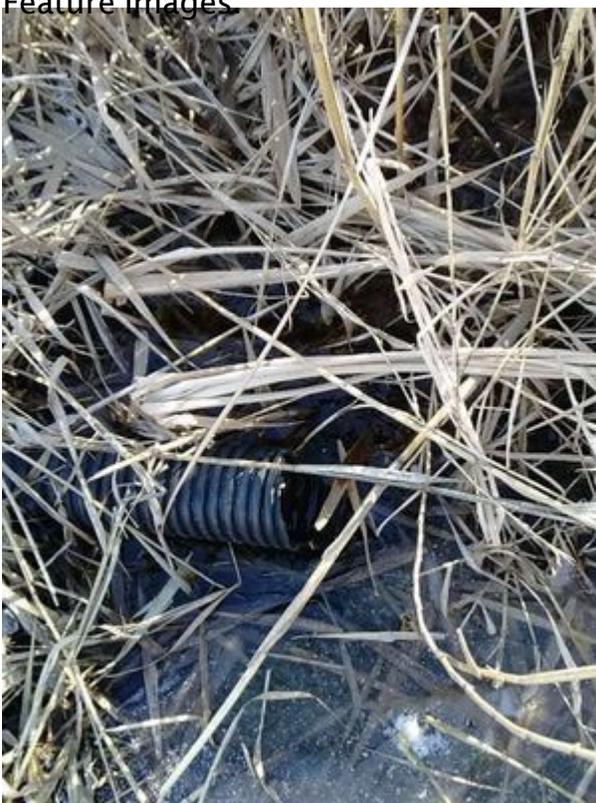
Feature	Longitude	Latitude	Elevation (ft)
Outlet Works	-76.6596978	41.0618780	515.847
Feature Condition			
Satisfactory			
Outlet Works			
OutletWorksToe_Drains			
Inspection Notes	#2 is dry.

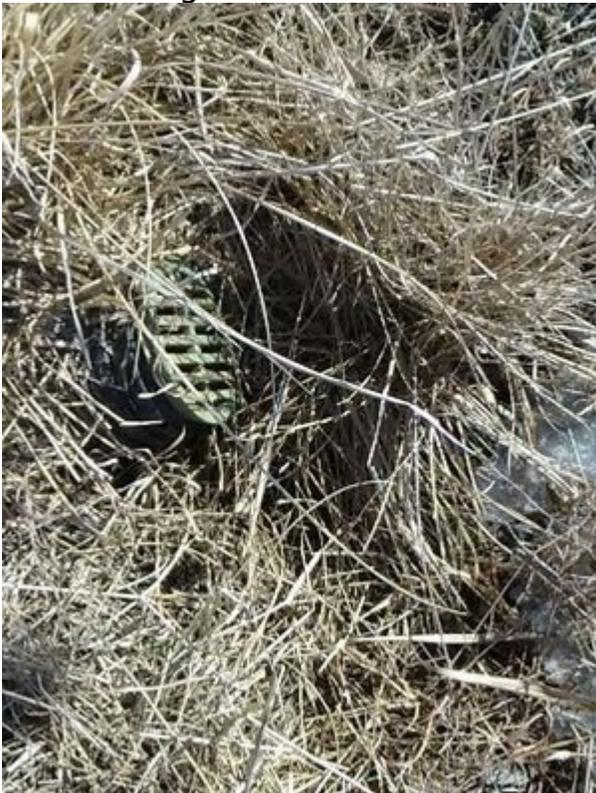
Feature	Longitude	Latitude	Elevation (ft)
Outlet Works	-76.6601037	41.0622537	531.267
Feature Condition			
Satisfactory			
Outlet Works			
OutletWorksToe_Drains			
Inspection Notes	#3 dry.

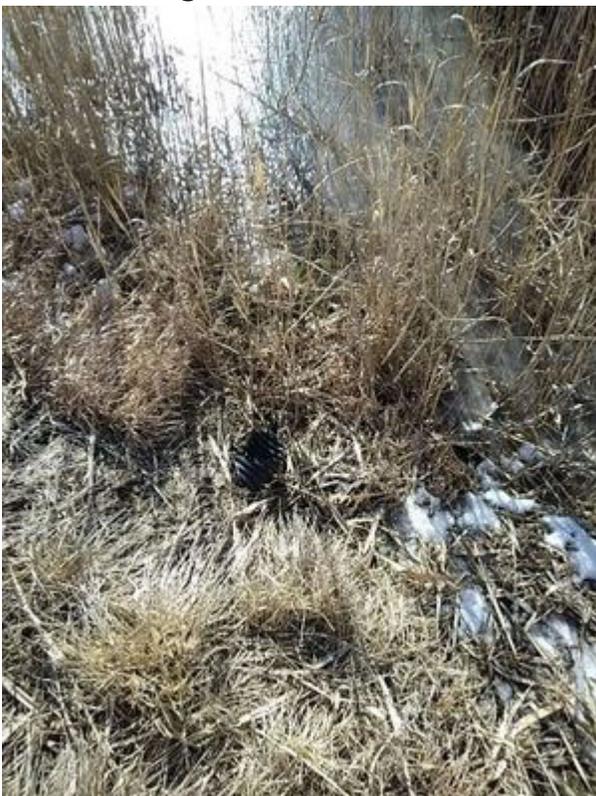
Feature	Longitude	Latitude	Elevation (ft)
Outlet Works	-76.6604195	41.0627132	533.563
Feature Condition			
Satisfactory			
Outlet Works			
OutletWorksToe_Drains			
Inspection Notes	#4 is dry.

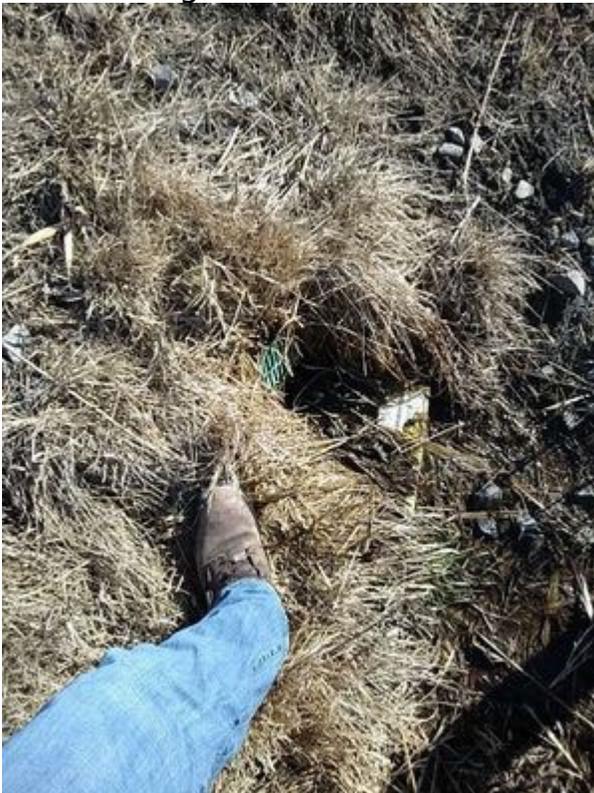
Feature	Longitude	Latitude	Elevation (ft)
Outlet Works	-76.6607637	41.0631450	533.563
Feature Condition			
Satisfactory			
Outlet Works			
OutletWorksToe_Drains			
Inspection Notes	#5 is draining at approx. 5 gpm.

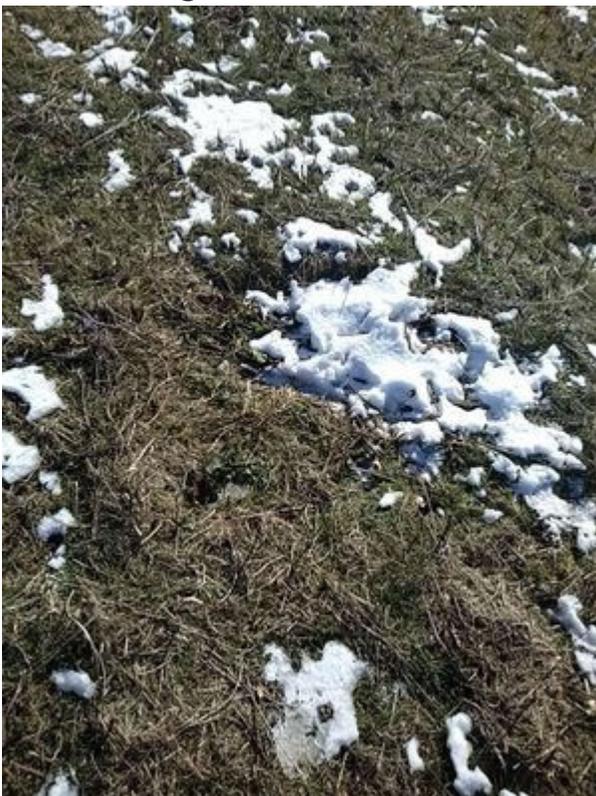
Feature	Longitude	Latitude	Elevation (ft)
Embankment	-76.6606568	41.0633083	539.469
Feature Condition			
Requires action			
Embankment	Embankment Factor		
EmbkOutsideSlope	Settlement		
Inspection Notes	Minor settlement approx. 6" deep.

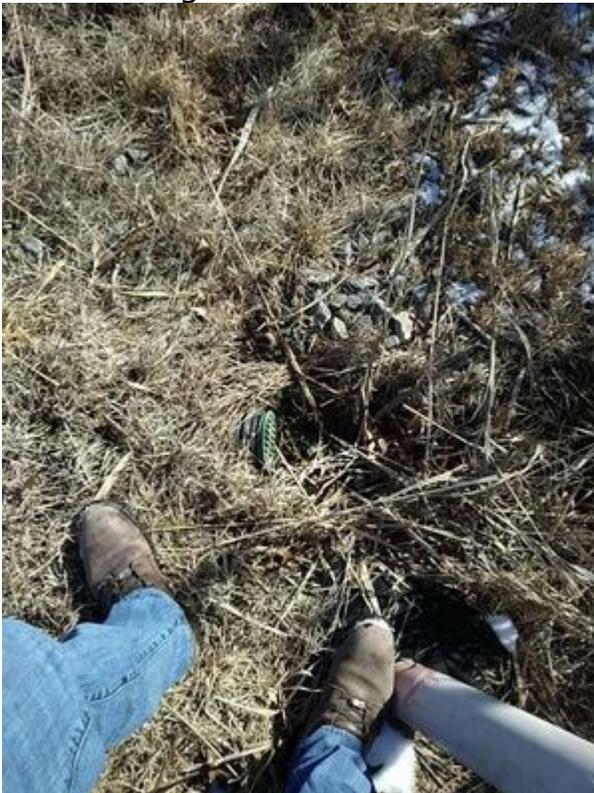
Feature	Longitude	Latitude	Elevation (ft)
Outlet Works	-76.6611073	41.0636410	529.954
Feature Condition			
Satisfactory			
Outlet Works			
OutletWorksToe_Drains			
Inspection Notes	#6 is dry.

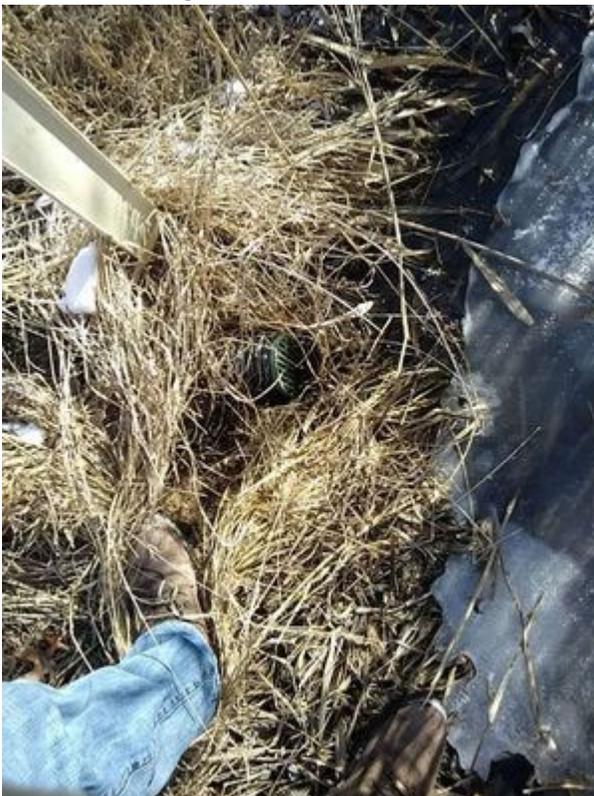
Feature	Longitude	Latitude	Elevation (ft)
Outlet Works	-76.6615083	41.0641588	536.516
Feature Condition			
Satisfactory			
Outlet Works			
OutletWorksToe_Drains			
Inspection Notes	#7 is trickling.

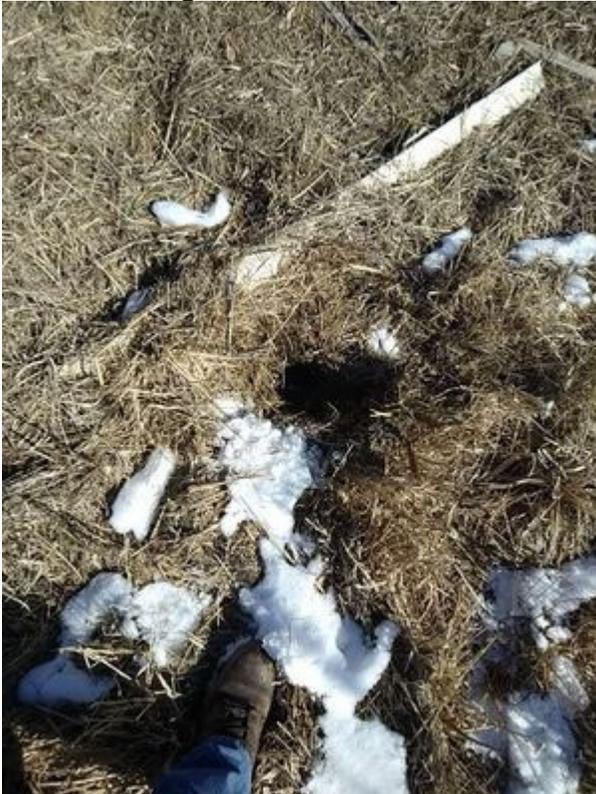
Feature	Longitude	Latitude	Elevation (ft)
Outlet Works	-76.6620205	41.0648775	535.860
Feature Condition			
Satisfactory			
Outlet Works			
OutletWorksToe_Drains			
Inspection Notes	#8 is dry.

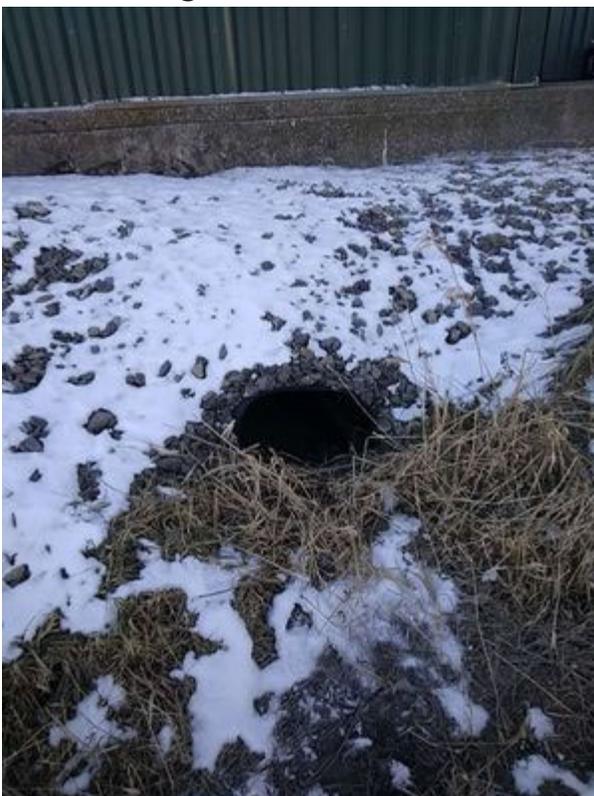
Feature	Longitude	Latitude	Elevation (ft)
Other	-76.6616718	41.0652947	537.500
Feature Condition			
Satisfactory but check carefully next inspection			
Inspection Notes	Stormwater pipe around outer perimeter of landfill.

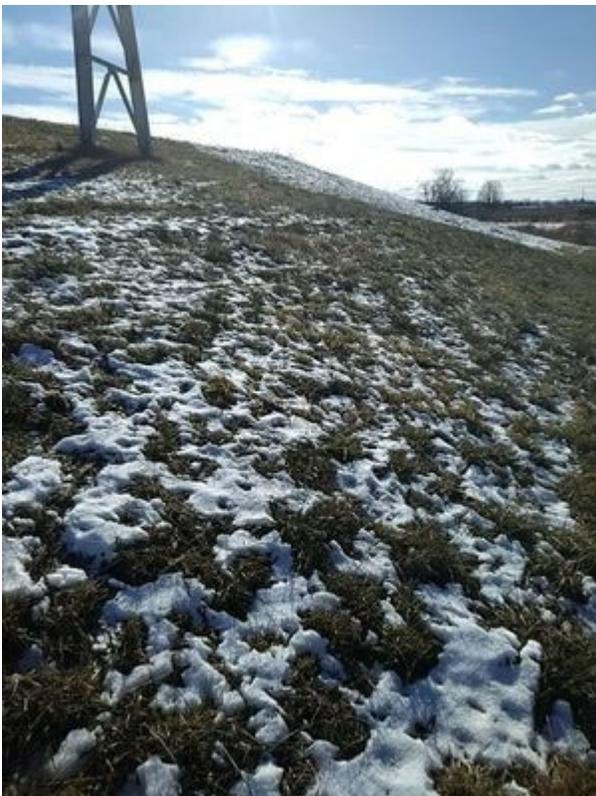
Feature	Longitude	Latitude	Elevation (ft)
Embankment	-76.6615450	41.0652632	545.046
Feature Condition			
Satisfactory			
Embankment			
EmbkOutsideSlope

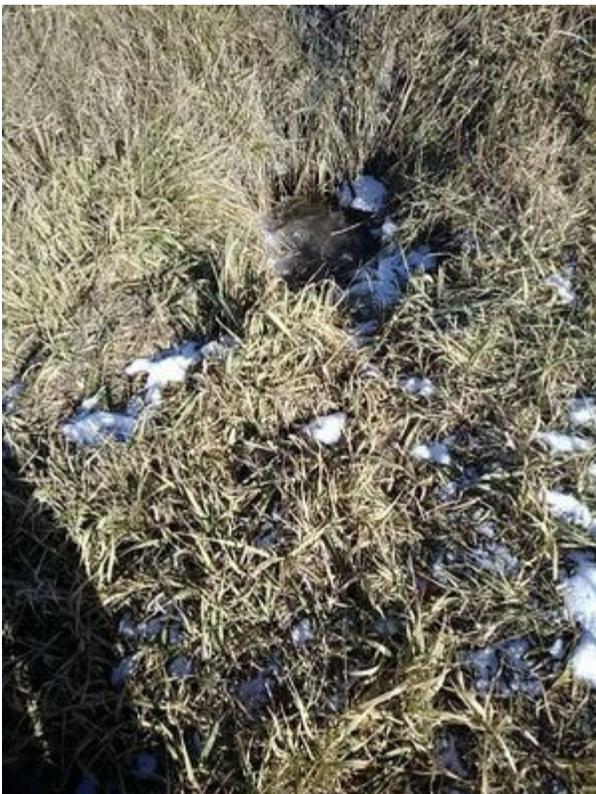
Feature	Longitude	Latitude	Elevation (ft)
Other	-76.6613002	41.0656065	533.891
Feature Condition			
Requires action			
Inspection Notes	Outer limits of landfill stormwater pipe is partially blocked.

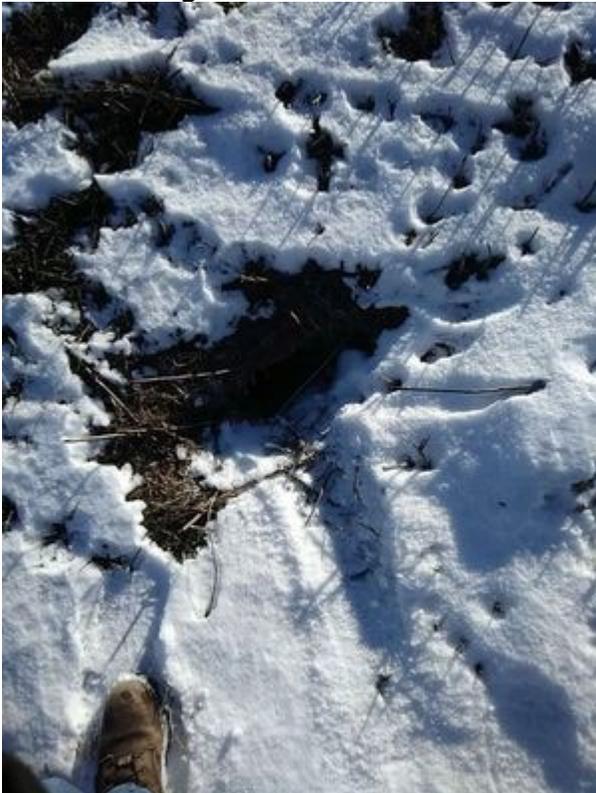
Feature	Longitude	Latitude	Elevation (ft)
Embankment	-76.6611098	41.0654815	555.545
Feature Condition			
Requires action			
Embankment	Embankment Factor		
EmbkOutsideSlope	Animal Burrows

The slopes were recently mowed providing good visibility of the structure. 7 groundhog holes were observed, and they were located on the exterior slopes. When burrows are located, removal of groundhogs should occur to prevent damage to the liner around the toe or the cover material followed by filling of the groundhog holes. A minor erosion scar was observed on the northern side of the landfill and should be backfilled and monitored. As noted in previous inspections, a slope irregularity was observed above the bench of the landfill, which is also seen in the aerial photogrammetry. There was no evidence of instability in this area, and the irregularity is reported to be the result of grading during construction.

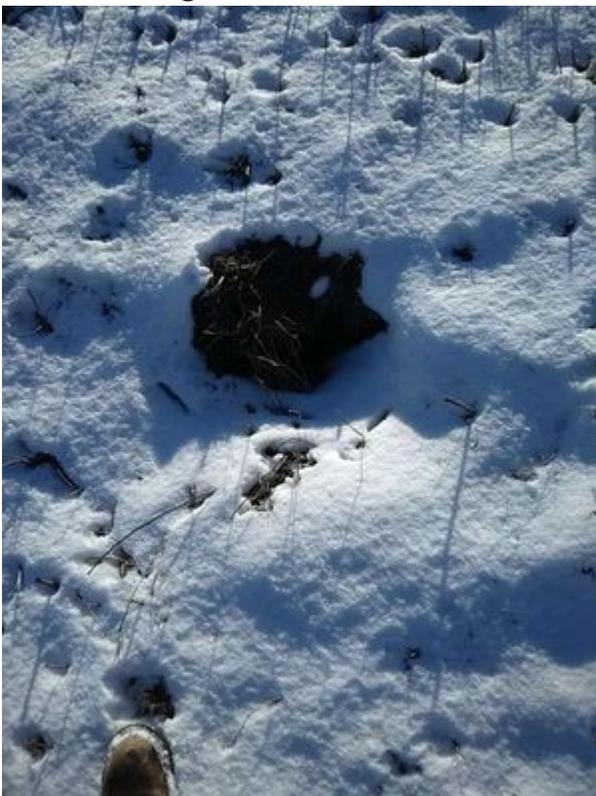
Feature	Longitude	Latitude	Elevation (ft)
Embankment	-76.6605932	41.0654670	544.390
Feature Condition			
Requires action			
Embankment		Embankment Factor	
EmbkOutsideSlope		Animal Burrows

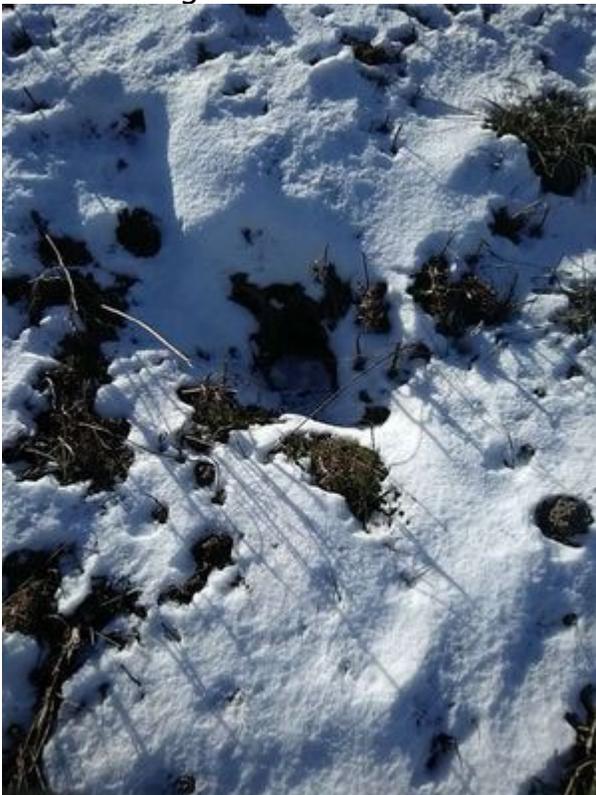
Feature	Longitude	Latitude	Elevation (ft)
Embankment	-76.6589340	41.0650948	553.904
Feature Condition			
Requires action			
Embankment	Embankment Factor		
EmbkOutsideSlope	Animal Burrows

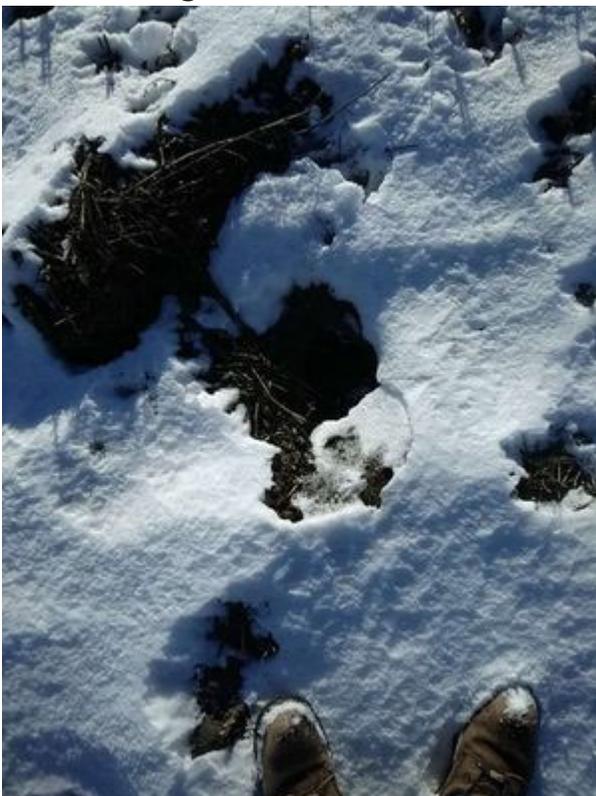
Feature	Longitude	Latitude	Elevation (ft)
Embankment	-76.6585382	41.0650070	556.201
Feature Condition			
Requires action			
Embankment	Embankment Factor		
EmbkOutsideSlope	Animal Burrows

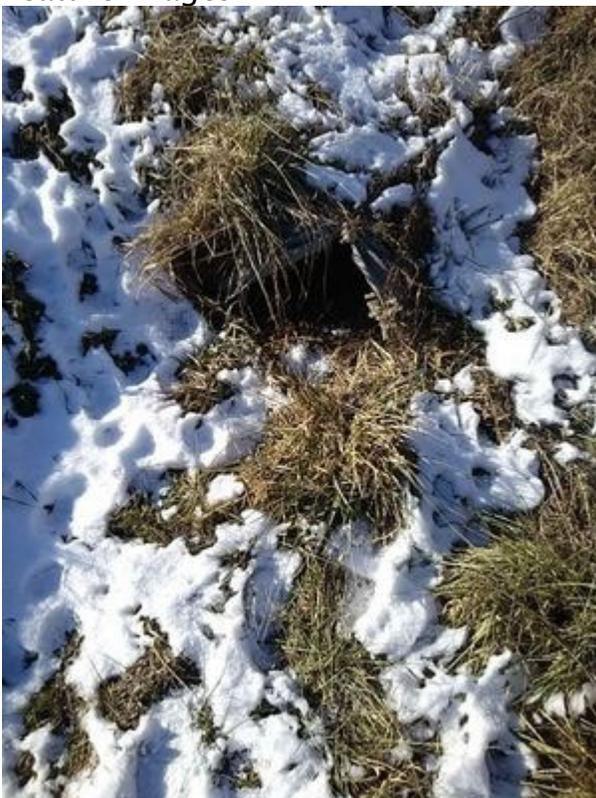
Feature	Longitude	Latitude	Elevation (ft)
Other	-76.6578270	41.0647560	552.264
Feature Condition			
Requires action			
Inspection Notes	Stormwater pipe off bench is partially blocked.

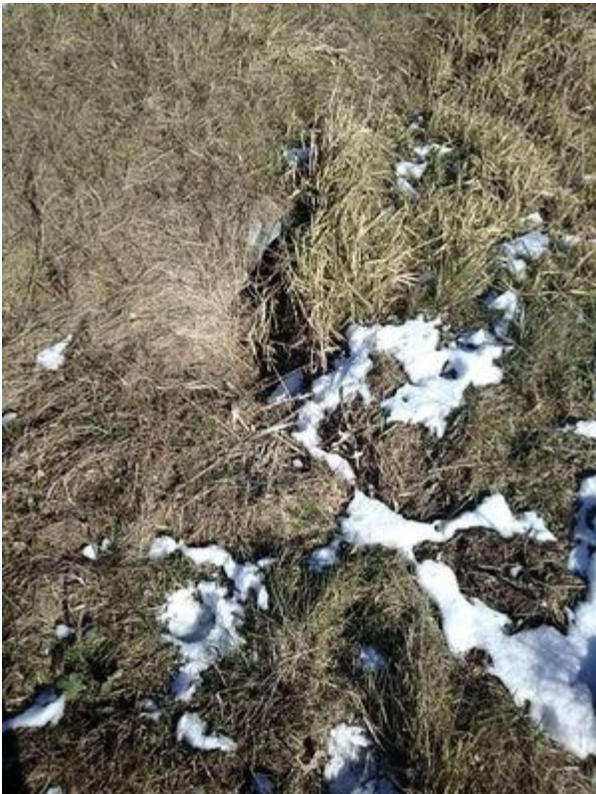
Feature	Longitude	Latitude	Elevation (ft)
Other	-76.6569870	41.0634075	542.093
Feature Condition			
Requires action			
Inspection Notes	Stormwater pipe partially filled in.

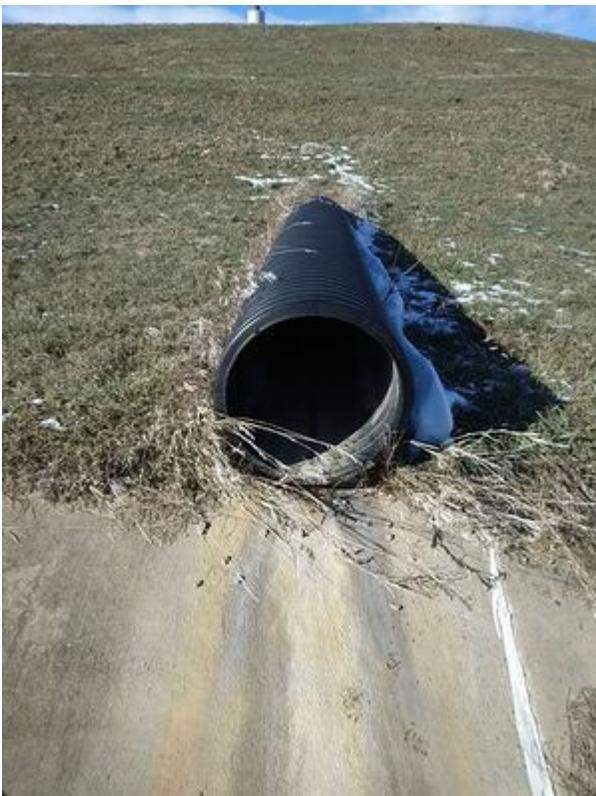
Feature	Longitude	Latitude	Elevation (ft)
Outlet Works	-76.6572057	41.0632335	536.516
Feature Condition			
Satisfactory			
Outlet Works			
OutletWorksOutlet_Pipes

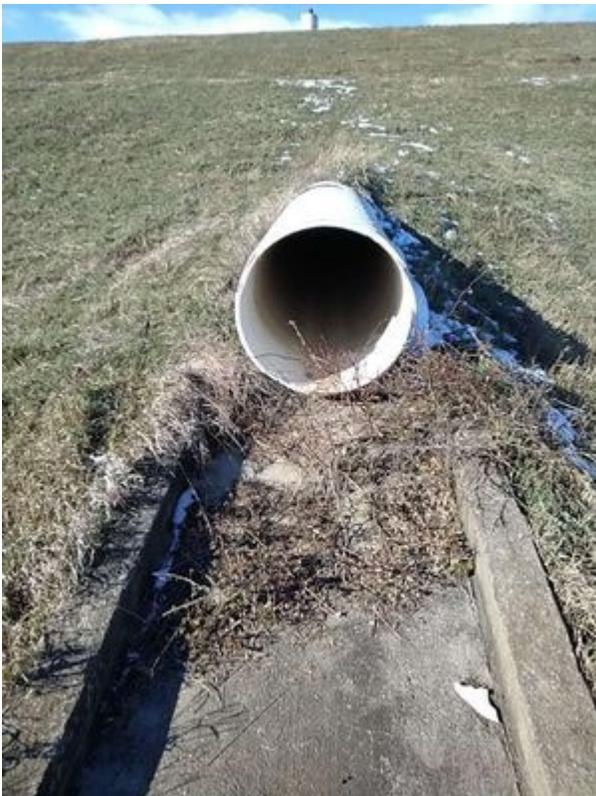
Feature	Longitude	Latitude	Elevation (ft)
Outlet Works	-76.6574770	41.0629965	538.485
Feature Condition			
Satisfactory			
Outlet Works			
OutletWorksOutlet_Pipes

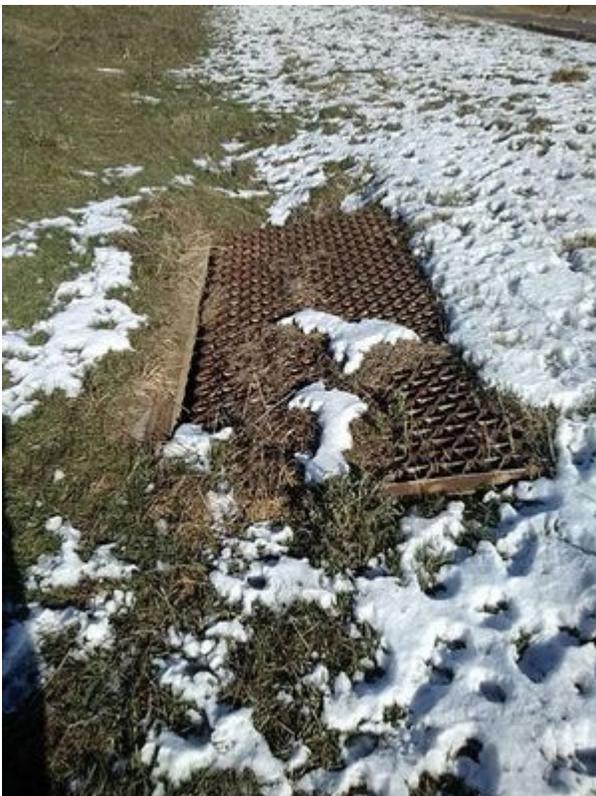
Feature	Longitude	Latitude	Elevation (ft)
Outlet Works	-76.6576837	41.0630970	536.516
Feature Condition			
Satisfactory			
Outlet Works			
OutletWorksConcrete_Structure

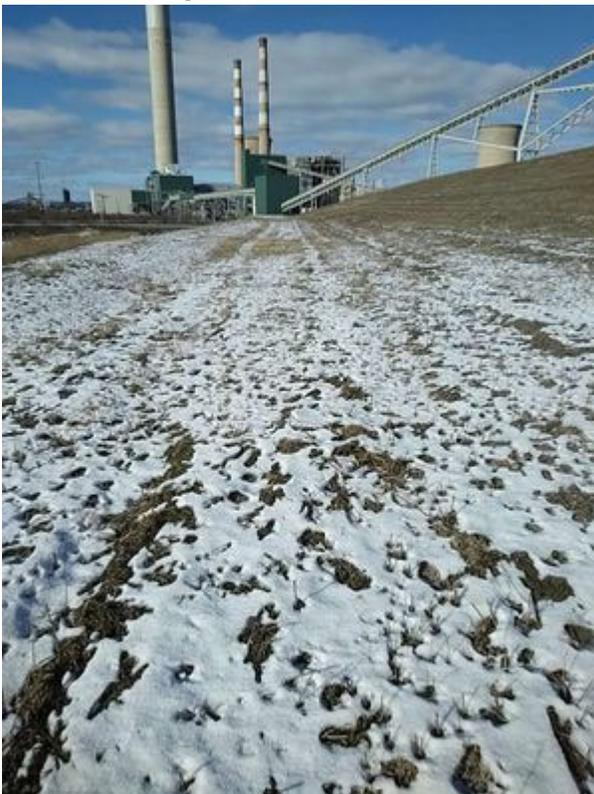
Feature	Longitude	Latitude	Elevation (ft)
Embankment	-76.6606187	41.0636730	550.296
Feature Condition			
Satisfactory			
Embankment			
EmbkOutsideSlope			
Inspection Notes	Bench is in good condition.

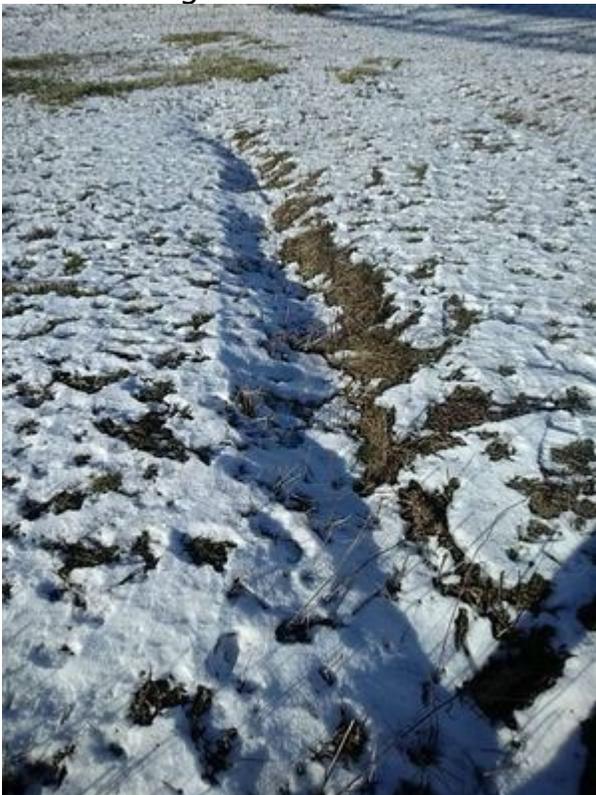
Feature	Longitude	Latitude	Elevation (ft)
Embankment	-76.6610168	41.0650990	575.230
Feature Condition			
Satisfactory but check carefully next inspection			
Embankment	Embankment Factor		
EmbkOutsideSlope	Erosion

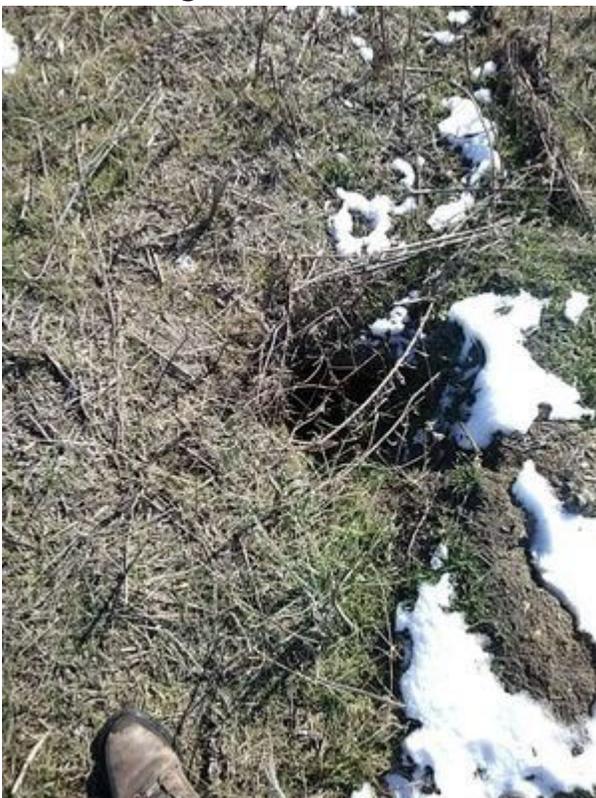
Feature	Longitude	Latitude	Elevation (ft)
Embankment	-76.6610233	41.0645663	574.574
Feature Condition			
Requires action			
Embankment	Embankment Factor		
EmbkOutsideSlope	Animal Burrows

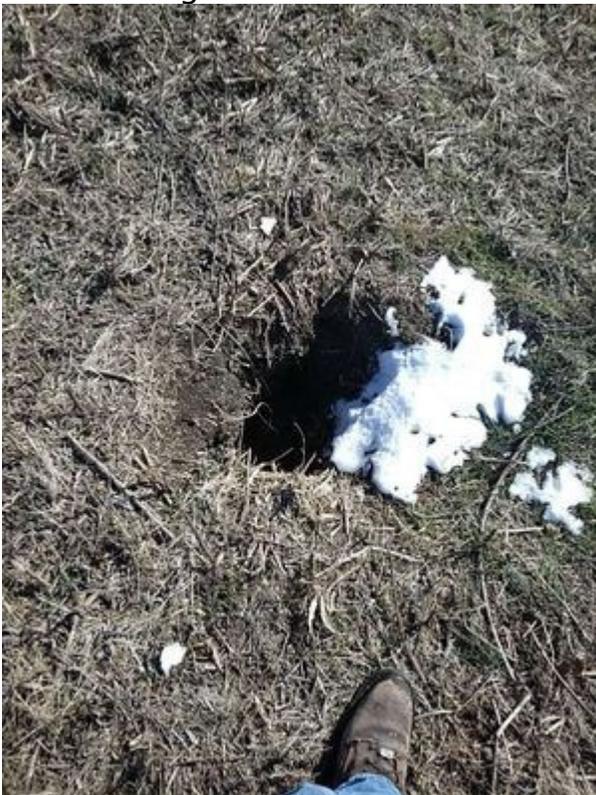
Feature	Longitude	Latitude	Elevation (ft)
Embankment	-76.6609833	41.0645435	573.261
Feature Condition			
Requires			
Embankment	Embankment Factor		
EmbkOutsideSlope	Animal Burrows

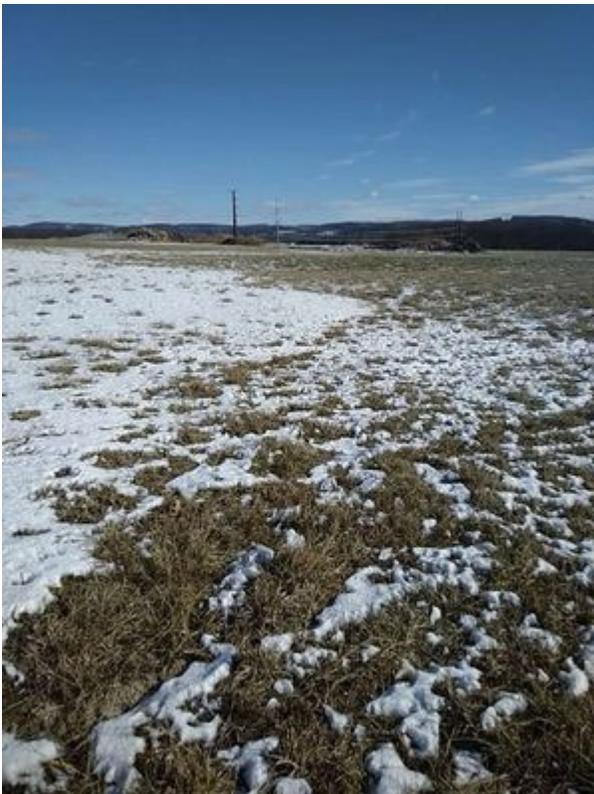
Feature	Longitude	Latitude	Elevation (ft)
Other	-76.6602508	41.0639628	589.338
Feature Condition			
Satisfactory			
Inspection Notes	Waste area.

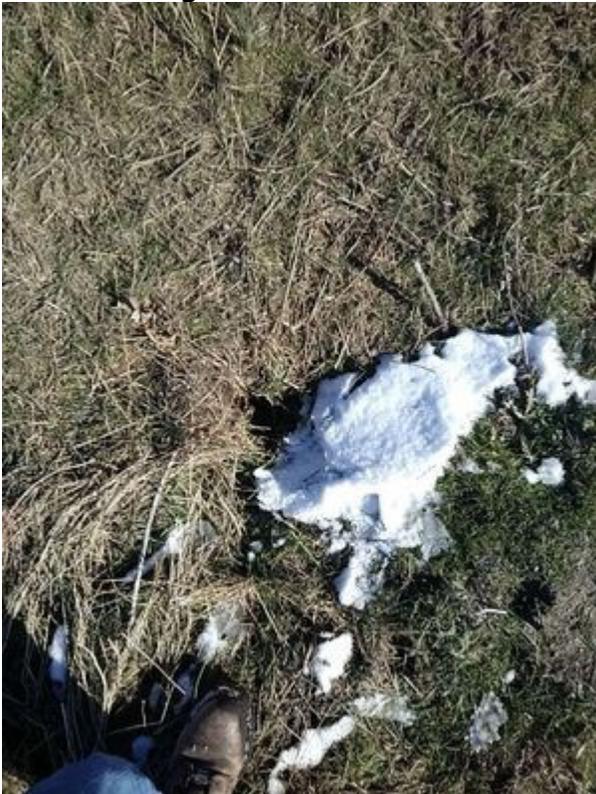
Feature	Longitude	Latitude	Elevation (ft)
Embankment	-76.6598323	41.0630172	580.807
Feature Condition			
Requires action			
Embankment	Embankment Factor		
EmbkOutsideSlope	Animal Burrows

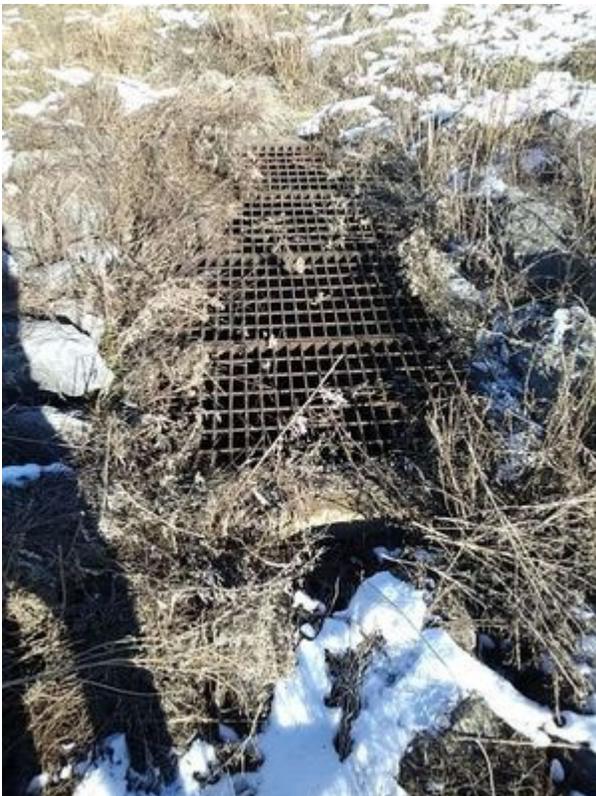
Feature	Longitude	Latitude	Elevation (ft)
Outlet Works	-76.6576667	41.0635278	569.653
Feature Condition			
Satisfactory			
Outlet Works			
OutletWorksConcrete_Structure

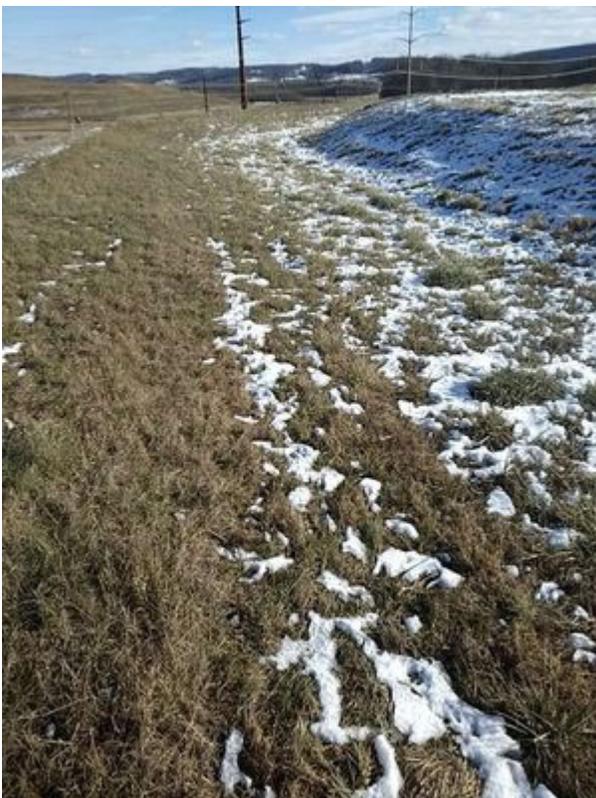
Feature	Longitude	Latitude	Elevation (ft)
Other	-76.6581613	41.0645188	567.028
Feature Condition			
Satisfactory			
Inspection Notes	Stormwater channel on waste level is in good condition.

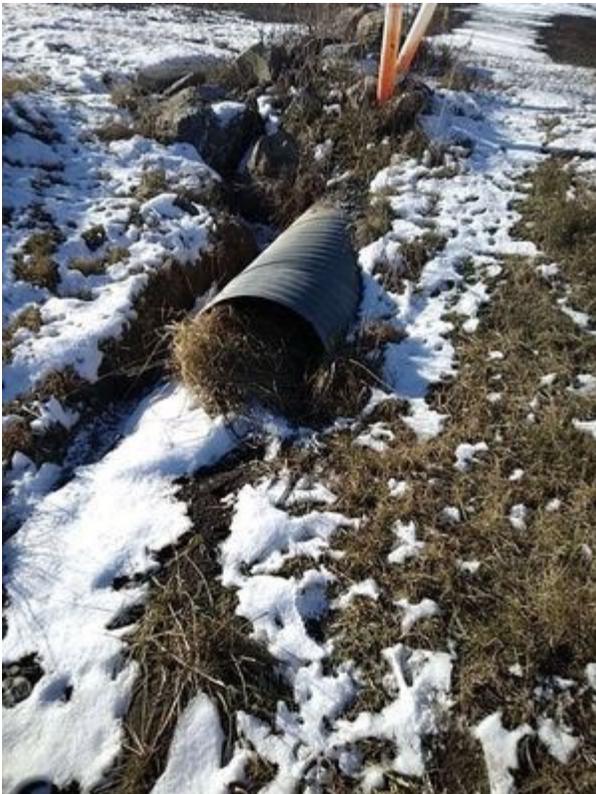
Feature	Longitude	Latitude	Elevation (ft)
Other	-76.6590470	41.0646853	571.949
Feature Condition			
Requires action

Inspection Notes	Stormwater pipe is partially blocked.
------------------	---------------------------------------

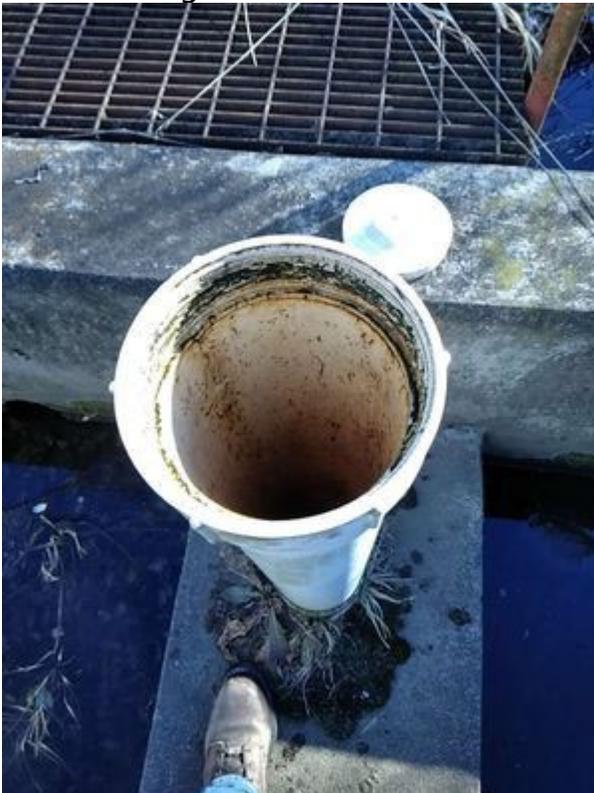
Feature	Longitude	Latitude	Elevation (ft)
Outlet Works	-76.6594212	41.0610445	520.768
Feature Condition			
Satisfactory			
Outlet Works			
OutletWorksOutlet_Pipes			
Inspection Notes	Underdrain observation pipe.
