# **PERIODIC STRUCTURAL STABILITY ASSESSMENT REPORT**

**ASH BASIN NO. 1  
MONTOUR STEAM ELECTRIC STATION  
DERRY TOWNSHIP, MONTOUR COUNTY, PENNSYLVANIA**

**CEC Project 132-065.2006**

**November 2025**

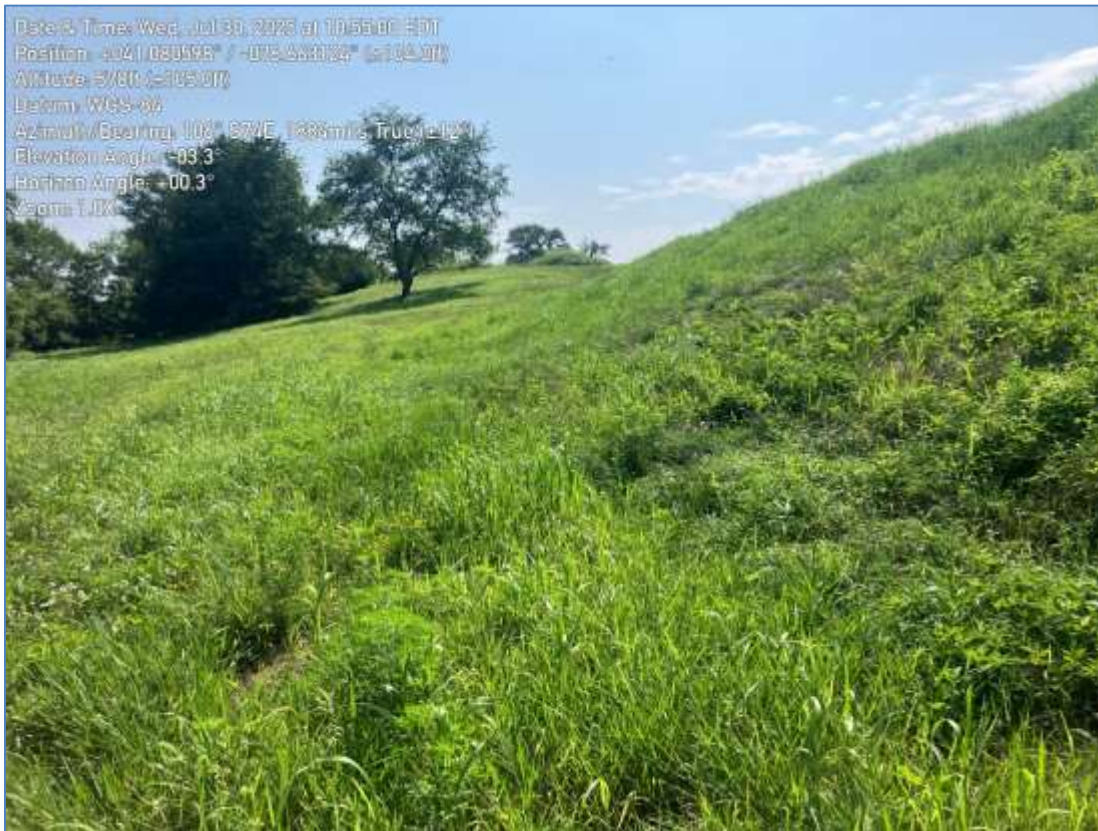
According to Section 3.5 of the Basin 1 History of Construction Report, the Basin 1 perimeter dike was primarily founded on bedrock consisting of weathered shale. The perimeter dike ties into natural existing grade at the northeastern and southeastern corners of the basin. According to the History of Construction Report, the abutment material at these locations consists of residual soils overlying weathered shale. A view of these northeastern and southeastern dike corners are shown in Photographs 1 and 2 in Appendix B.

**Photograph 1 – Northeast corner downstream dike slope**

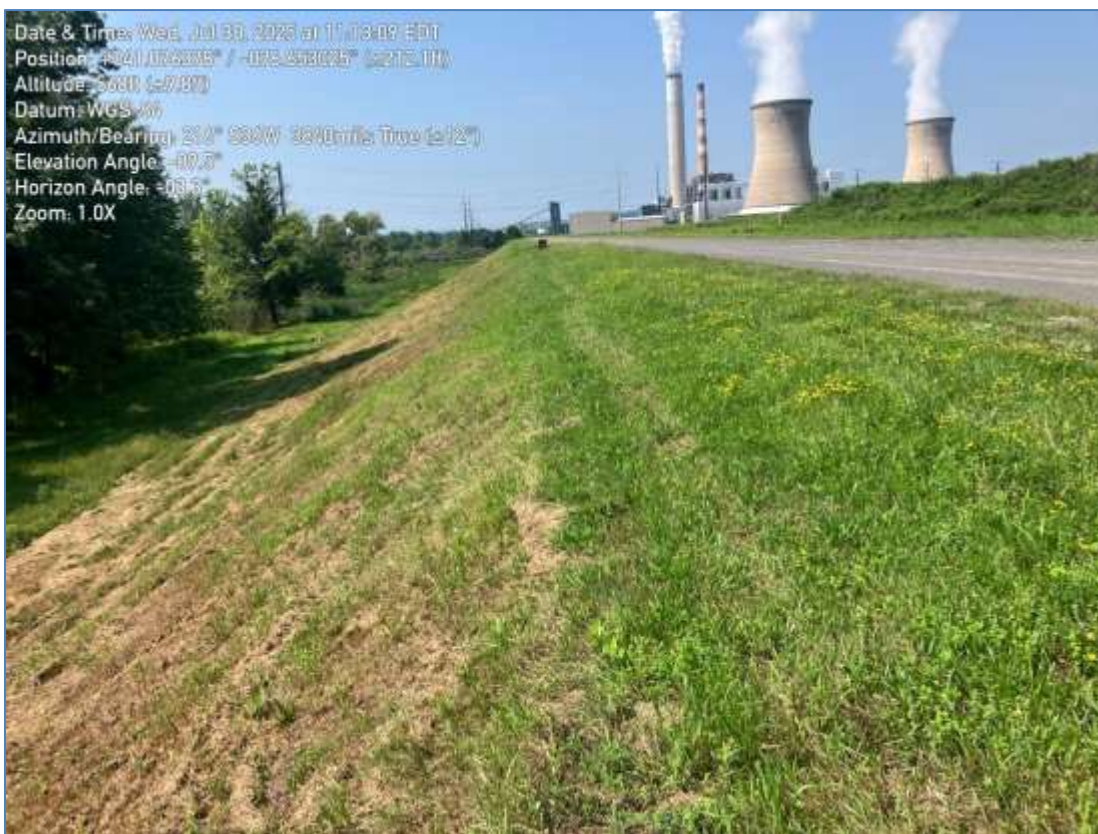
**Photograph 2 – Southern dike slope and crest**

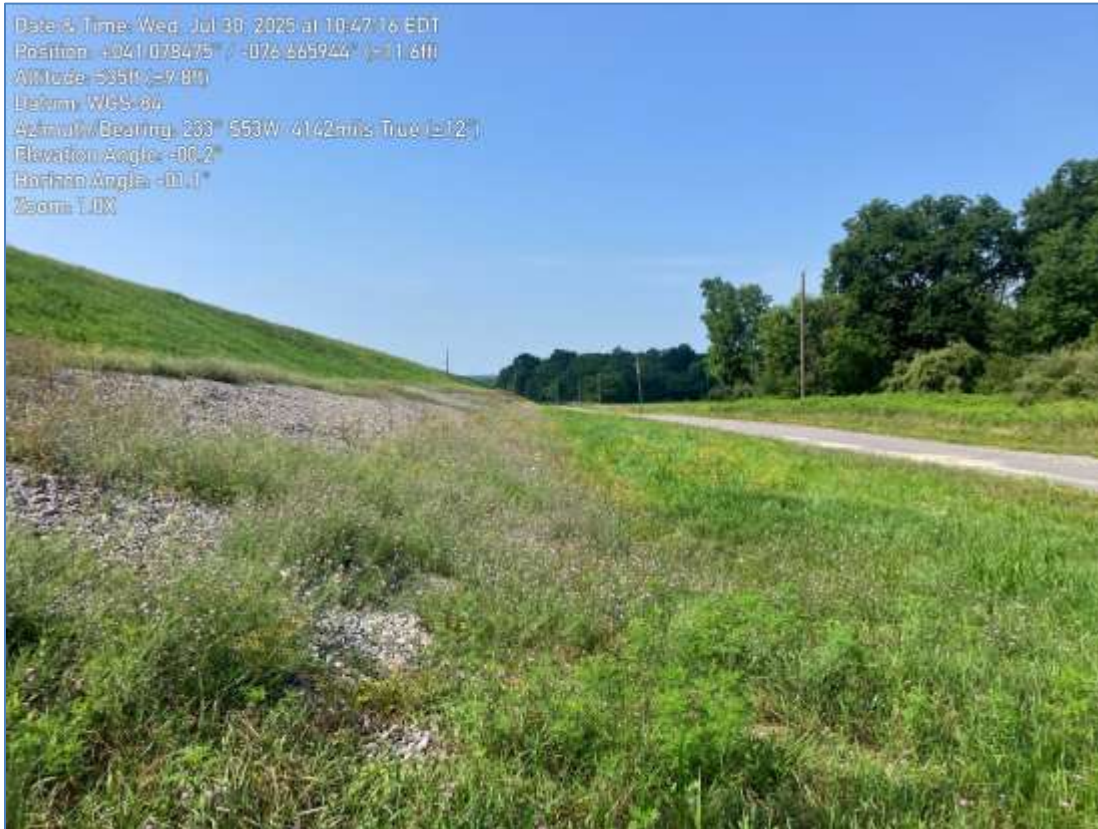
The seep that was observed during CEC's site visit in June 2016 at the toe of the northern dike slope, just upstream of the seepage collection system was not observed during our October 2020 or our July 2025 site visit. According to our conversations with Montour, this seep occurred due to a blockage in the seepage collection system which was cleaned out in October 2016. A view of this area from our July 2025 site visit can be seen in Photograph 3 in Appendix B.

**Photograph 3 – Area of previously observed seep along northern dike slope**

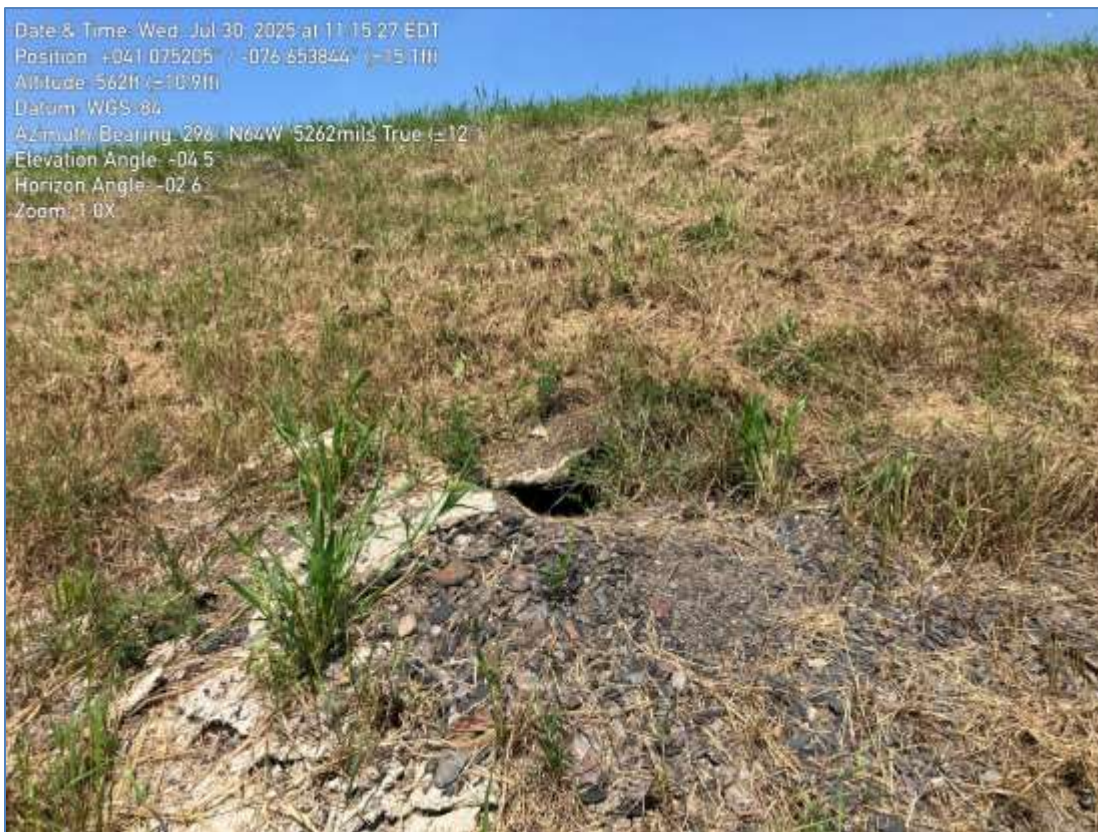
At the time of CEC's site visit, downstream dike slopes were mostly covered with grassy vegetation excluding the areas where riprap has been placed and where the overtopping protection was installed. CEC observed 12 animal burrow holes, each approximately 6 to 12 inches in diameter along the downstream dike slopes. These holes were present along the southern dike and southern portion of the western dike. One of these holes is shown in Photograph 4 in Appendix B. Based on our observations and conversations with Montour, animal burrow holes are filled on a regular basis as part of their normal maintenance and the holes observed by CEC will be filled in. On November 7, 2025, Talen informed CEC that 42 animal

**Photograph 4 – View of animal burrow hole on western dike slope**

burrows along the dike slopes at Basin 1 were recently filled with grout. The downstream dike slopes vegetation was generally in accordance with the Rule requirements. Larger vegetation such as shrubs or trees were not present on the downstream dike slopes. Photographs 1, 2, 3, 4, 7, 11, 12, 16, and 23 show the condition of the vegetation on the downstream dike slopes at the time of our site visit.

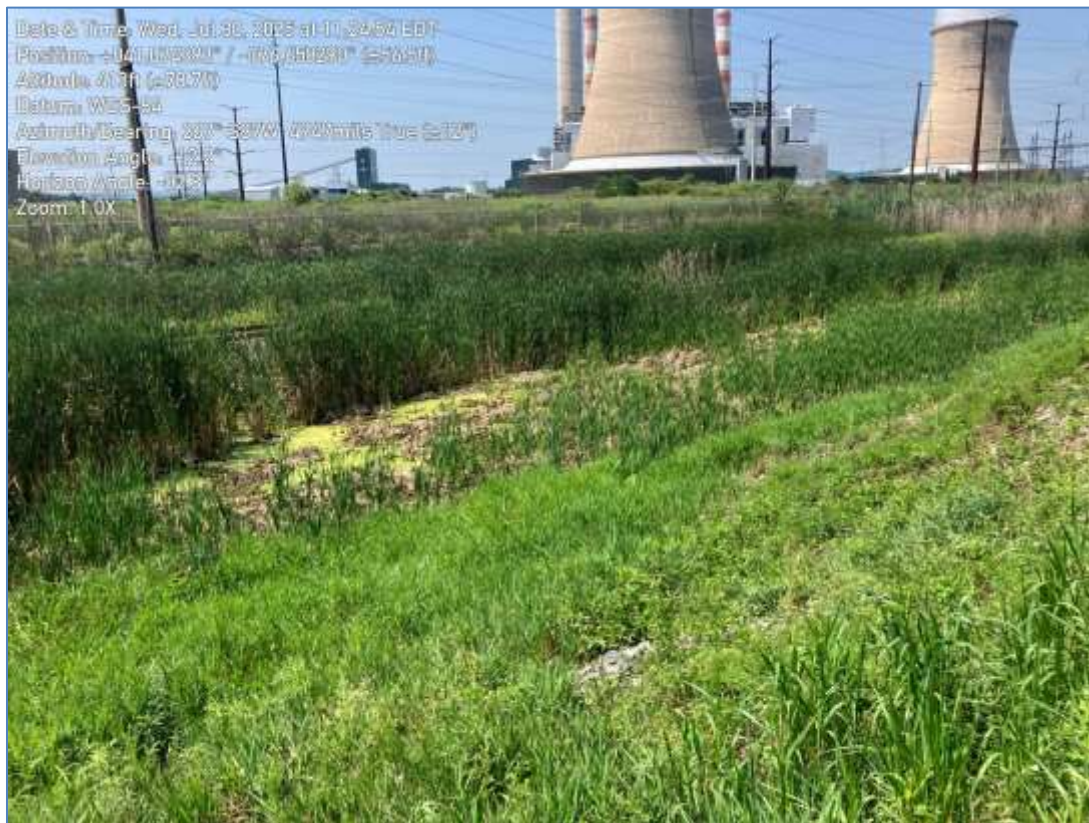
Ponding water was observed between the existing rail line and the toe of the western dike embankment, south of the pipe bridge, at the time of our site visit as shown in Photographs 5 and 6 in Appendix B. Ponding water was also observed at the toe of the western dike embankment, north of the pipe bridge as shown in Photograph 7. No signs of slope instability were observed along the western dike embankment. A rock buttress was constructed in 2007 along the western downstream dike slope in the area of the pipe bridge to increase stability.

**Photograph 5 – Evidence of ponding water at toe of western dike slope**

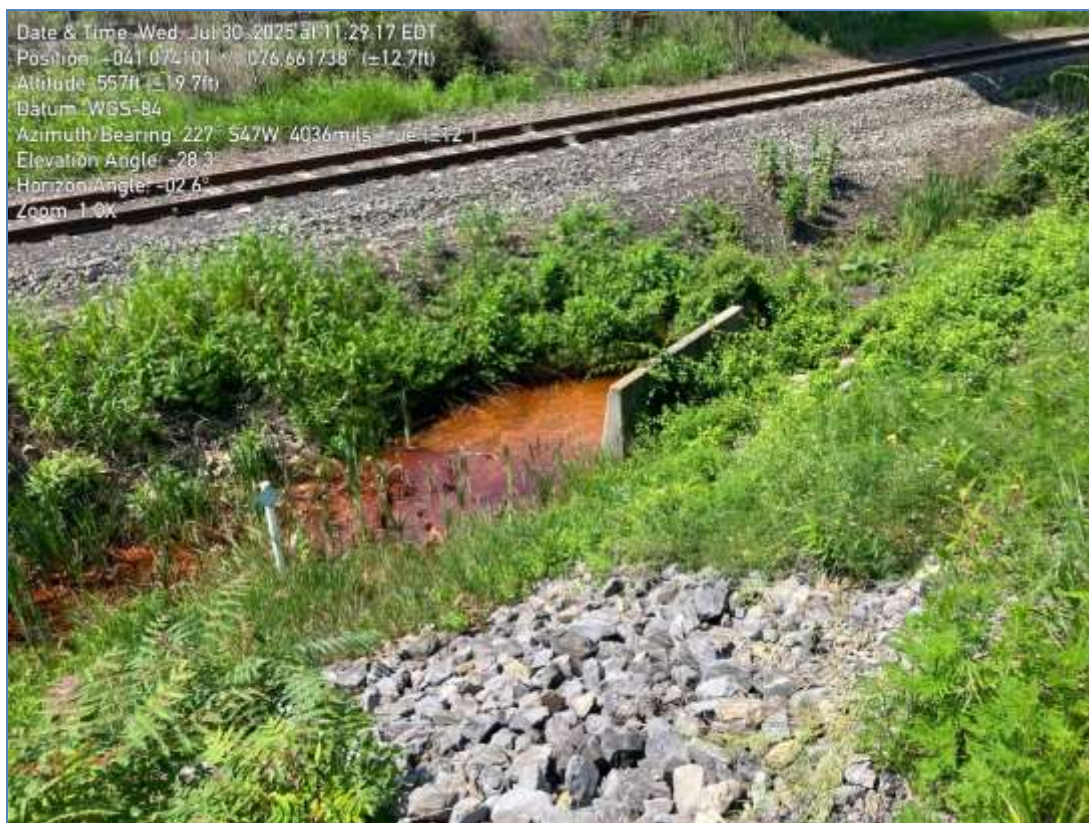
**Photograph 6 – Iron oxidizing bacteria was observed in the sanding water at the toe of the western dike slope**

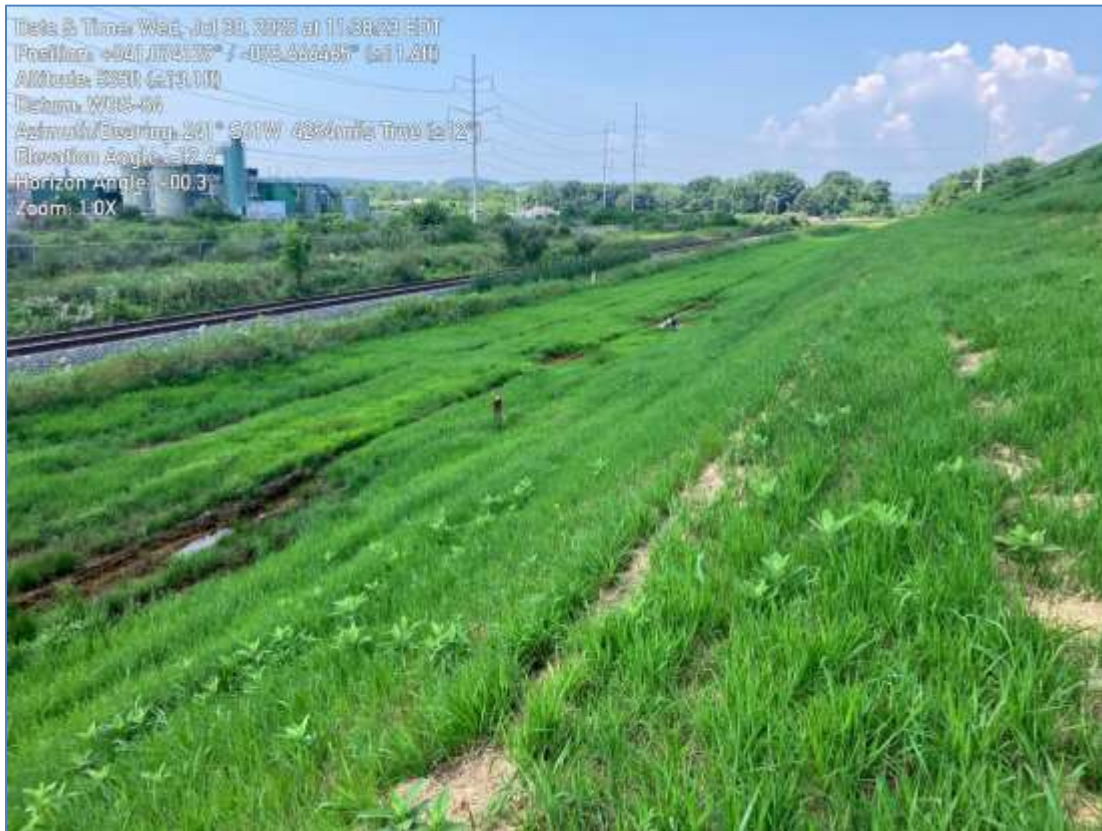
**Photograph 7 – Ponding water at western dike slope toe, north of the pipe bridge**

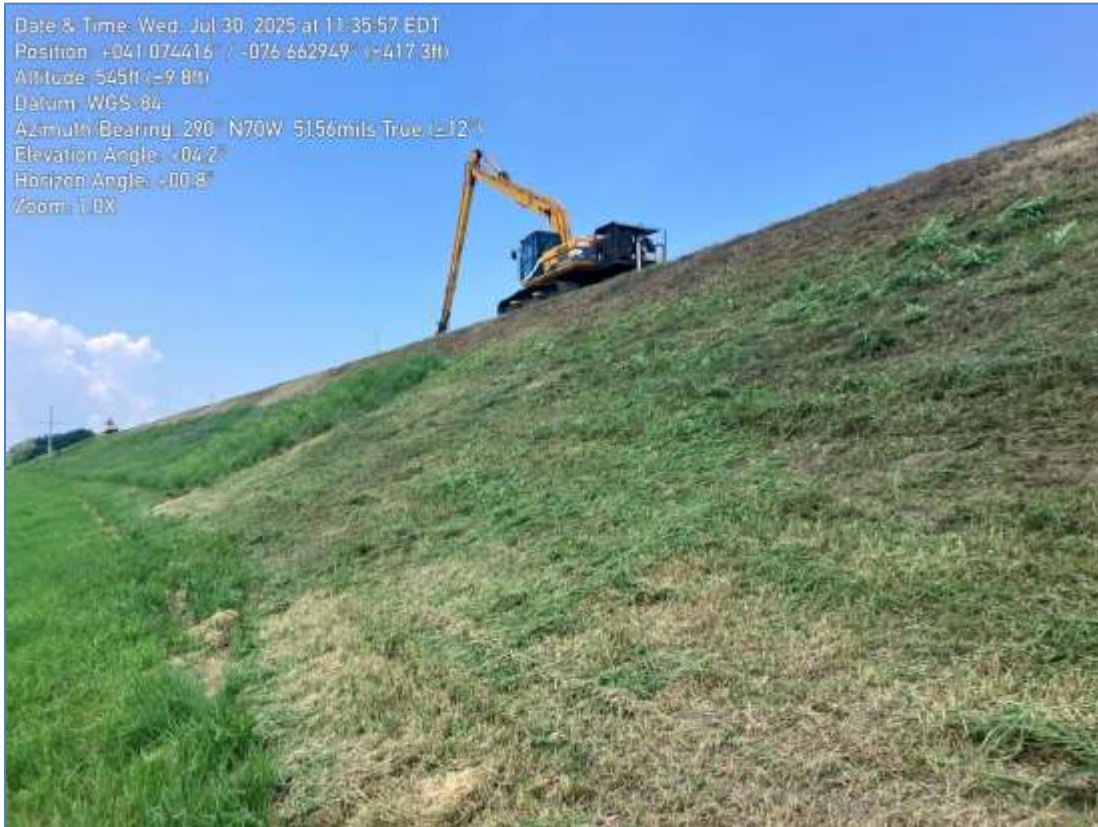
The CCR Rule states that the vegetation on the dikes and surrounding areas shall not exceed 6 inches above the slope of the dike, except for slopes which have an alternate form or forms of slope protection. Montour's vegetation control program calls for cutting vegetation on the dike slopes at least three times a year during the growing season. In accordance with Section 257.83(a)(i) of the CCR Rule, Montour performs weekly inspections of the dike slopes. During these inspections the condition of the vegetation is documented and any issues reported are promptly addressed. Mowing of a portion of the dike slopes was being performed during CEC's site visit in July as shown in Photograph 11 in Appendix B.

**Photograph 11 – Mowing of western dike slope**

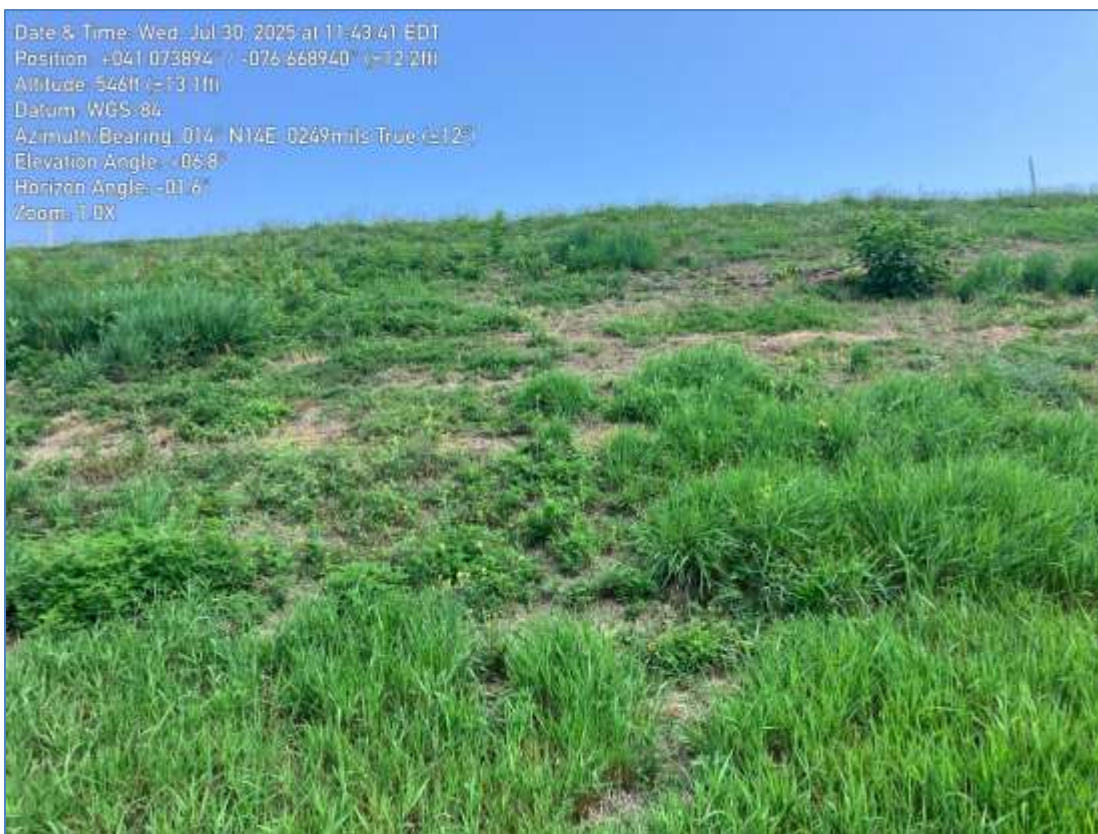
**Photograph 12 – Sparse vegetation on southern dike slope**

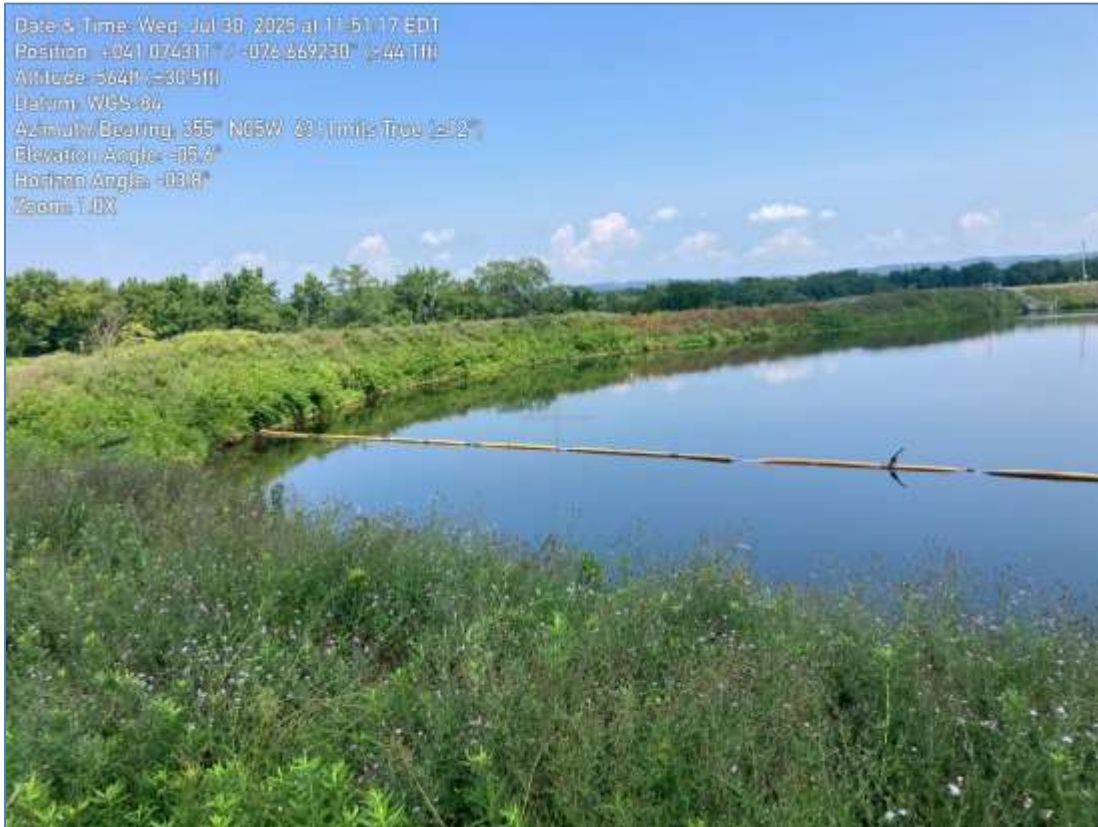
CCR were placed to the top of the dike elevation which covers the upstream side of the dike in Subbasin A (see Photographs 8 and 9) and most of Subbasin B except for the western portion which are exposed (see Photographs 10 and 22). The interior dike slopes in Subbasin C are also exposed as shown in Photographs

**Photograph 13 – Subbasin C western upstream dike slope**

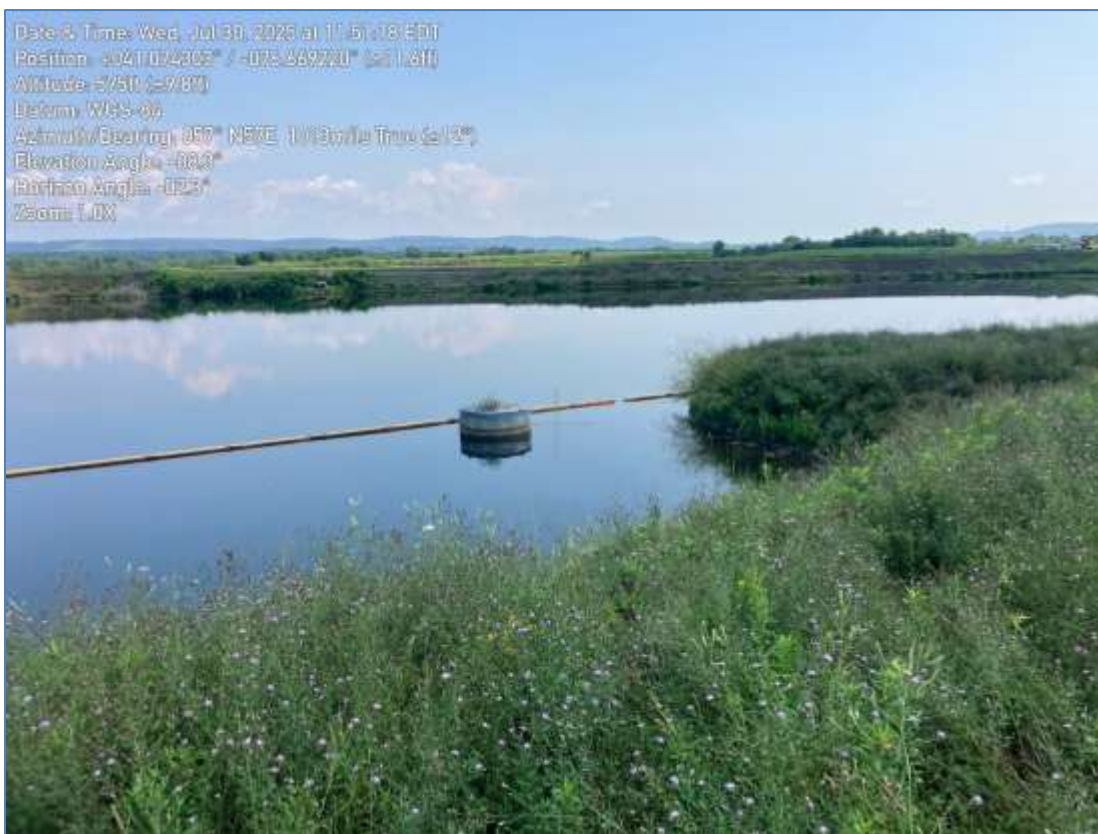
13, 14, and 15. The exposed upstream slopes in these two areas are mostly covered with vegetation to protect against erosion. Section 3.6.4 of the History of Construction Report states that a berm was constructed along the perimeter dike to protect against erosion from wave action and was constructed of reclaimed bottom ash and coal mill rejects. Our observations and topography indicates that this berm has remained in place. Refer to Section 5.4 of this report for more information on dike vegetation.

**Photograph 14 – Subbasin C western and southern upstream dike slopes**

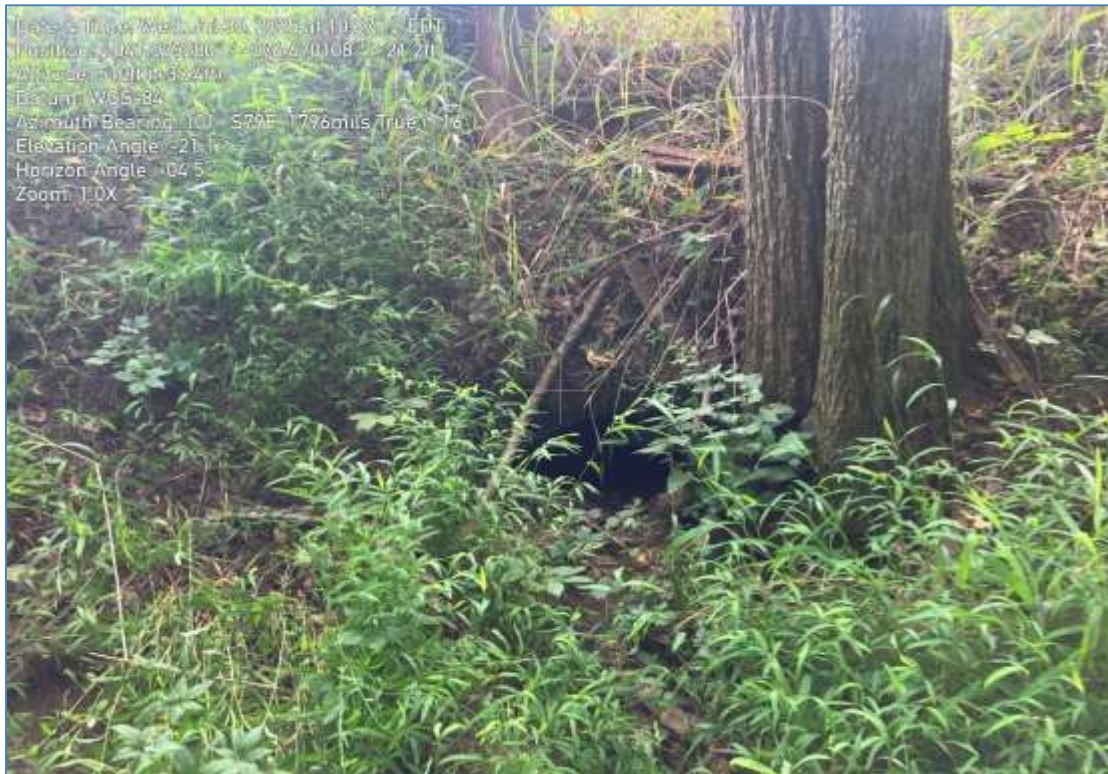
Two abandoned reinforced concrete pipe culverts are present beneath the dike on the north side of Basin 1 as shown on Figure 2. The outlet of the western plugged culvert is exposed and is shown in Photograph 17 in Appendix B. According to the Initial Annual Inspection Report, this pipe was inspected from the downstream end with a ROV by Montour in 2014. A concrete plug was encountered during the inspection approximately 59 feet from the outlet end. Drawing G-199945-13 by Ebasco Services, Inc. dated March 15, 1968 indicates that the eastern plugged culvert was temporarily installed to allow flow of an existing creek through the dike embankment, most likely during construction. The exact location of the eastern plugged culvert is unknown.

**Photograph 17 –Abandoned, plugged overflow culvert pipe outlet**
