**Subject: 2026 Annual USEPA CCR Landfill Inspection Report**  
**Brunner Island Ash Disposal Area No. 8**

**APPENDIX A**  
**INSPECTION PHOTOGRAPHS WITH MAP LOCATIONS**

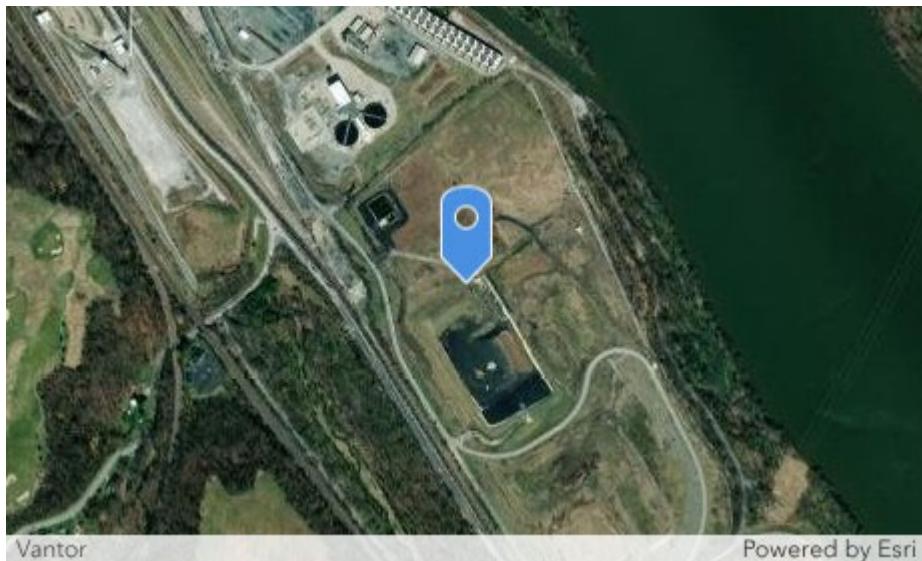
Inspection Record: 120925 122219

Feature	Longitude	Latitude	Elevation (ft)
Embankment	-76.6897149	40.0879721	297.172
Feature Condition			
Satisfactory			
Embankment			
EmbkOutsideSlope

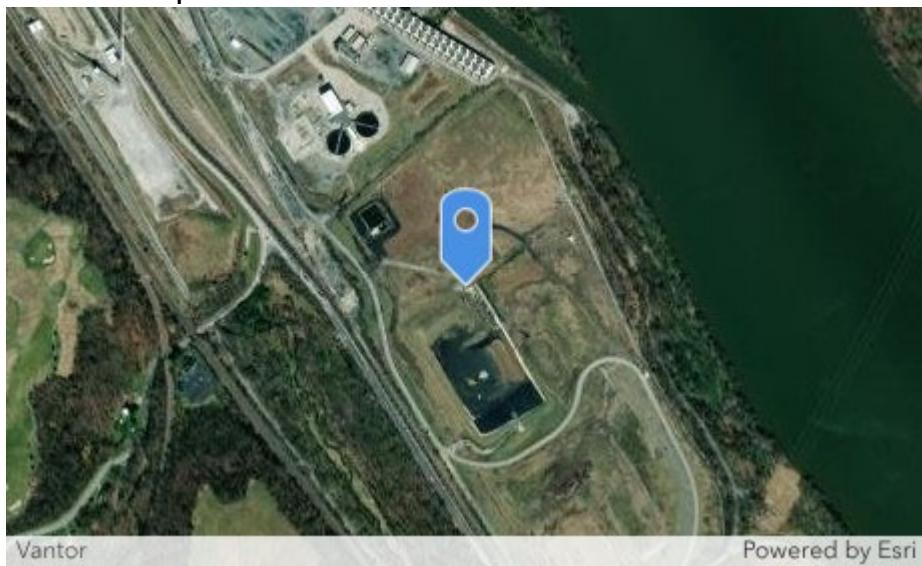
Inspection Record: 120925 130821

Feature	Longitude	Latitude	Elevation (ft)
Outlet Works	-76.6895343	40.0880968	295.278
Feature Condition	Satisfactory but check carefully next inspection		
Outlet Works			
OutletWorksOutlet_Pipes			
Inspection Notes	Pump #1 is off. #2 and #3 are in auto.

- Clean out the partially blocked culvert under the access road.
- Continue to monitor the leakage rate into the leachate detection zone. If the leakage rate increases to previously high levels, identify the cause and repair if necessary.
- Place additional stone overtop the eastern berm/rain flap where the geotextile protection layer is exposed.
- Continue to evaluate the need to raise the elevations on the exterior slopes, specifically the northern and western slopes, against the waste and place additional waste and soil and stabilize, as necessary, to meet design grades. This should be performed with the use of topographic survey.
- Perform necessary repairs to pump 1 and re-establish the pump to the “auto” setting.

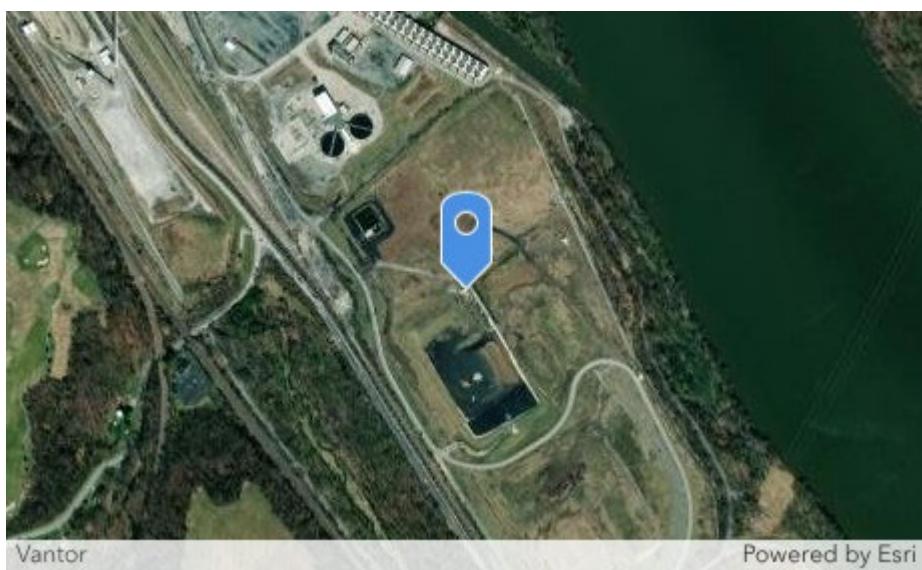
Inspection Record: 120925 131019

Feature	Longitude	Latitude	Elevation (ft)
Outlet Works	-76.6894149	40.0880441	292.770
Feature Condition			
Satisfactory			
Outlet Works			
OutletWorksOutlet_Pipes			
Inspection Notes	Leachate pipes are exposed and surrounding filter is intact.

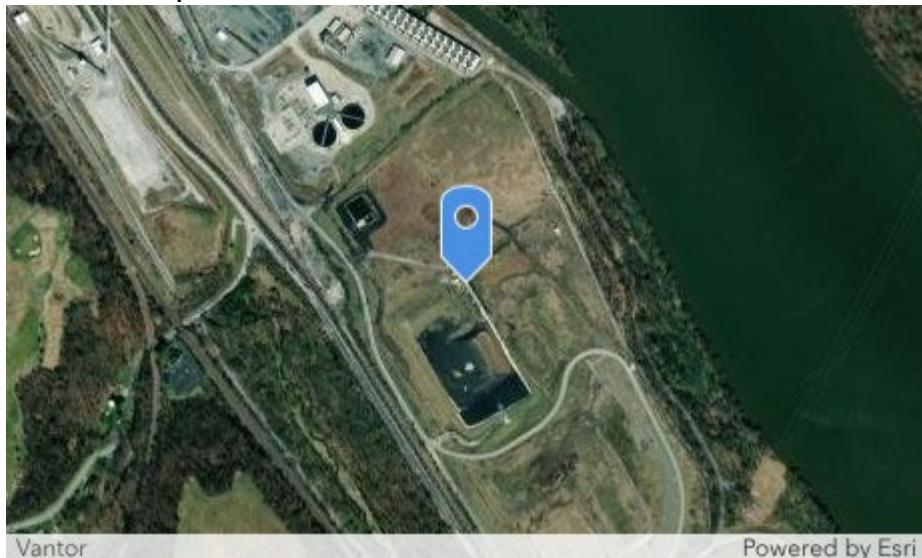
Inspection Record: 120925 131149			
Feature	Longitude	Latitude	Elevation (ft)
Other	-76.6892403	40.0879766	294.738
Feature Condition			
Requires action this season			
Inspection Notes	Replace pea gravel on rainflap berm in 10 locations.

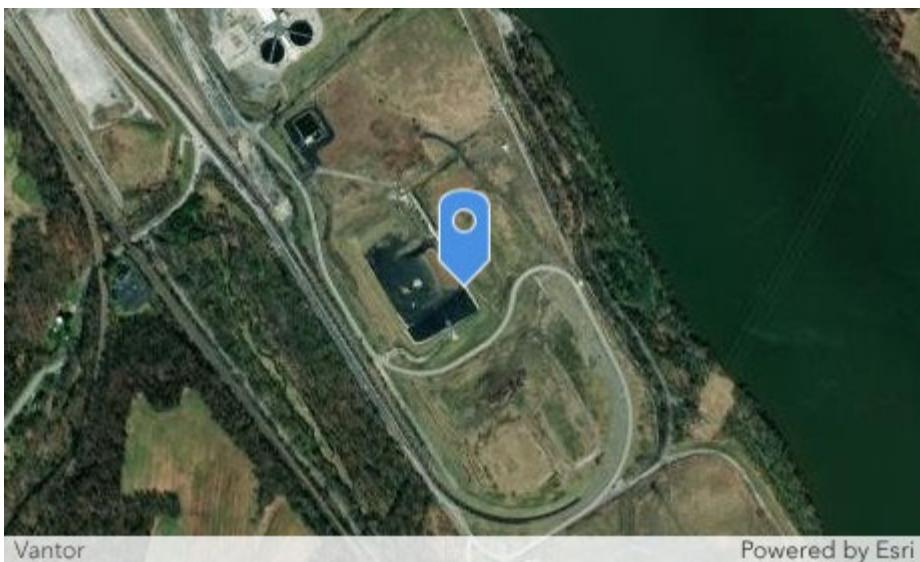
Inspection Record: 120925 131626

Feature	Longitude	Latitude	Elevation (ft)
Other	-76.6881670	40.0865892	305.557
Feature Condition			
Satisfactory			
Inspection Notes	Permitted in and out area of the landfill.

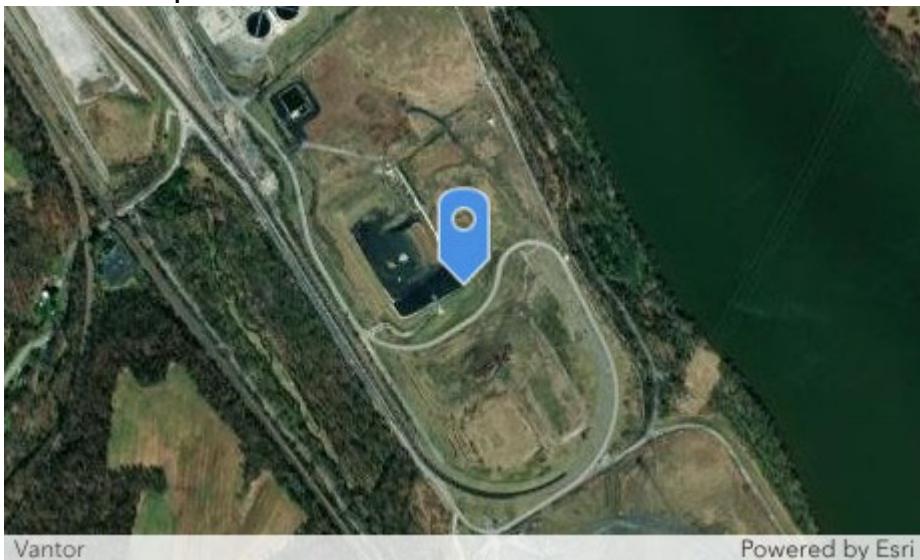
Inspection Record: 120925 131903

Feature	Longitude	Latitude	Elevation (ft)
Embankment	-76.6878576	40.0861951	310.198
Feature Condition			
Satisfactory			
Embankment			
EmbkOutsideSlope			
Inspection Notes	Southern end of landfill.

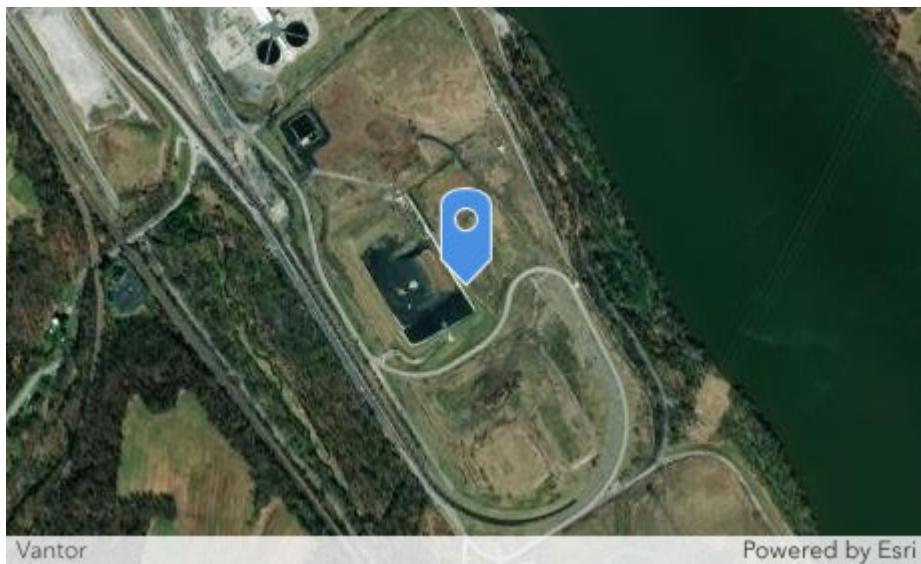
Inspection Record: 120925 132148

Feature	Longitude	Latitude	Elevation (ft)
Embankment	-76.6880353	40.0866133	293.515
Feature Condition			
Satisfactory			
Embankment			
EmbkOutsideSlope

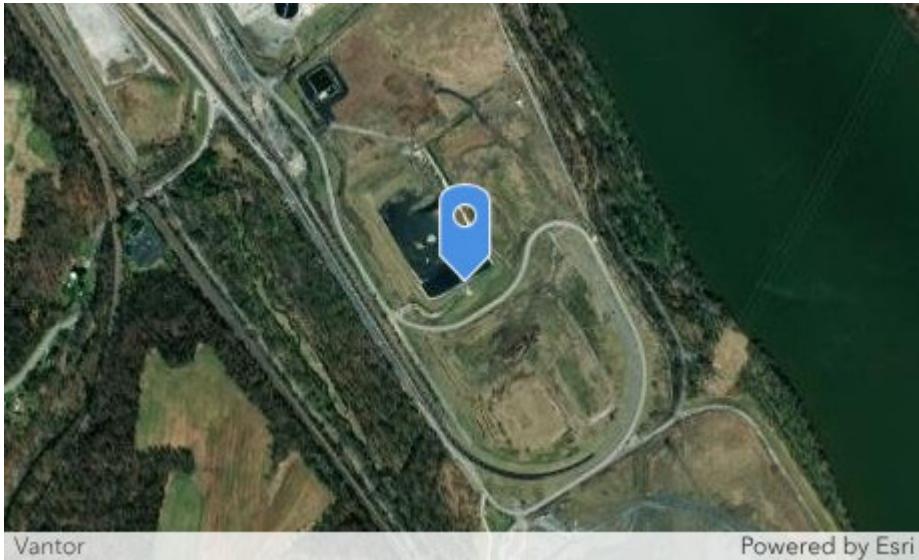
Inspection Record: 120925 132422

Feature	Longitude	Latitude	Elevation (ft)
Access Rd	-76.6884862	40.0859224	309.996
Feature Condition			
Satisfactory			
Inspection Notes	Access into the in and out area.

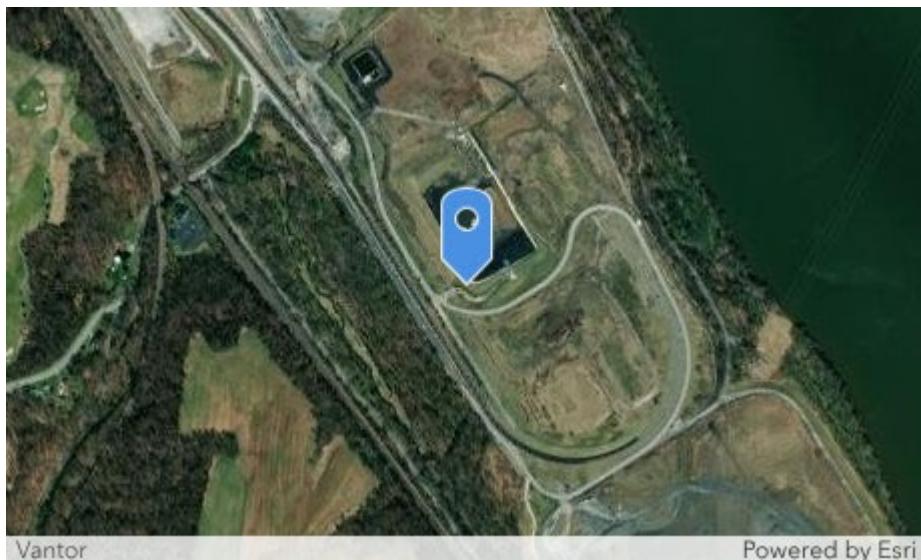
Inspection Record: 120925 132915

Feature	Longitude	Latitude	Elevation (ft)
Embankment	-76.6893838	40.0855824	290.794
Feature Condition			
Satisfactory			
Embankment			
EmbkOutsideSlope

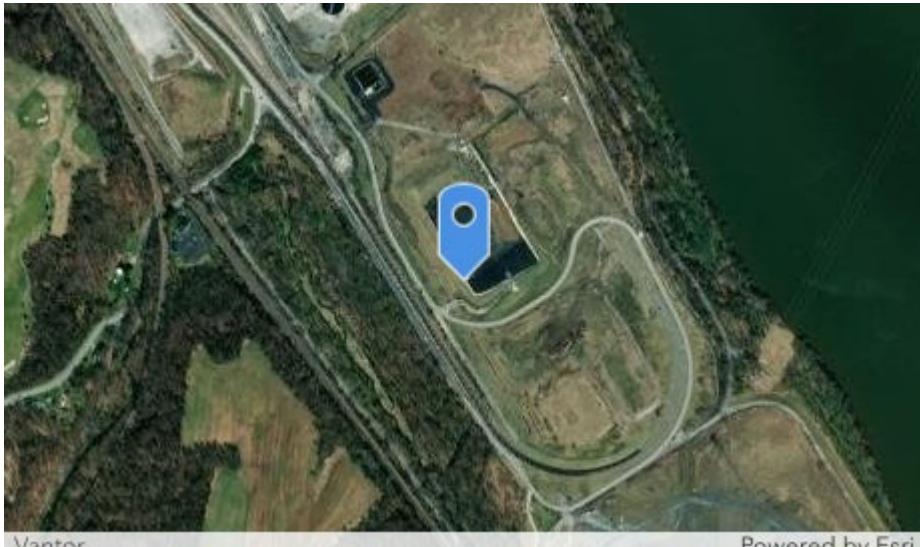
Inspection Record: 120925 133029

Feature	Longitude	Latitude	Elevation (ft)
Other	-76.6894496	40.0858418	304.282
Feature Condition			
Satisfactory			
Inspection Notes	Edge of liner sign.

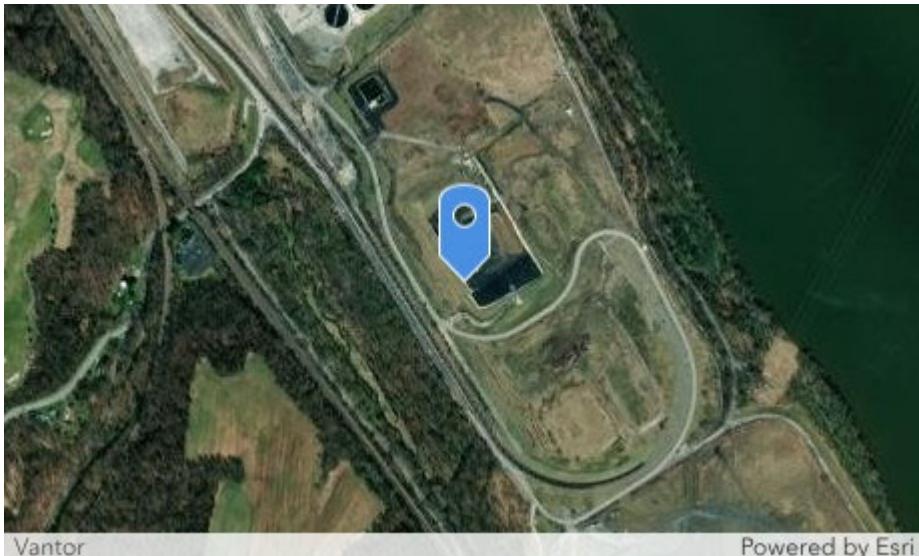
Inspection Record: 120925 133122

Feature	Longitude	Latitude	Elevation (ft)
Other	-76.6895516	40.0860385	305.471
Inspection Notes	Area that is to be filled in the future.

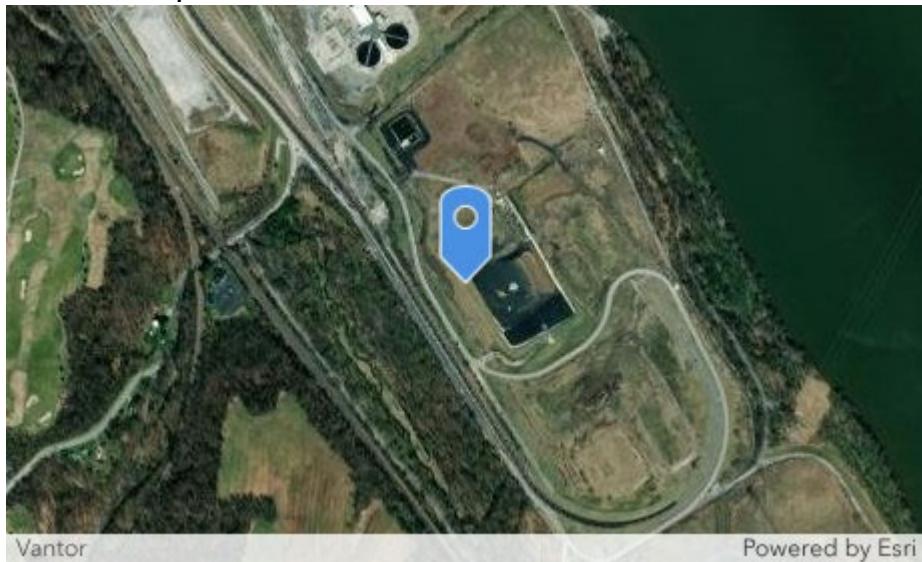
Inspection Record: 120925 133404

Feature	Longitude	Latitude	Elevation (ft)
Other	-76.6901747	40.0866697	301.260
Feature Condition			
Satisfactory			
Inspection Notes	Stormwater channel is in good condition.

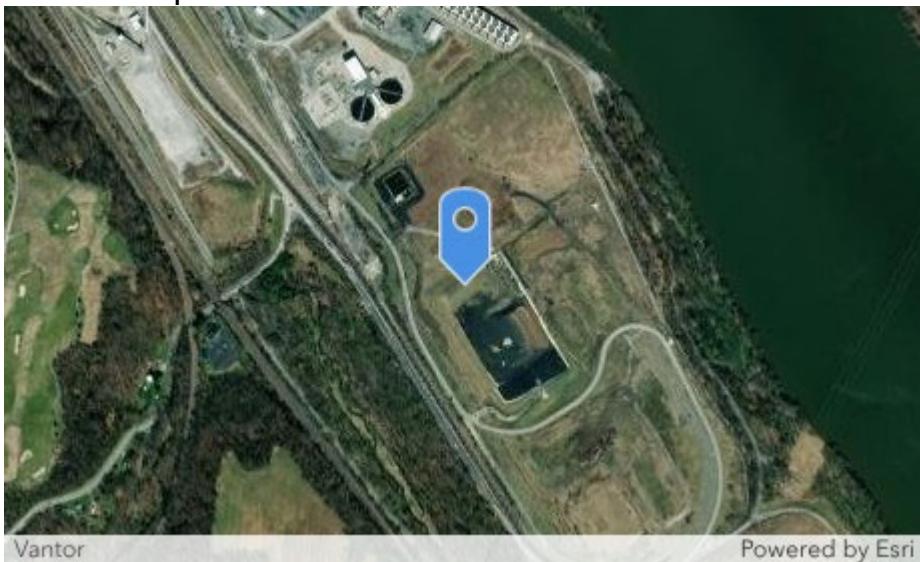
Inspection Record: 120925 133741

Feature Condition	
Requires action this season

Inspection Notes	Top bench berm. Appears to be slightly shorter than design. Confirm with survey and raise as needed.
------------------	--

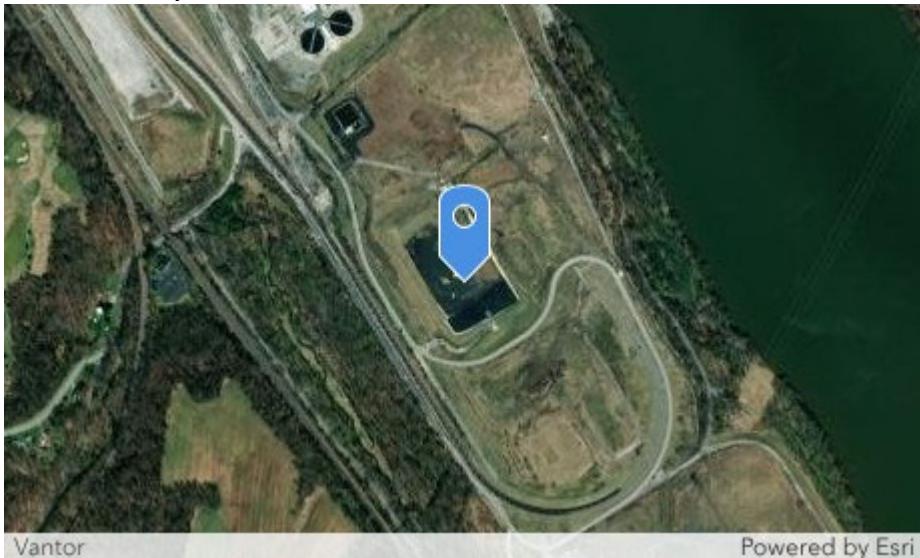
Feature Condition	
Satisfactory	
Inspection Notes	Active waste area has been rolled and compacted.
