**Subject: 2026 USEPA CCR Landfill Inspection Report
Montour Ash Disposal Area No. 3**

1.0 Summary

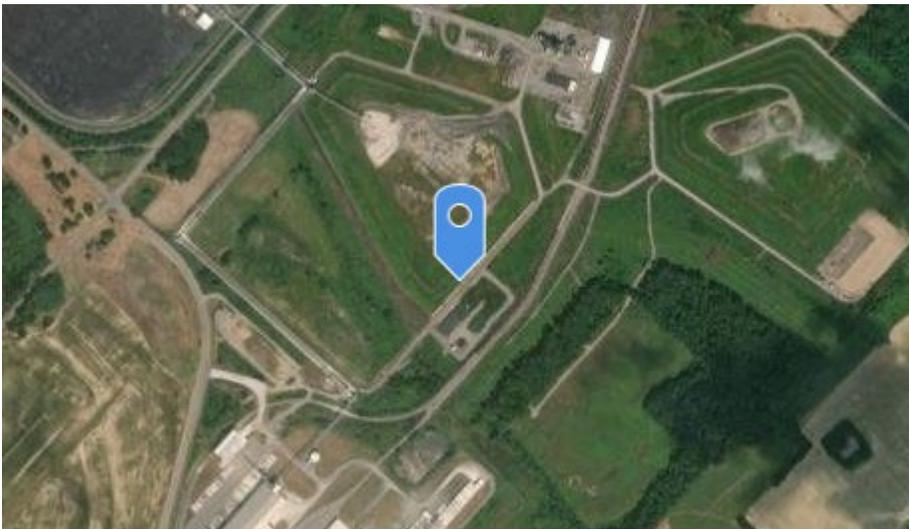
Inspection Record: 121225 120636

Feature	Longitude	Latitude	Elevation (ft)
Other	-76.6585495	41.0620747	530.611
Feature Condition			
Requires action			
Inspection Notes	Settlement along edge of concrete channel.

landfill or asphalt (non-landfill) side of the concrete channel where the void spaces are observed due to settling. Continue to maintain the top perimeter berm and remove sediment from the swale as necessary to maintain swale capacity. Remove the vegetation from below the flapper gate where the groundwater drainage system daylight and lubricate the gate.

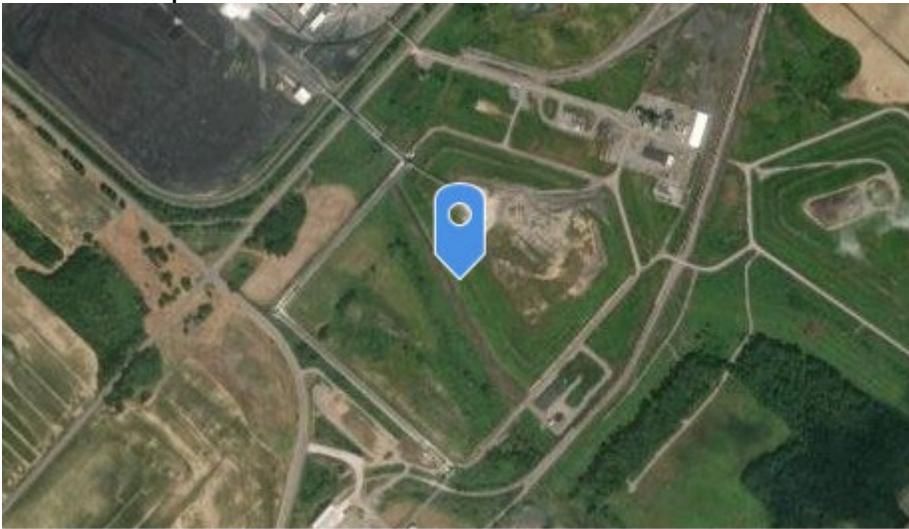
Inspection Record: 121225 122907

Feature	Longitude	Latitude	Elevation (ft)
Embankment	-76.6606568	41.0633083	539.469
Feature Condition			
Requires action			
Embankment	Embankment Factor		
EmbkOutsideSlope	Settlement		
Inspection Notes	Minor settlement approx. 6" deep.

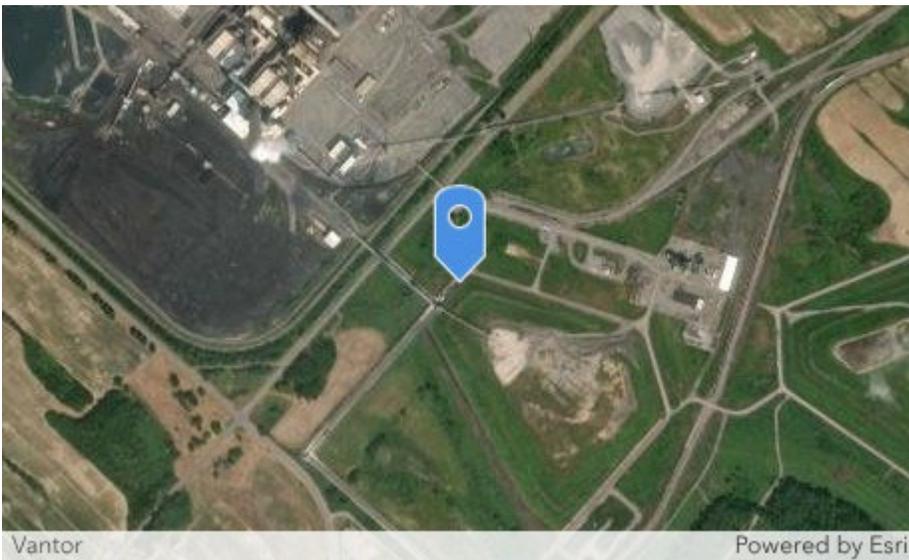
Inspection Record: 121225 123934

Feature	Longitude	Latitude	Elevation (ft)
Other	-76.6613002	41.0656065	533.891
Feature Condition			
Requires action			
Inspection Notes	Outer limits of landfill stormwater pipe is partially blocked.

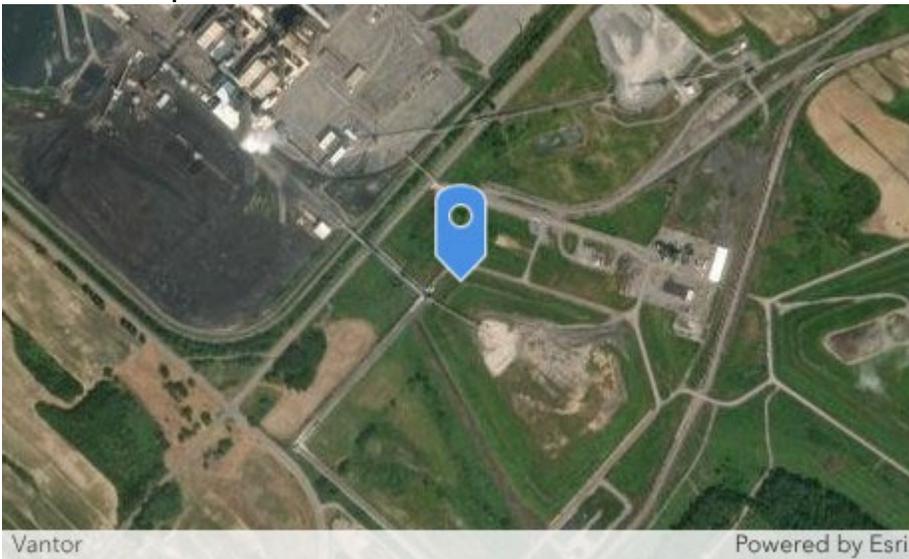
Inspection Record: 121225 124044

Feature	Longitude	Latitude	Elevation (ft)
Embankment	-76.6611098	41.0654815	555.545
Feature Condition			
Requires action			
Embankment	Embankment Factor		
EmbkOutsideSlope	Animal Burrows

The slopes were recently mowed providing good visibility of the structure. 7 groundhog holes were observed, and they were located on the exterior slopes. When burrows are located, removal of groundhogs should occur to prevent damage to the liner around the toe or the cover material followed by filling of the groundhog holes. A minor erosion scar was observed on the northern side of the landfill and should be backfilled and monitored. As noted in previous inspections, a slope irregularity was observed above the bench of the landfill, which is also seen in the aerial photogrammetry. There was no evidence of instability in this area, and the irregularity is reported to be the result of grading during construction.

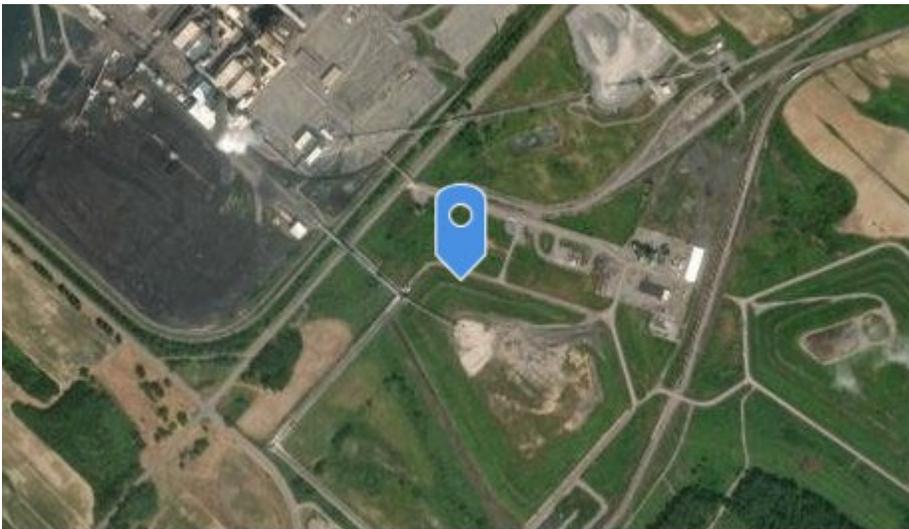
Inspection Record: 121225 124145

Feature	Longitude	Latitude	Elevation (ft)
Embankment	-76.6605932	41.0654670	544.390
Feature Condition			
Requires action			
Embankment		Embankment Factor	
EmbkOutsideSlope		Animal Burrows

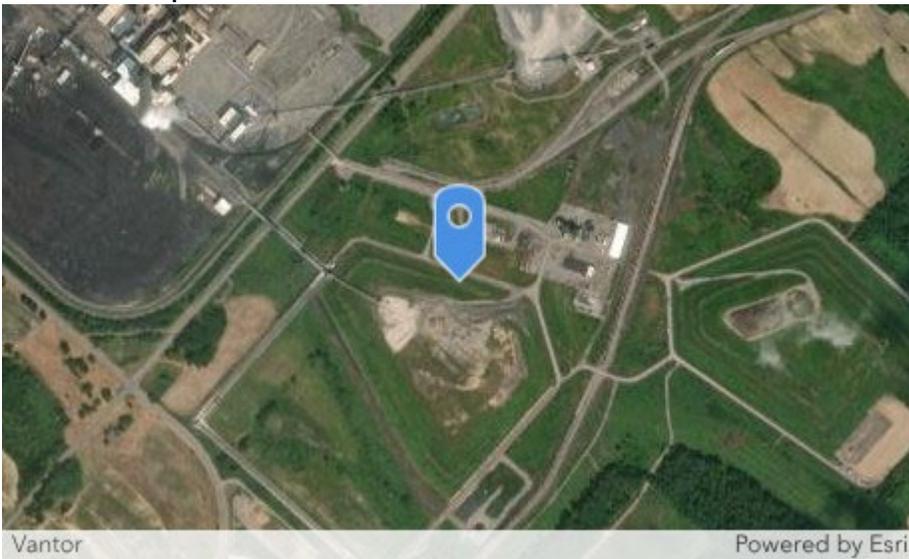
Inspection Record: 121225 124527

Feature	Longitude	Latitude	Elevation (ft)
Embankment	-76.6589340	41.0650948	553.904
Feature Condition			
Requires action			
Embankment	Embankment Factor		
EmbkOutsideSlope	Animal Burrows

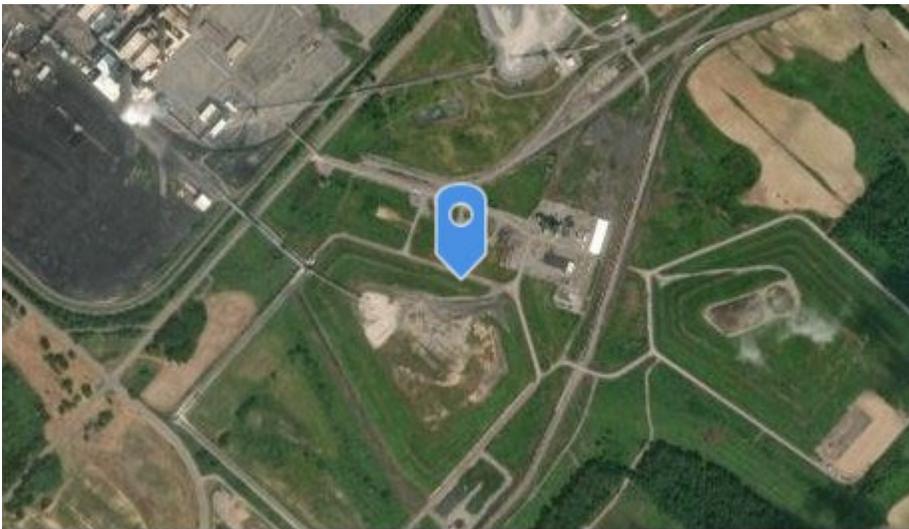
Inspection Record: 121225 124610

Feature	Longitude	Latitude	Elevation (ft)
Embankment	-76.6585382	41.0650070	556.201
Feature Condition			
Requires action			
Embankment	Embankment Factor		
EmbkOutsideSlope	Animal Burrows

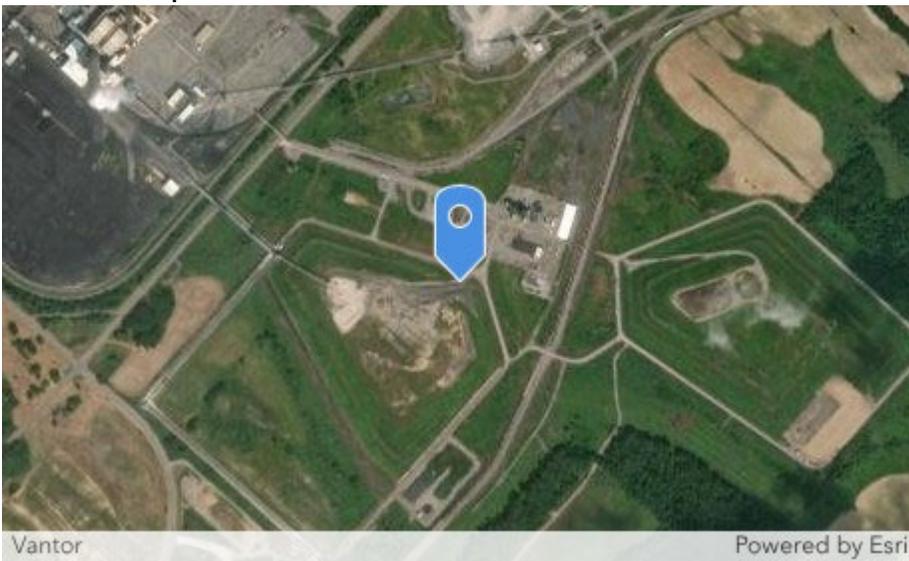
Inspection Record: 121225 124800

Feature	Longitude	Latitude	Elevation (ft)
Other	-76.6578270	41.0647560	552.264
Feature Condition			
Requires action			
Inspection Notes	Stormwater pipe off bench is partially blocked.

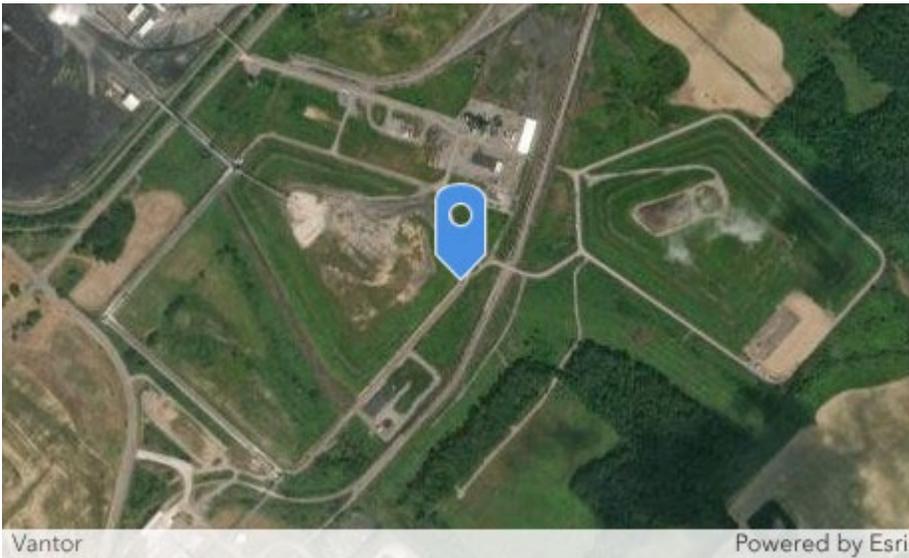
Inspection Record: 121225 125131

Feature	Longitude	Latitude	Elevation (ft)
Other	-76.6569870	41.0634075	542.093
Feature Condition			
Requires action			
Inspection Notes	Stormwater pipe partially filled in.

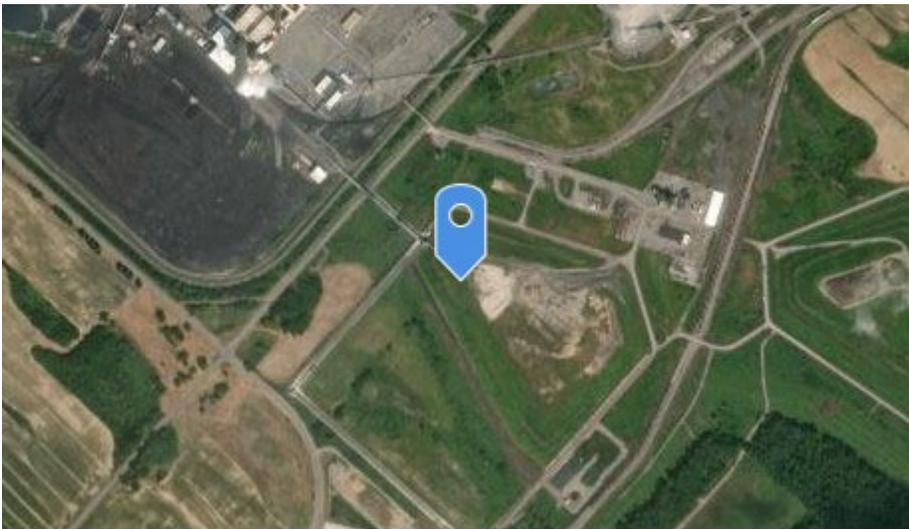
Inspection Record: 121225 131104

Feature	Longitude	Latitude	Elevation (ft)
Embankment	-76.6610233	41.0645663	574.574
Feature Condition			
Requires action			
Embankment	Embankment Factor		
EmbkOutsideSlope	Animal Burrows

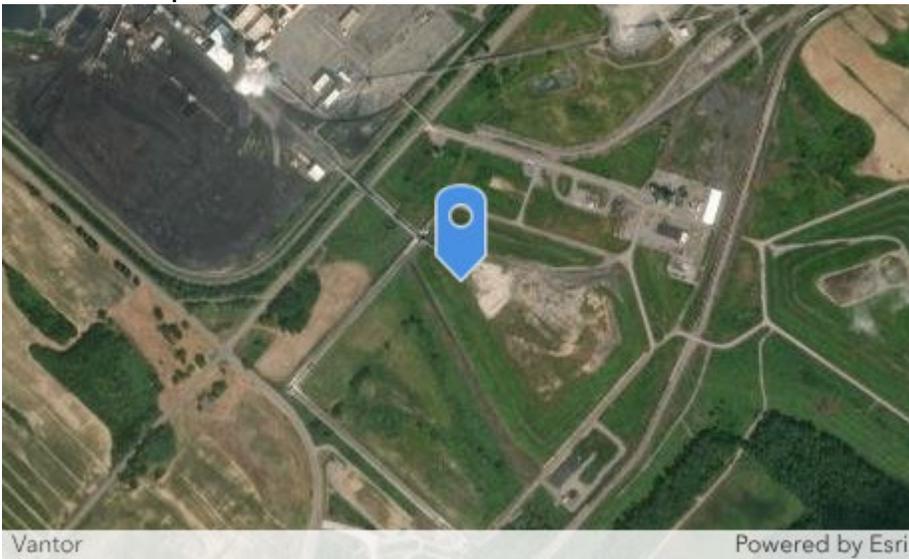
Inspection Record: 121225 131135

Feature	Longitude	Latitude	Elevation (ft)
Embankment	-76.6609833	41.0645435	573.261
Feature Condition			
Requires			
Embankment	Embankment Factor		
EmbkOutsideSlope	Animal Burrows

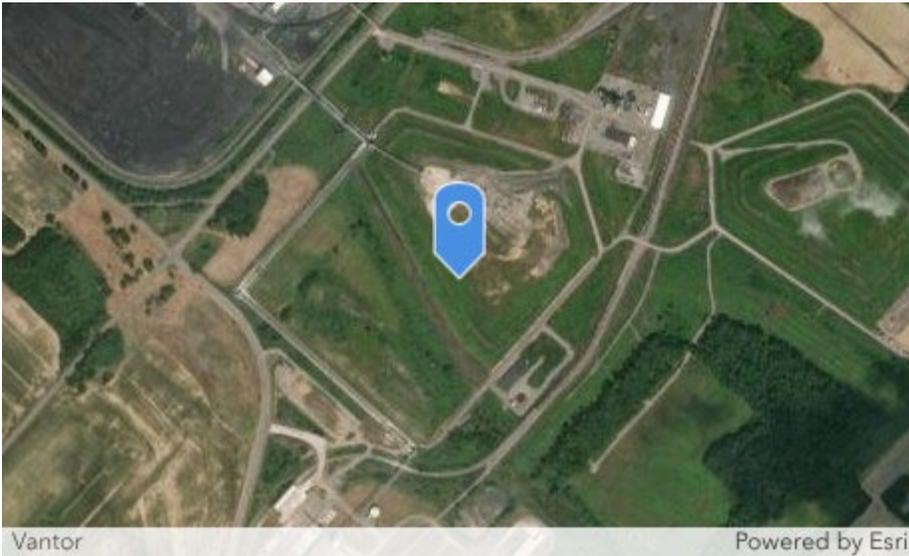
Inspection Record: 121225 131528

Feature	Longitude	Latitude	Elevation (ft)
Embankment	-76.6598323	41.0630172	580.807
Feature Condition			
Requires action			
Embankment	Embankment Factor		
EmbkOutsideSlope	Animal Burrows

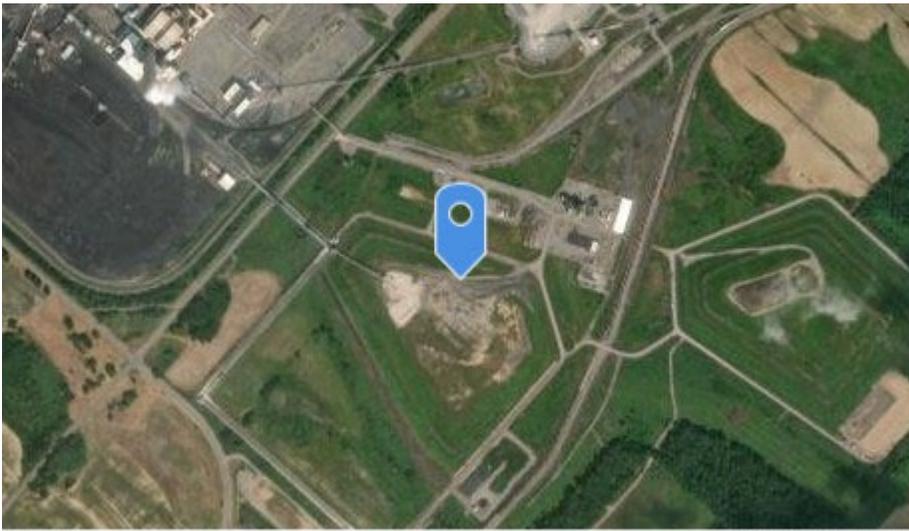
Inspection Record: 121225 132357

Feature	Longitude	Latitude	Elevation (ft)
Other	-76.6590470	41.0646853	571.949
Feature Condition			
Requires action

Inspection Notes	Stormwater pipe is partially blocked.
------------------	---------------------------------------

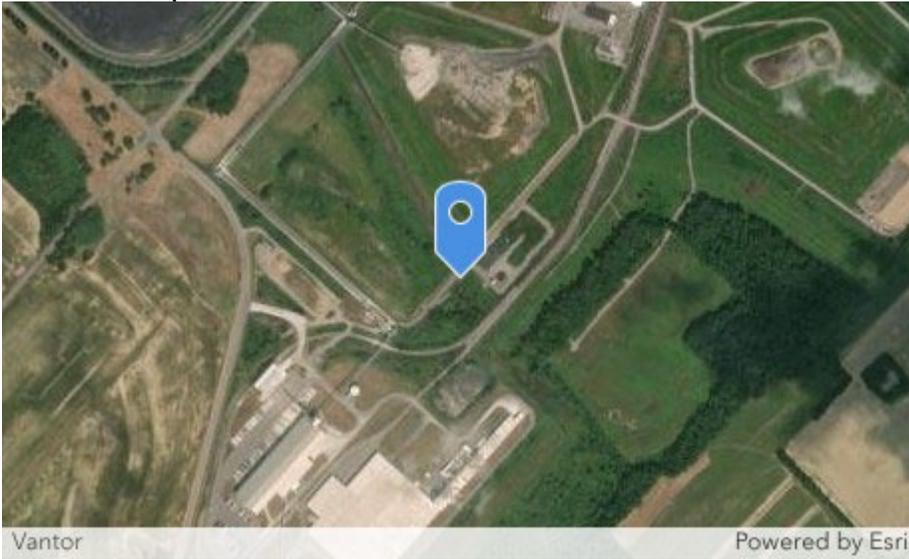
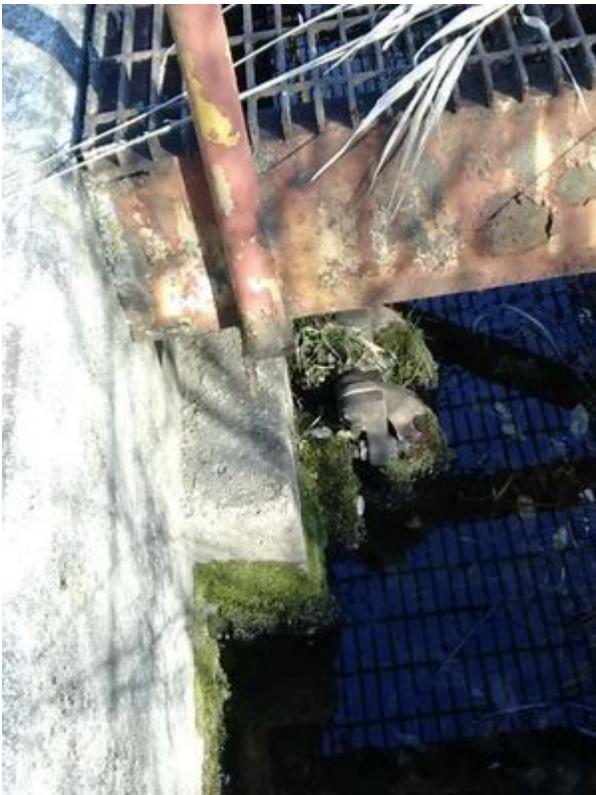
Inspection Record: 121225 133519

Feature	Longitude	Latitude	Elevation (ft)
Vegetation	-76.6594300	41.0610325	523.065
Feature Condition			
Requires action this season			
Inspection Notes	Remove vegetation from flapper.
